Re: Colorado Interstate Gas Company, L.L.C.
Docket No. CP19-56-000
CIG High Plains Kiowa Lateral Expansion Project
Weekly Environmental Inspector Report No. 10

| CIG Weekly Environmental Inspector Report No. 10 | | |
| Project Name: | CIG High Plains Kiowa Lateral Expansion Project | |
| Reporting Period: | June 16, 2019 to June 22, 2019 | |

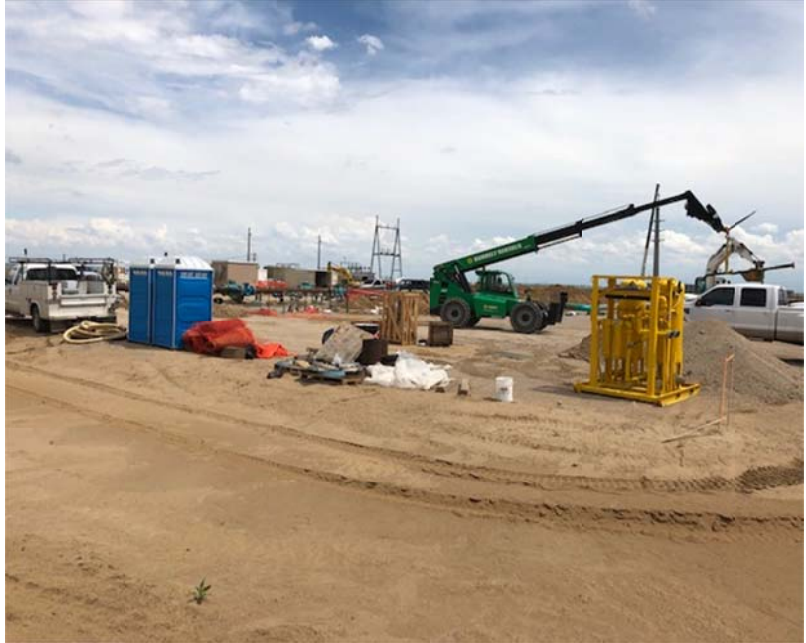
Location: Prairie Hound Meter Station
Direction of Photo: South
Description: Prairie Hound Meter Station

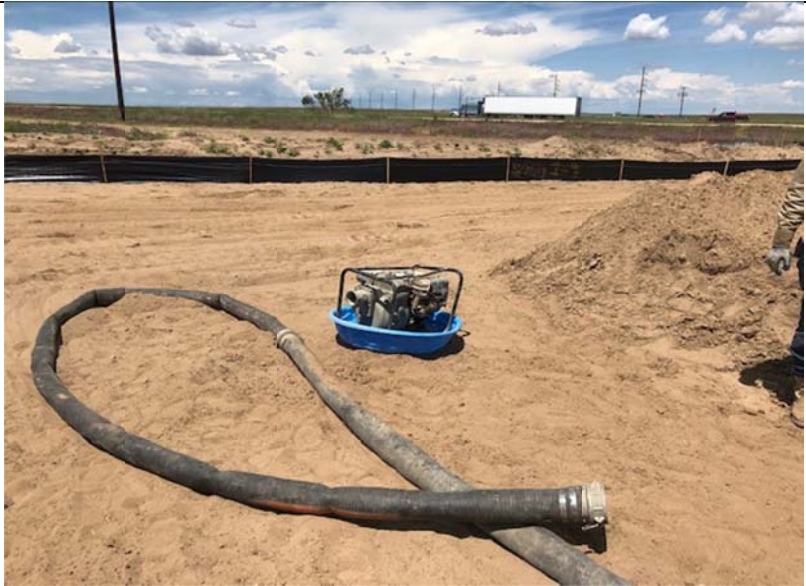
Location: STA 16+29
Direction of Photo: West
Description: Water pump in secondary containment.

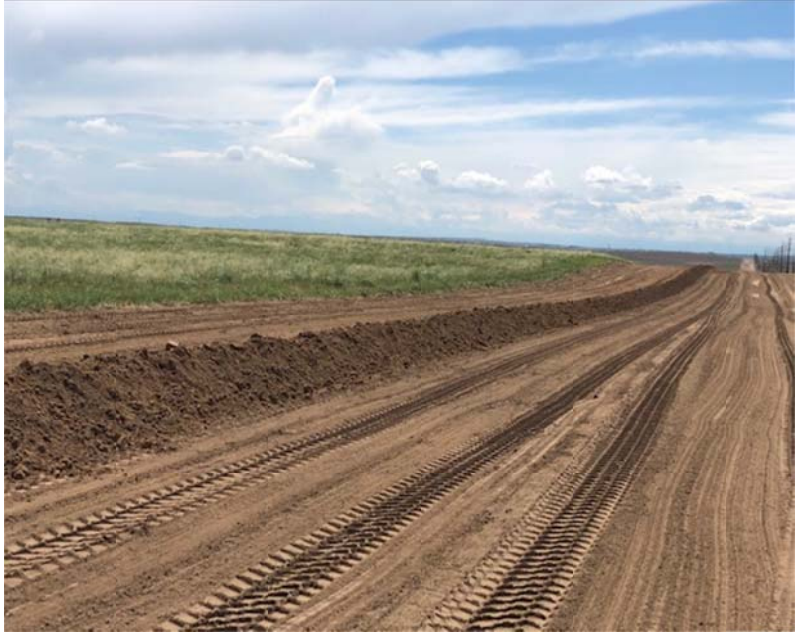
Location: STA 355+00
Direction of Photo: Southwest
Description: ROW being graded and the ditch line crowned.

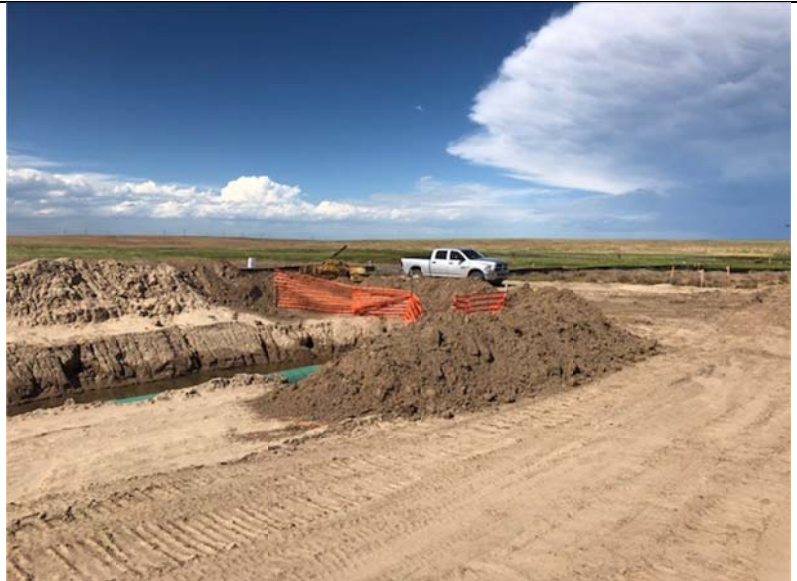
Location: STA 77+00
Direction of Photo: Northeast
Description: Bell Hole

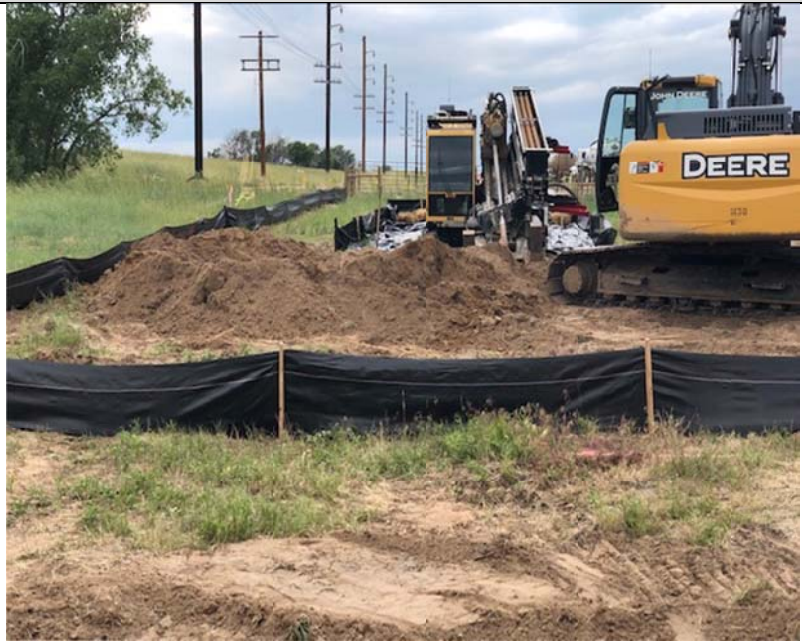
Location: STA 125+50
Direction of Photo: West
Description: Environmental controls

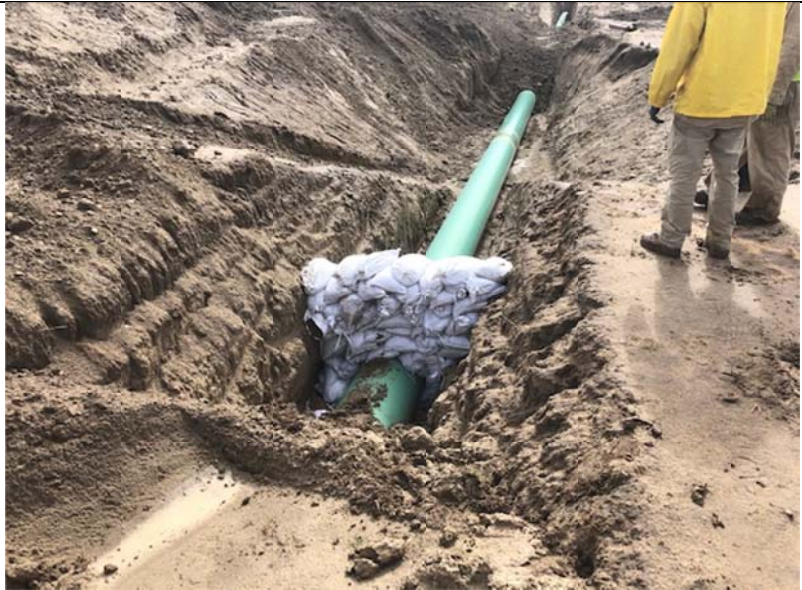
Location: STA 50+50
Direction of Photo: East
Description: Sand bag trench breaker installed.

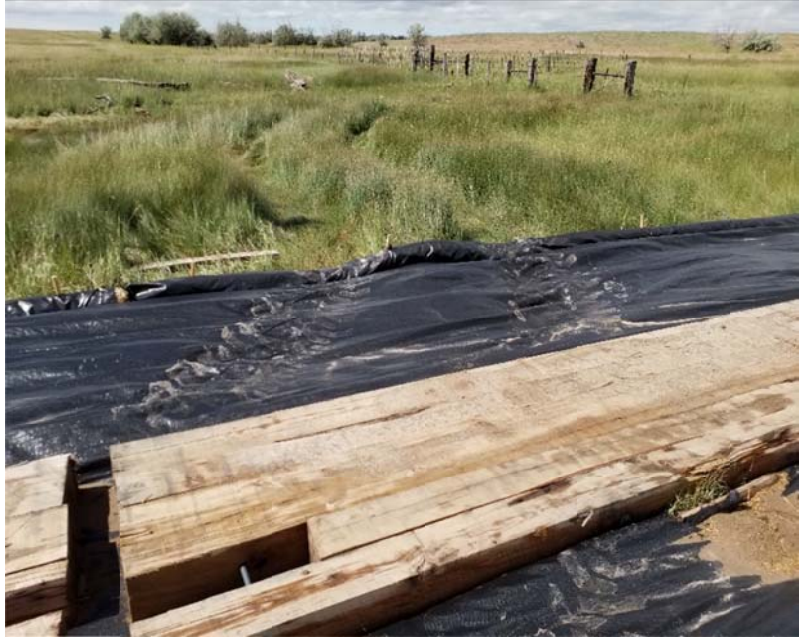
Location: STA 69+50

| <p>On June 22, a backhoe operator from United Power accessed an adjacent ROW, not related to the Kiowa Lateral project. United Power is a local contractor and not associated with the Kiowa Lateral Project. This off-ROW access occurred through a wetland. CIG contacted United Power and explained the concerns with off-ROW access through wetlands. Photographs are attached.</p> | | |

Description: United Power Company's rubber tire hoe got off the mats and went south, then west to their ROW tracking and making ruts through the wetland.

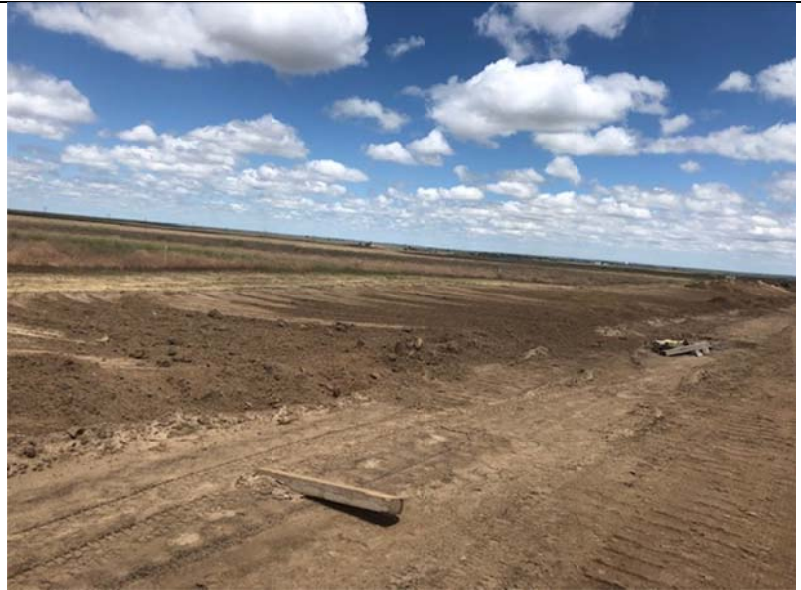
Location: STA 49+50

Description: ROW graded after backfill.
