Re: Colorado Interstate Gas Company, L.L.C.  
Docket No. CP19-56-000  
CIG High Plains Kiowa Lateral Expansion Project  
Weekly Environmental Inspector Report No. 11

<b>CIG Weekly Environmental Inspector Report No. 11</b>		
<b>Docket No. CP19-56-000</b>		
<b>Project Name:</b>	CIG High Plains Kiowa Lateral Expansion Project	
<b>County/State:</b>	Weld County, Colorado	<b>Date:</b> 7/3/2019
<b>Reporting Period:</b>	June 23, 2019 to June 29, 2019	
<b>Environmental Inspector:</b>	Ken Lupi	
<p><b>1. Summary of Construction Activity for Inspection Period:</b> During this reporting period, the pipe at the wetland located at STA 472+72 was lowered in and backfilled. The pumps and mats were removed. Work continued at the Prairie Hound and High Five Meter Stations. Tie-ins are being made and the hot taps on the High Five Lateral were completed. Lowering in and backfilling continued on Kiowa lateral.</p> <p><b>2. Relevant Environmental Activities:</b> During this reporting period, no one received environmental training. A total of one-hundred and fifty-seven (157) people have received training on the CIG High Plains Kiowa Lateral Expansion Project.</p> <p>The FERC inspection was held on June

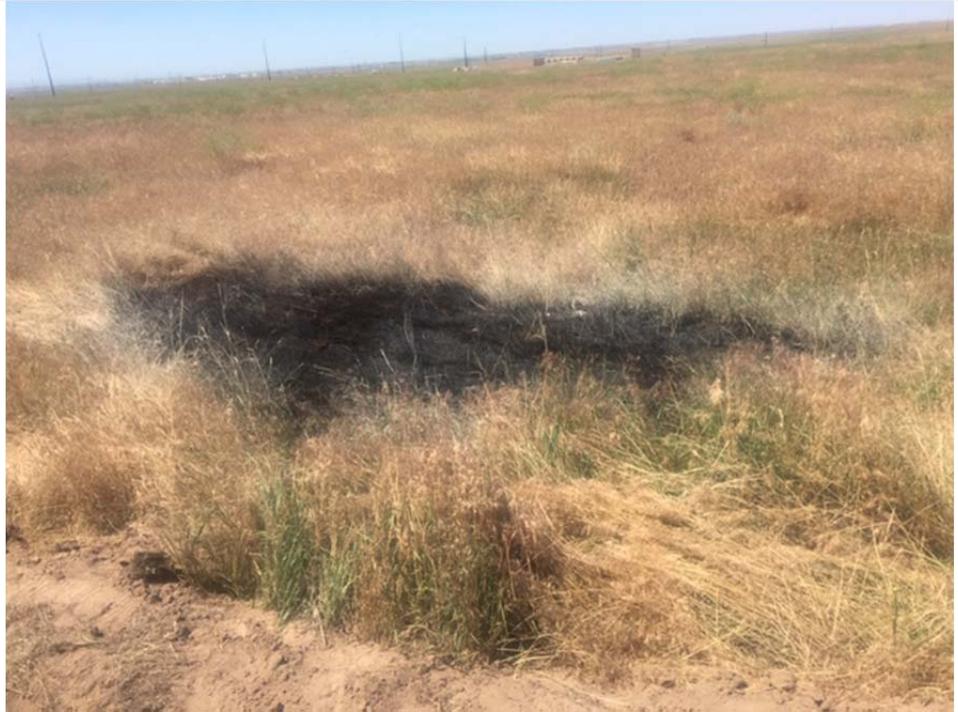
**Location:** STA  
130+00  
**Direction of Photo:**  
Northeast  
**Description:** Burned  
area.

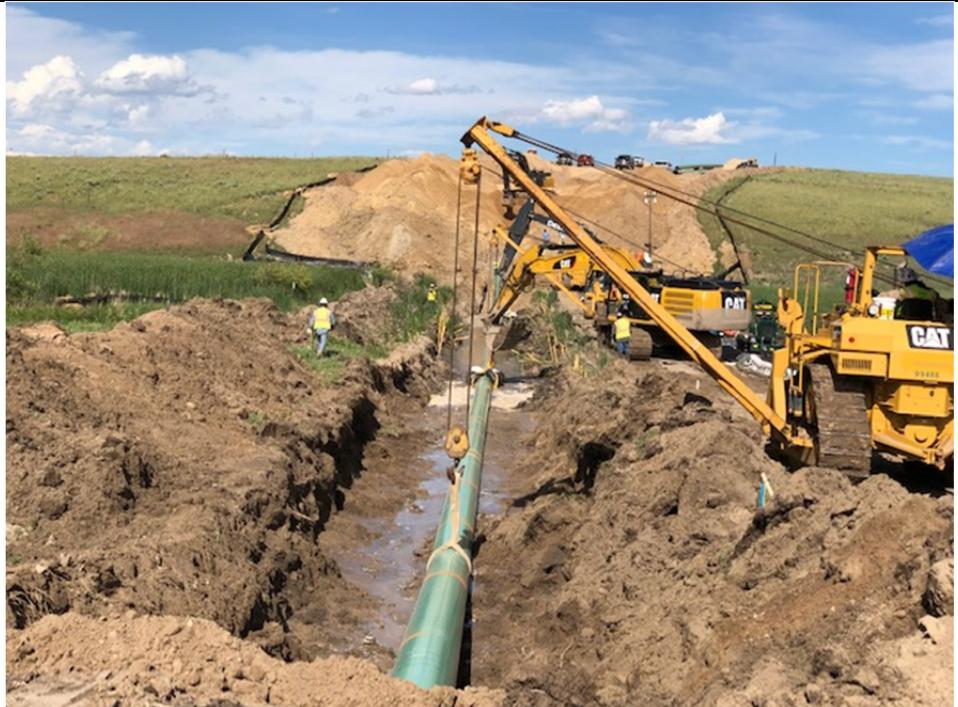
**Location:** STA  
472+73 to 470+19  
**Direction of Photo:**  
Northeast  
**Description:** Lower-in  
the pipe in the wetland  
ditch.

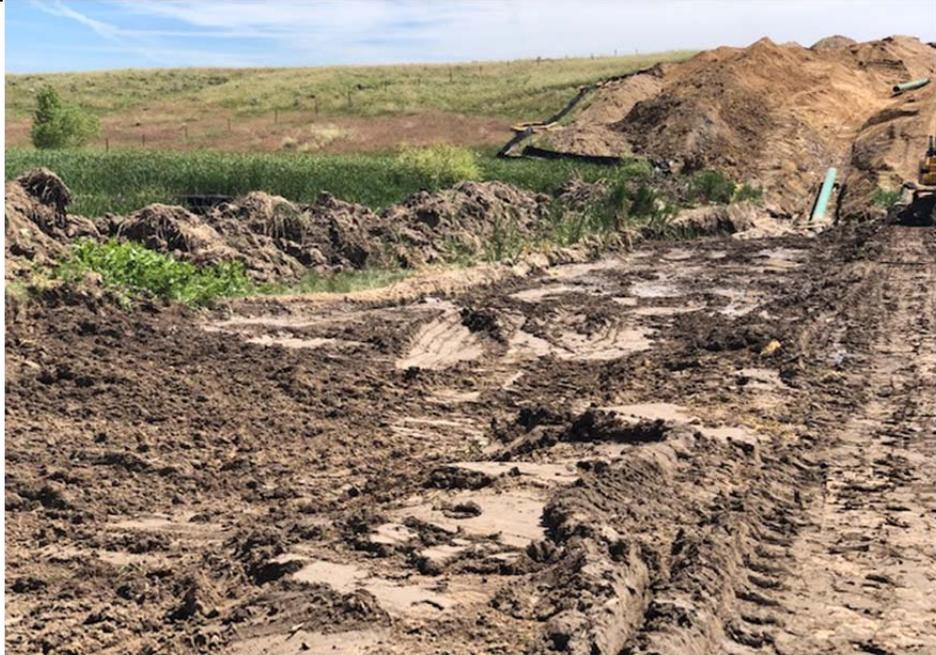
**Location:** STA  
470+19 to 472+73  
**Direction of Photo:**  
East  
**Description:** Wetland  
backfilled and ready to  
start spreading the  
topsoil.

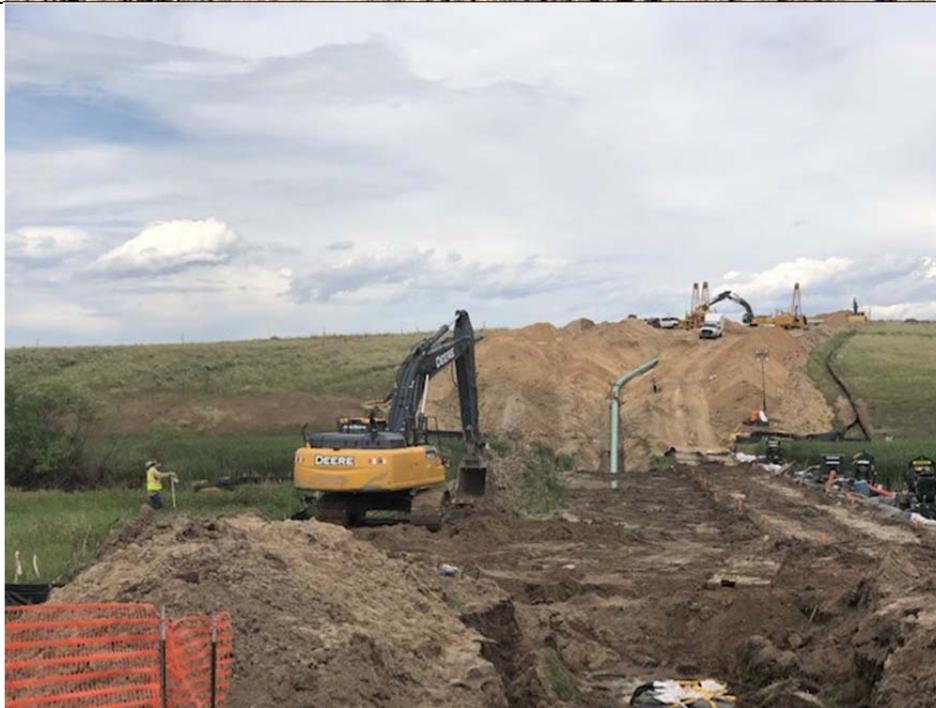
**Location:** STA  
472+50  
**Direction of Photo:**  
East  
**Description:**  
Contractor spreading  
out the topsoil.

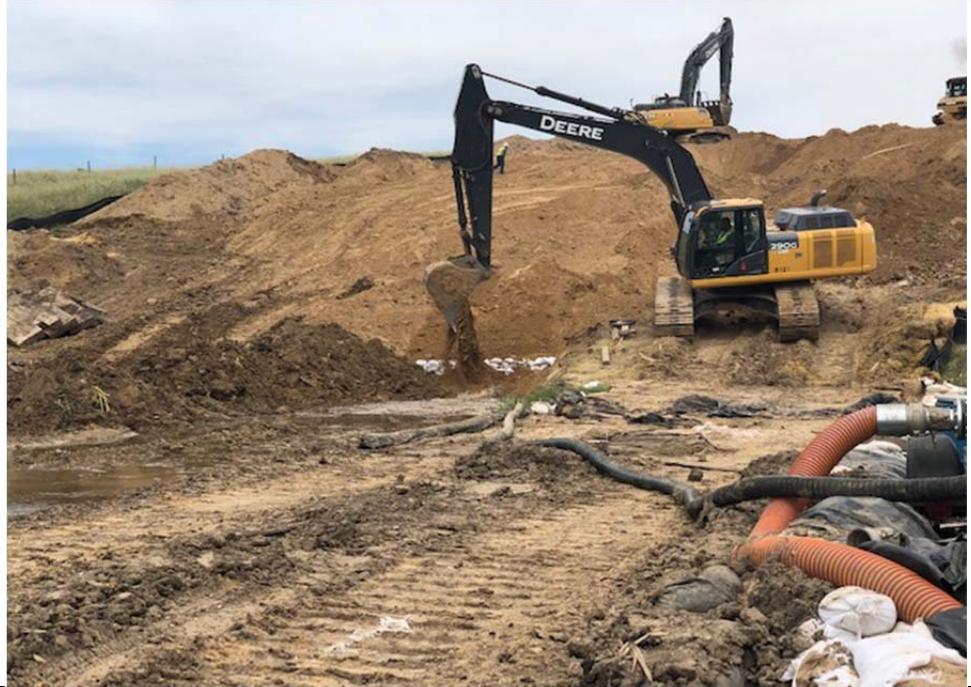
**Location:** STA  
469+90  
**Direction of Photo:**  
East  
**Description:**  
Backfilling the trench  
breaker near the  
wetland boundary.

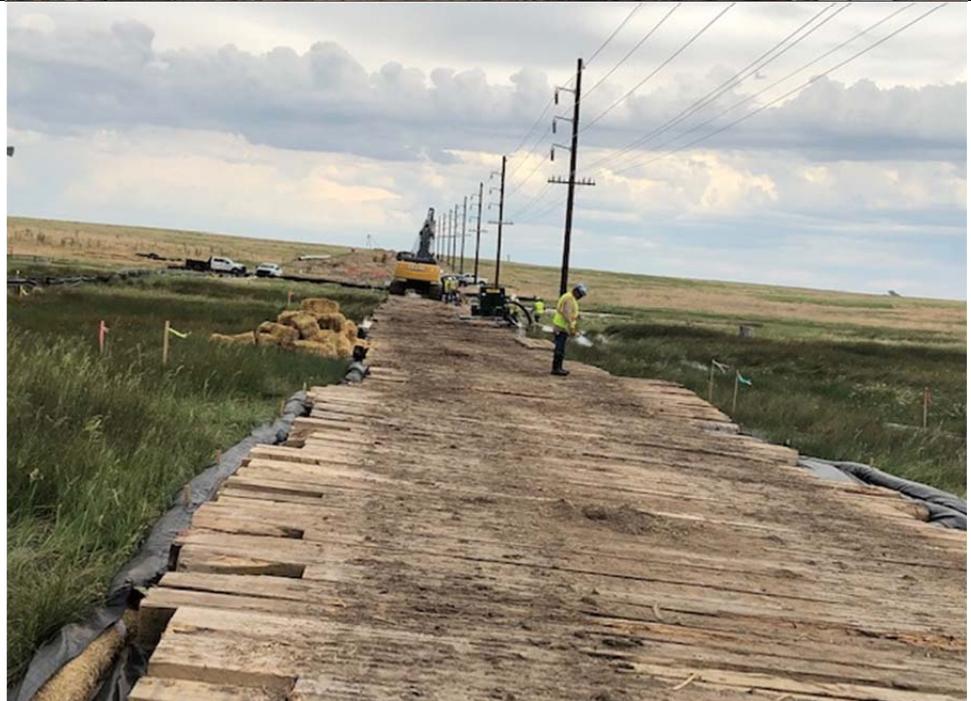
**Location:** STA  
67+47 to 73+37  
**Direction of Photo:**  
East  
**Description:**  
Wetland travel lane  
completely matted.

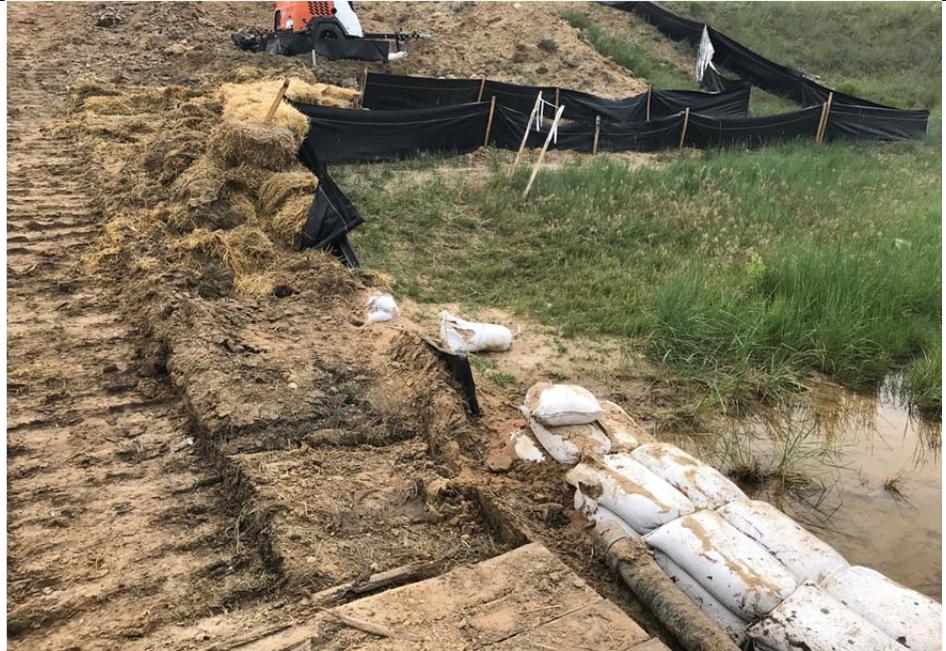
**Location:** STA  
472+42  
**Direction of Photo:**  
East  
**Description:**  
Damaged silt fence  
discovered during the  
FERC inspection.

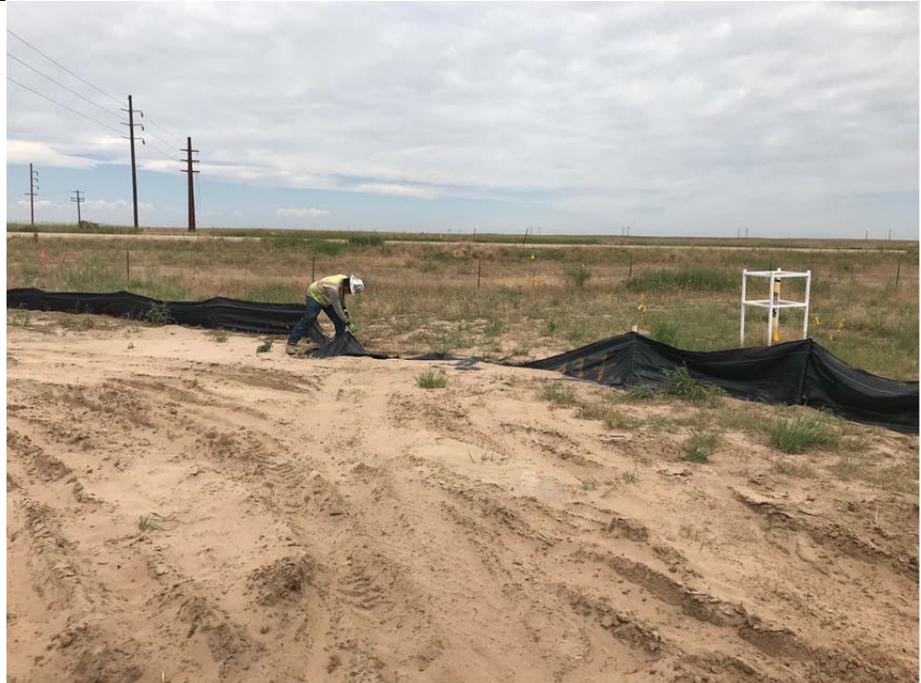
**Location:** STA 15+00

**Description:** Silt fence  
damaged from the  
power company.

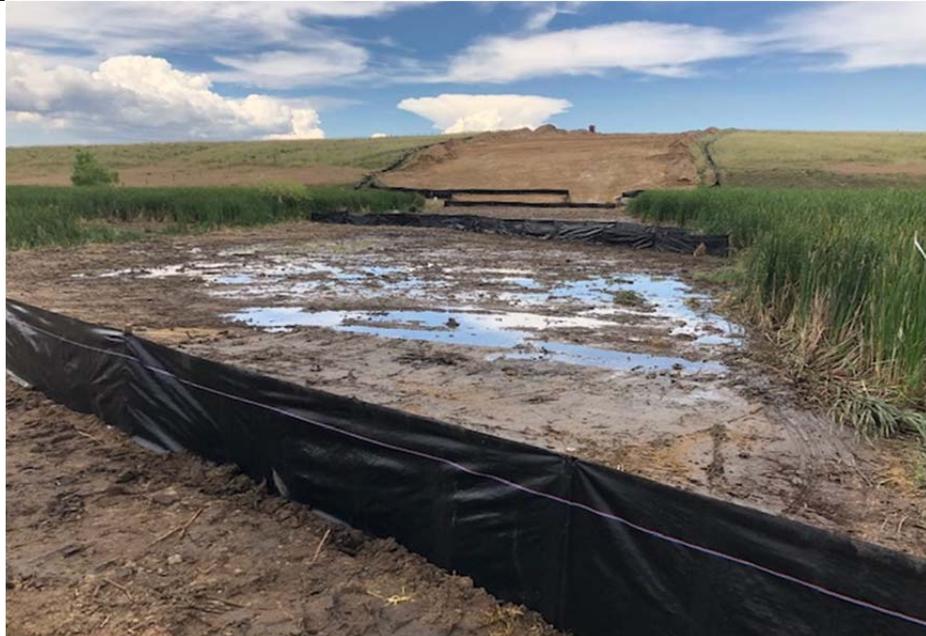
**Location:** STA  
472+73 to 470+19  
**Direction of Photo:**  
East  
**Description:** Wetland  
final cleanup.

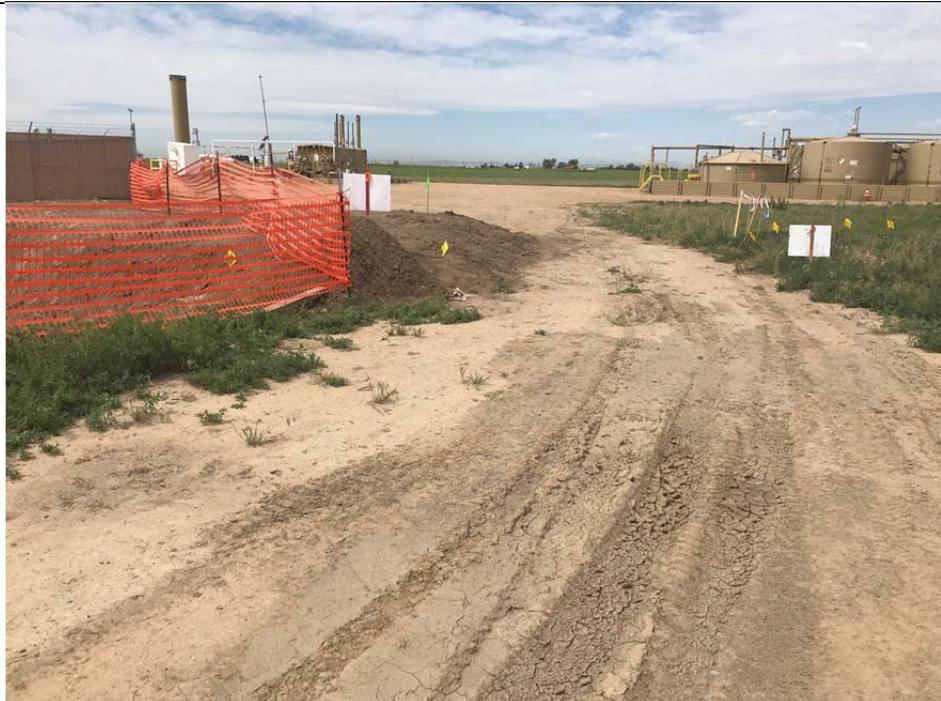
**Location:** STA  
475+20  
**Direction of Photo:**  
West  
**Description:** Extra  
workspace required  
for coating repairs
