Docket No. CP19-28-000

Northern Delaware Basin Expansion Project Weekly Environmental Inspector Report No. 13

EPNG Weekly Environmental Inspector Report No. 13		
Docket No. CP19-28-000		
Project Name:	Northern Delaware Basin Expansion Project	
County/State:	Winkler, Ector, Crane and Upton	Date : 5/30/2019
Reporting Period:	Counties, Texas May 19, 2019 to May 25, 2019	
Environmental Inspector:	David McCullough

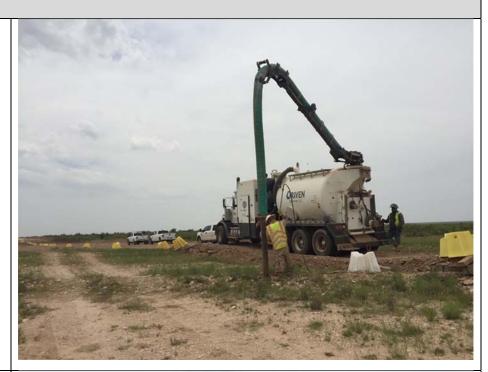
Description: Potholing an unknown foreign line near Station No. 702+00 with a hydrovac truck.

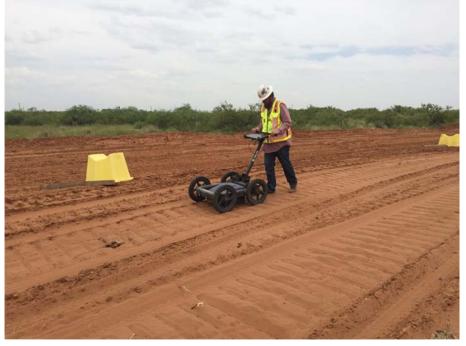
No. 641+00

Description: Utilizing ground penetrating radar to locate unknown foreign lines.

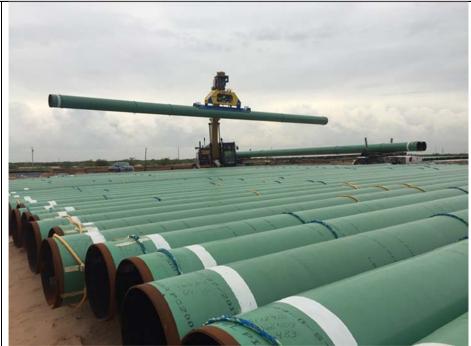
Location: Keystone Compressor Station **Direction of Photo:**

Description: Loading out pipe for delivery to the new loop line

ROW.

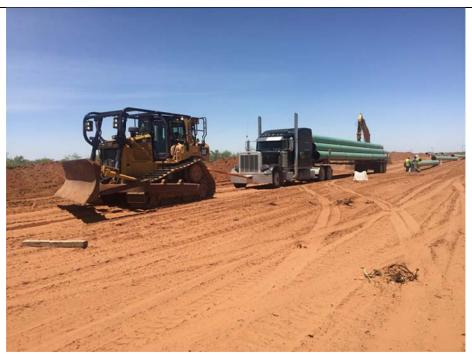
No. 504+00

Description: Pulling one of the pipeline trucks through a sandy area with a dozer.

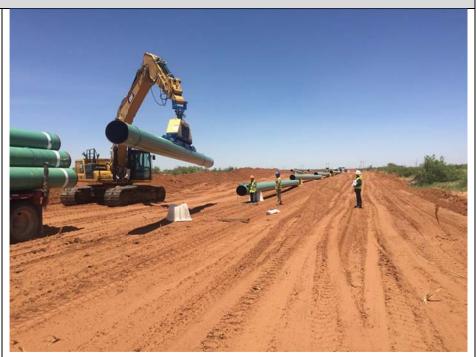
No. 504+00

Description: Stringing pipe along the ROW.

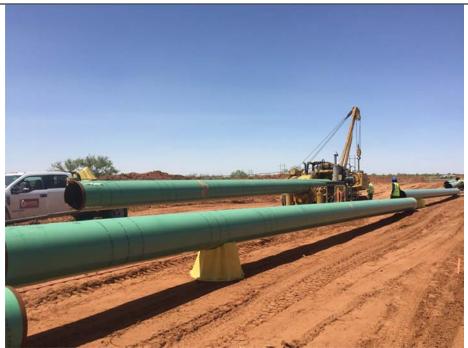
No. 486+00

Description: Bending pipe along the ROW.

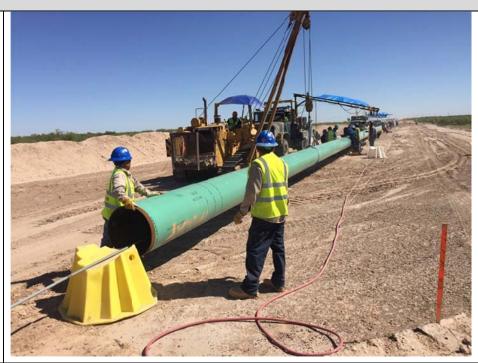
No. 311+00

Description: Lining up the pipe for a weld.

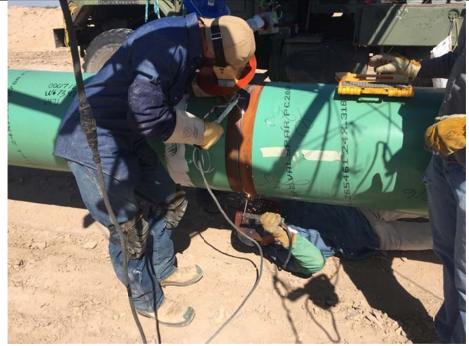
No. 309+00

Description: Making an initial weld on the

pipe.

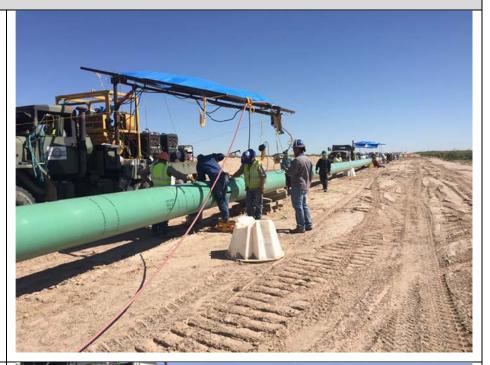
No. 311+00

Description: Welding

activities.

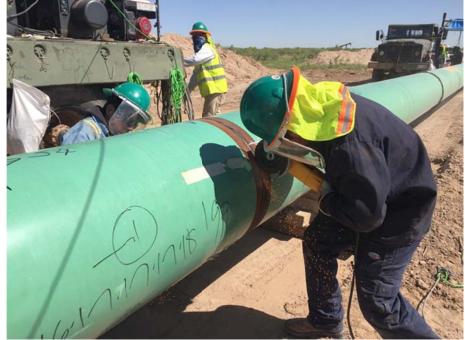
No. 312+00

Description: Grinding

a weld.

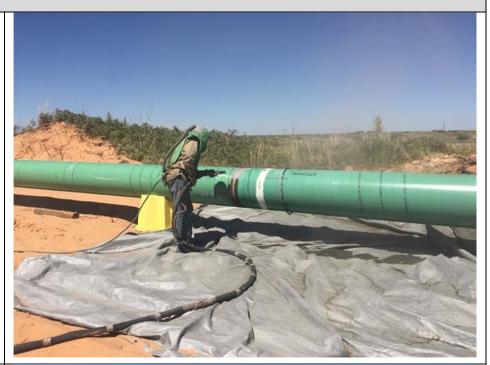
No. 59+00

Description: Abrasive blasting a weld prior

to coating.

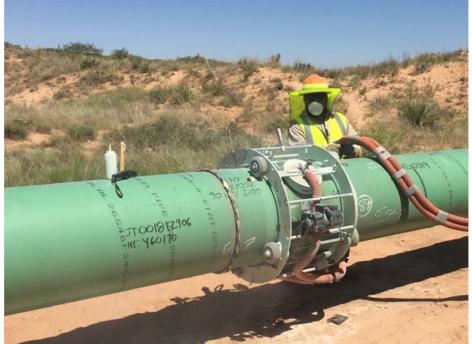
No. 56+00

Description: Coating

a weld.

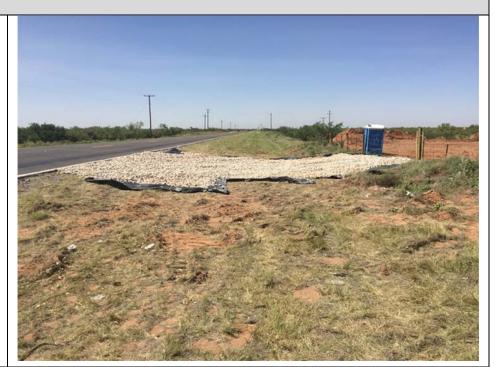
No. 401+00

Construction crossing at Texas Highway 874.

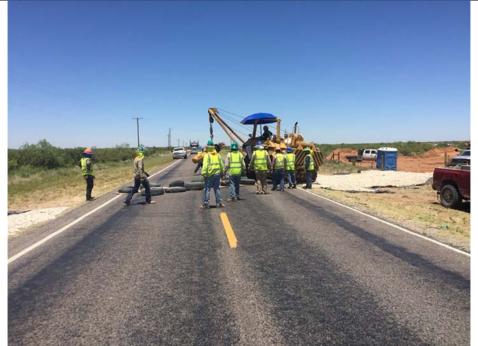
No. 401+00

Description: Crossing the welding crew equipment across Texas Highway 874.

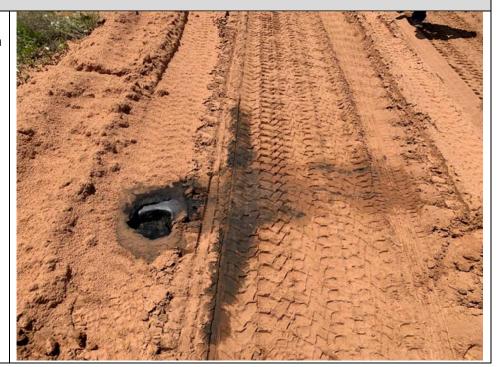
During topsoiling activities, crews encountered oil-contaminated soil at approximate Station No. 218+85 along the new loop line ROW. Upon further investigation and minimal excavation (using hand tools), crews unearthed a two-inch oil line that appears to have leaked. The contaminated soil was removed and containerized, and oil absorbent pads were used to soak up approximately 0.5 to 1 gallon of pooled oil. Contaminated soil was taken to a containment structure at the Keystone Compressor Station to await disposal. EPNG has identified the owner of the oil line and has contacted them.

Abandoned oil line that leaked to the surface during topsoiling activities.
