Re: El Paso Natural Gas Company, L.L.C.;
Docket No. CP19-28-000
Northern Delaware Basin Expansion Project
Weekly Environmental Inspector Report No. 14

| EPNG Weekly Environmental Inspector Report No. 14 | | |
| Project Name: | Northern Delaware Basin Expansion Project | |
| Reporting Period: | May 26, 2019 to June 1, 2019 | |

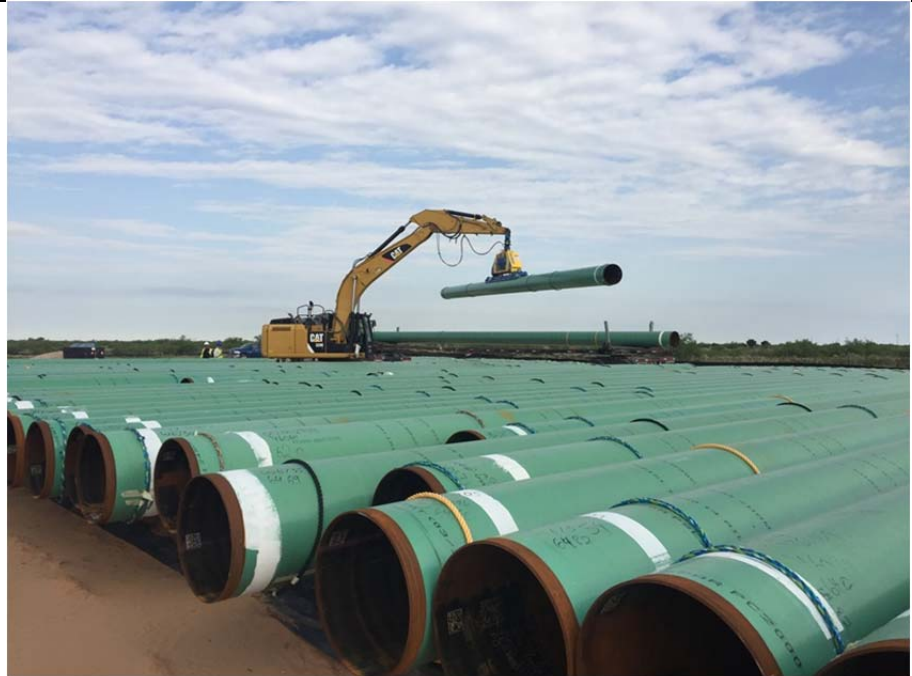
Location: Keystone
Pipeyard

Description: Loading pipe
onto a pipe truck for
delivery to the Line No.
31111 ROW.

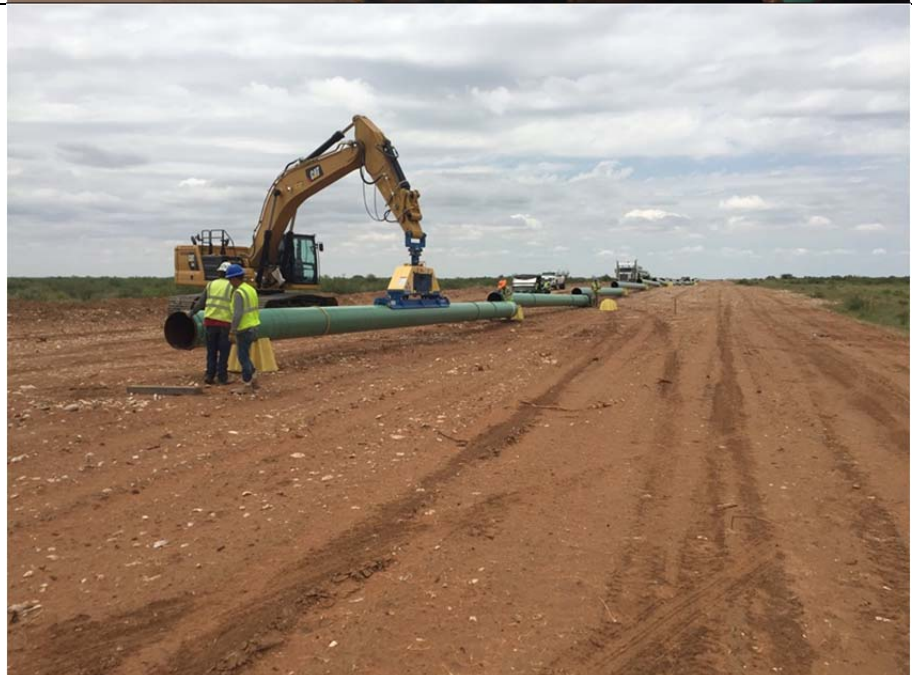
Location: Line No. 31111
Sta. 732+00

Direction of Photo: North
Description: Stringing pipe
along the ROW near Sta.
732+00.

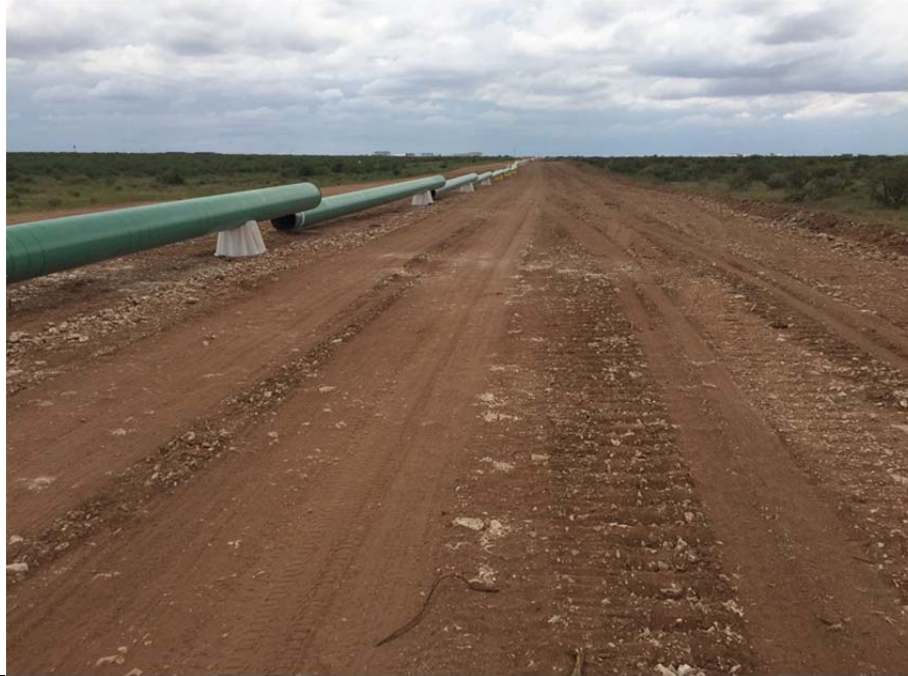
Location: Line No. 31111
Sta. 684+00

Description: Pipe strung
along the ROW near Sta.
684+00.

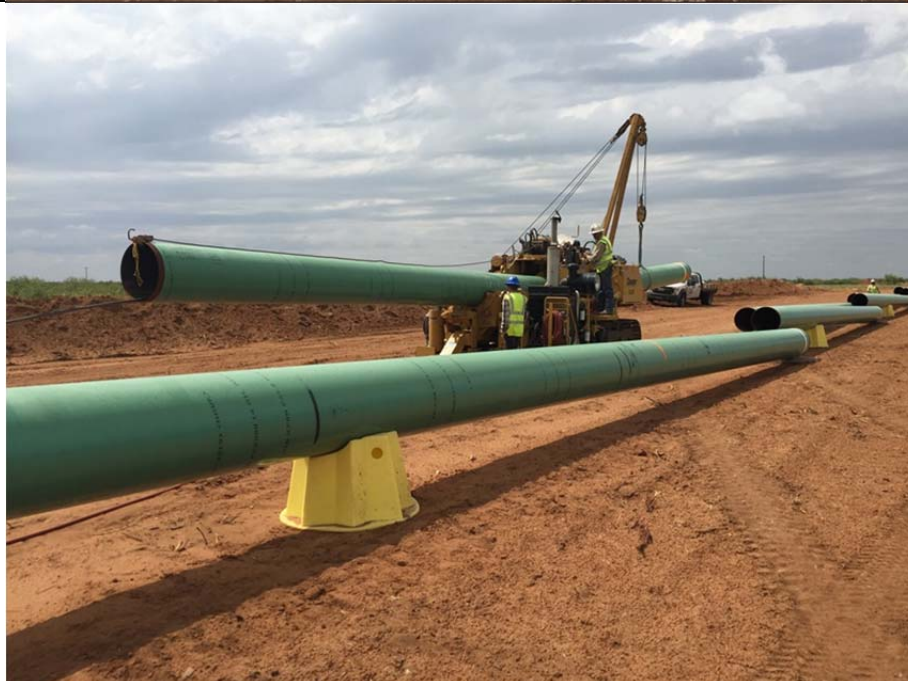
Location: Line No. 31111
Sta. 662+00

Description: Bending pipe
with the bending machine
near Sta. 662+00.

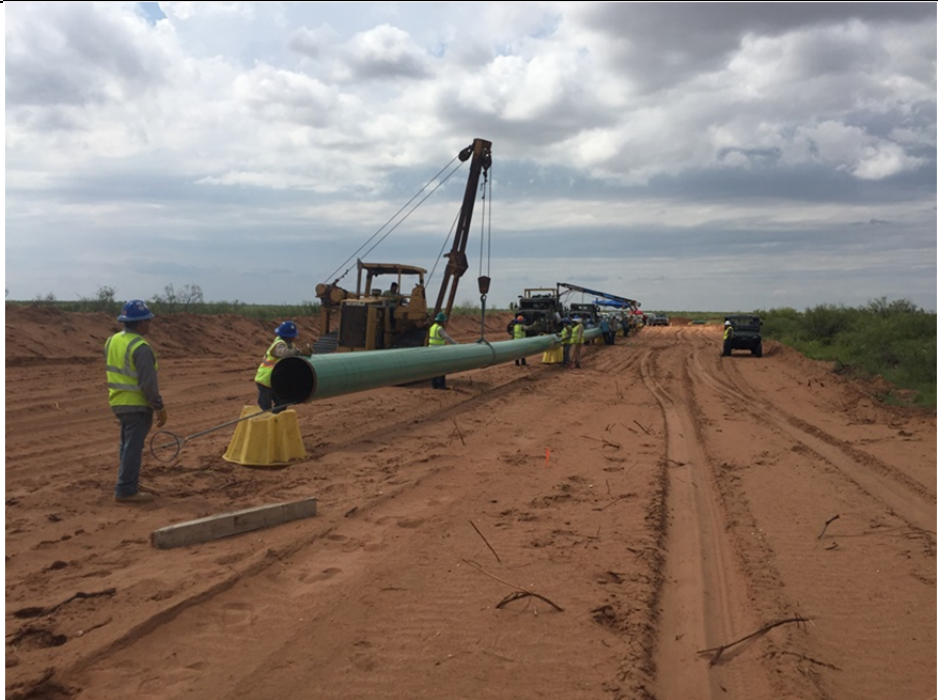
Location: Line No. 31111
Sta. 587+00

Description: Lining up a
weld with the Pipe Gang
near Sta. 587+00.

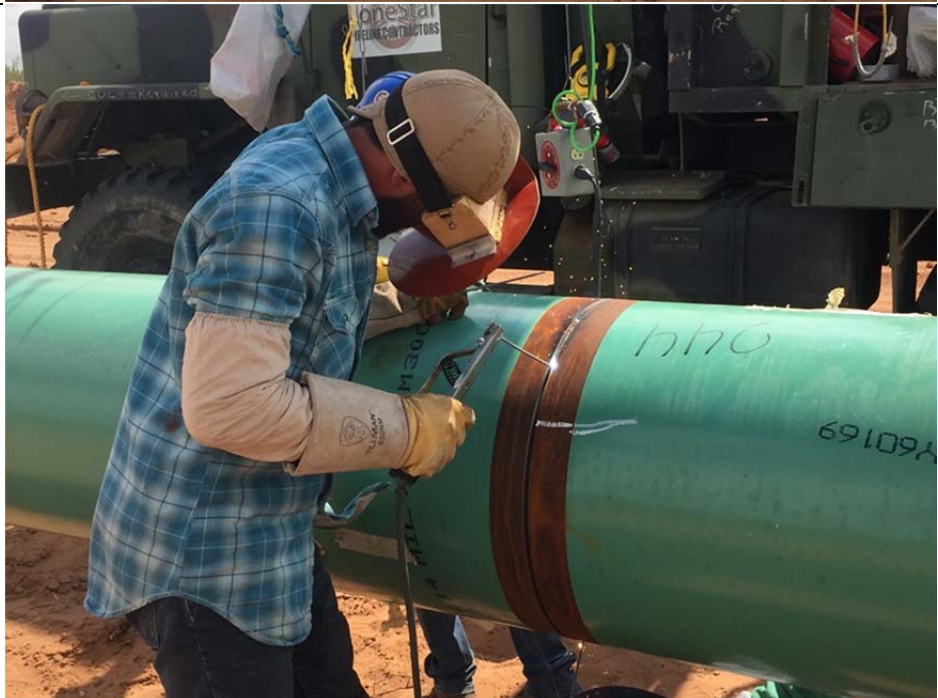
Location: Line No. 31111
Sta. 587+00

Description: Making the
initial pass on a weld
near Sta. 587+00.

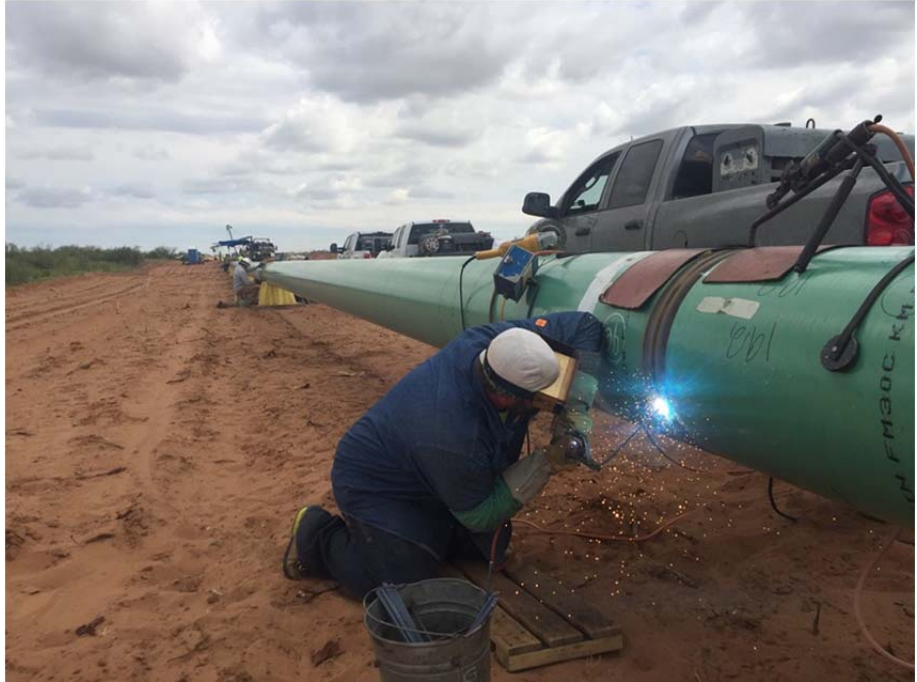
Location: Line No. 31111
Sta. 583+00
Direction of Photo: South
Description: Capping a
weld near Sta. 583+00.

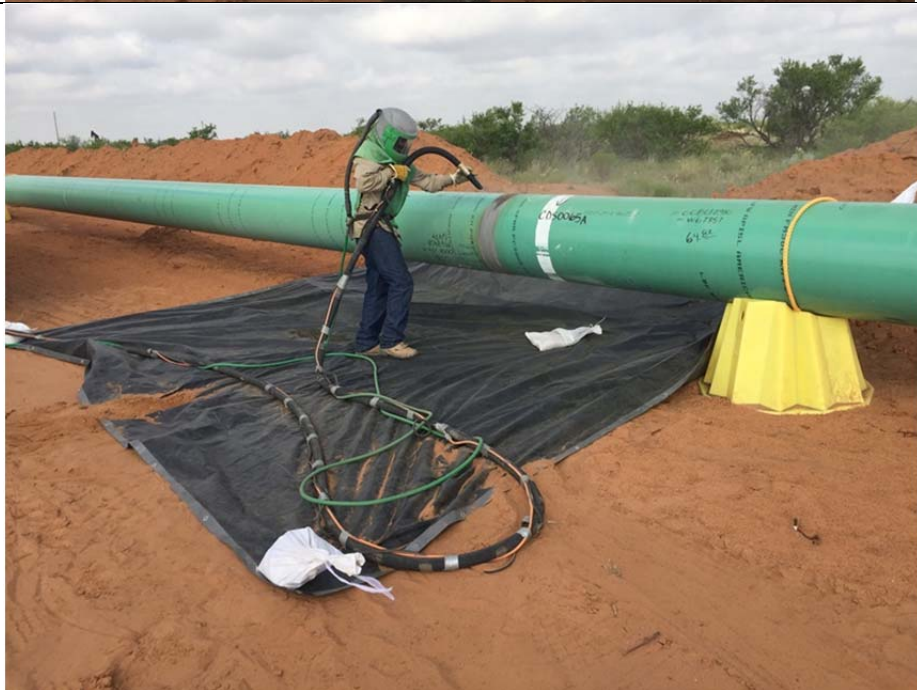
Location: Line No. 31111
Sta. 195+00
Direction of Photo: West
Description: Abrasive
blasting a weld near Sta.
195+00.

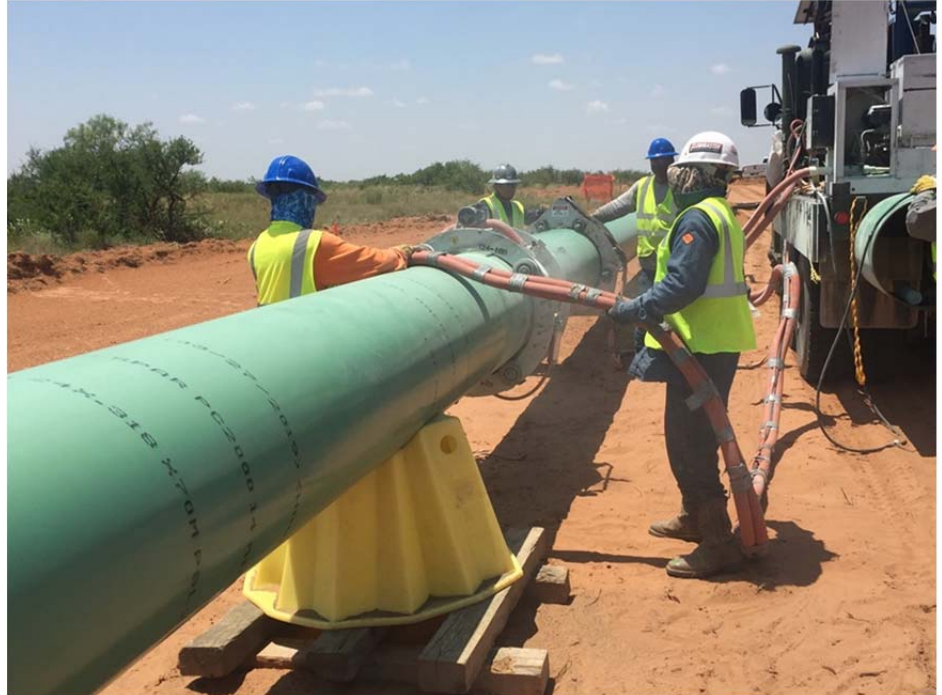
Location: Line No. 31111
Sta. 206+00
Direction of Photo:
Southwest
Description: Coating a
weld near Sta. 206+00.

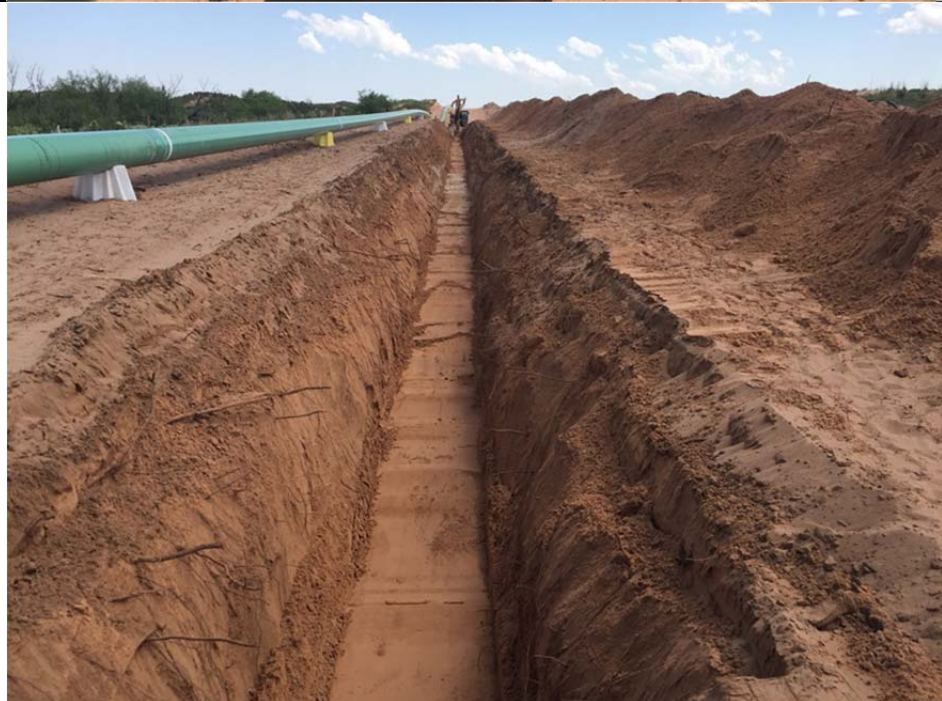
Location: Line No. 31111
Sta. 50+00
Direction of Photo: South
Description: Ditching
with a track hoe near Sta.
50+00.

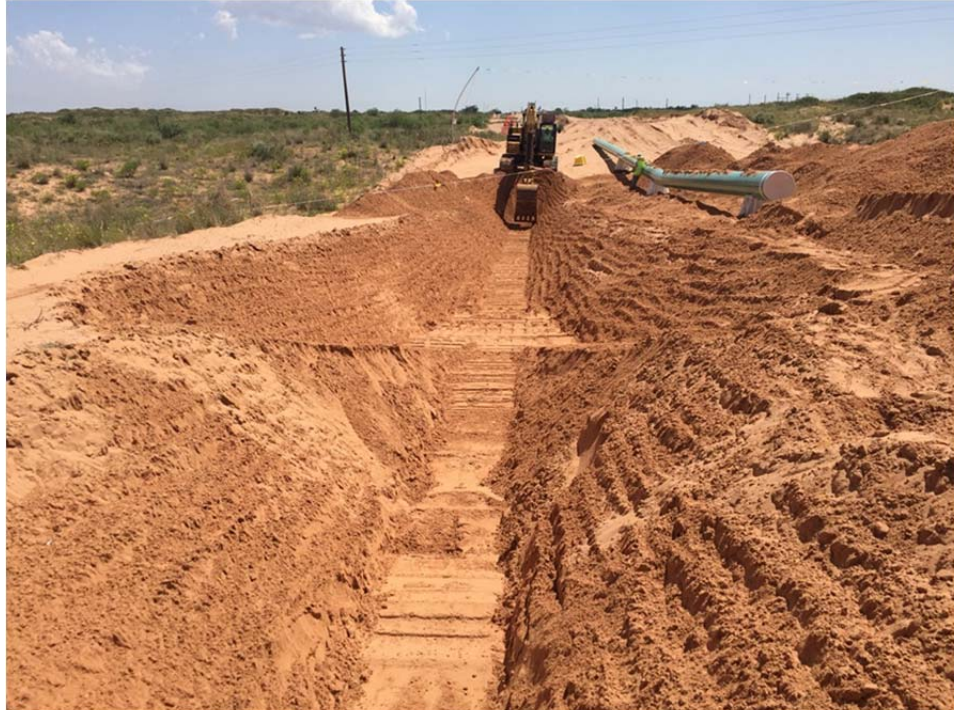
Location: Line No.
31111 Sta. 63+00

Description: Ditching
with a track hoe near
Sta.63+00.

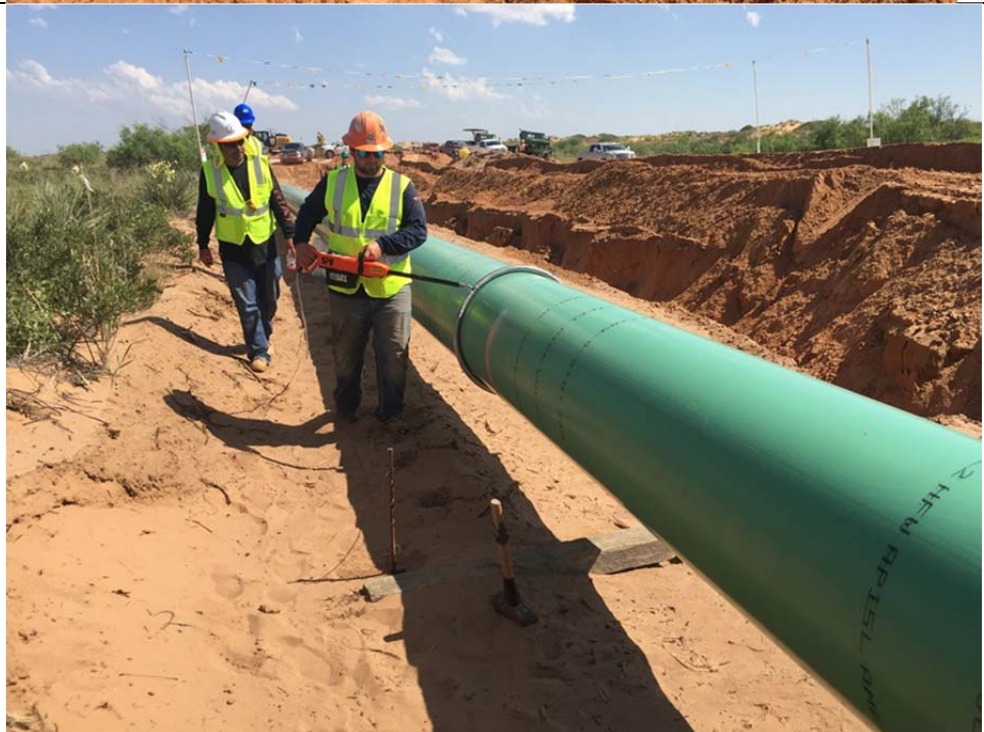
Location: Line No.
31111 Sta. 40+00

Description: Jeeping
the pipe prior to
lowering the pipe into
the ditch near Sta.
40+00.

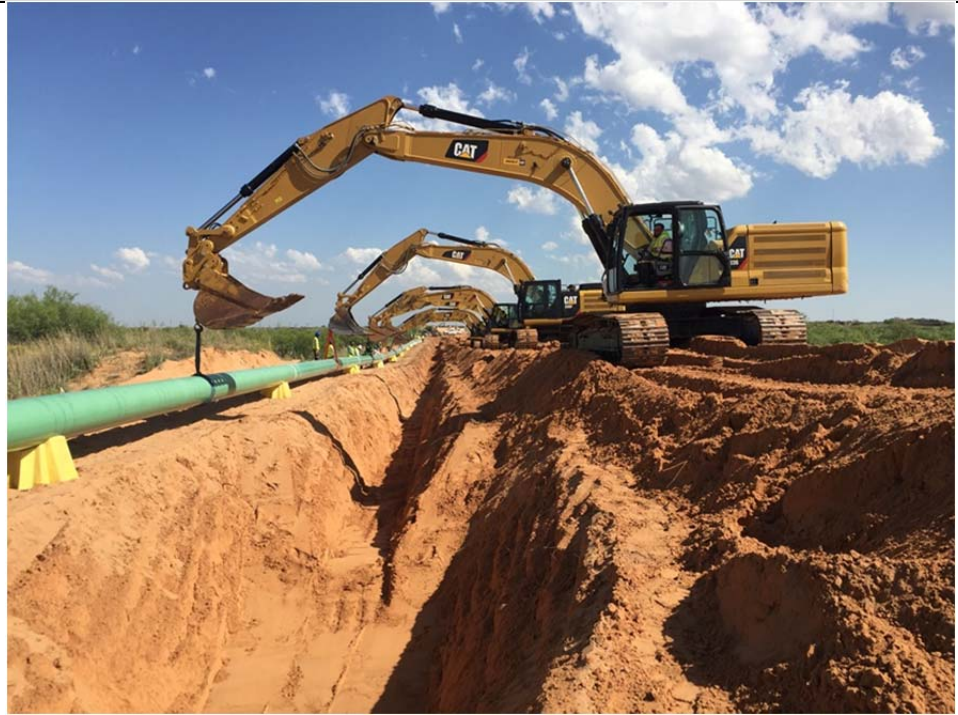
Location: Line No. 31111 Sta. 33+00
Direction of Photo: South
Description: Lowering the pipe into the ditch near Sta. 33+00.

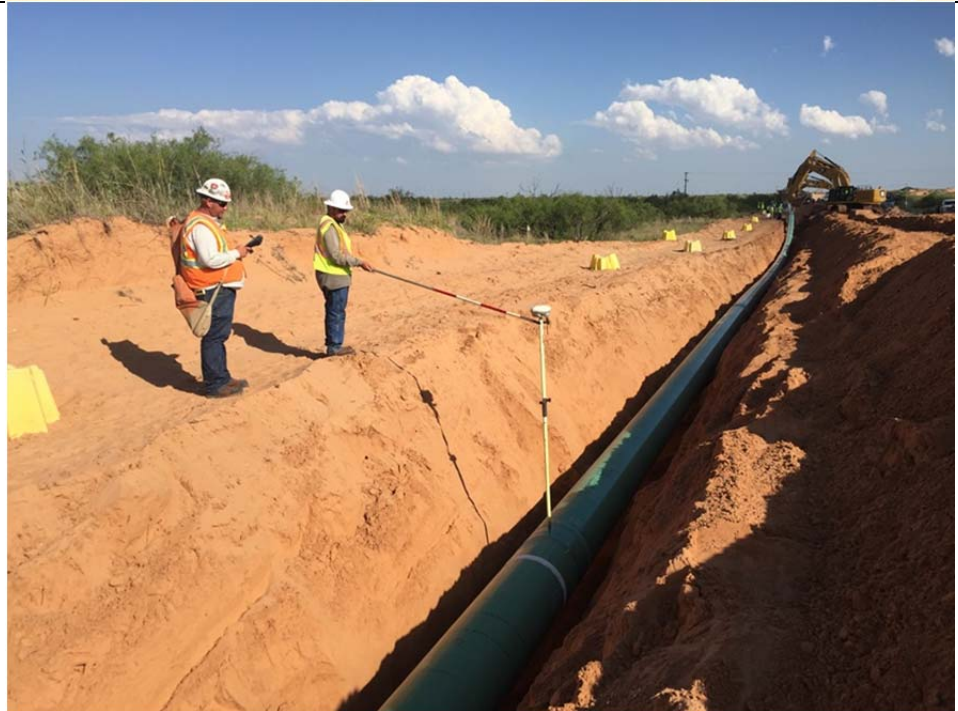
Location: Line No. 31111 Sta. 34+00
Direction of Photo: South
Description: Taking survey readings of the pipe in the ditch near Sta. 34+00.

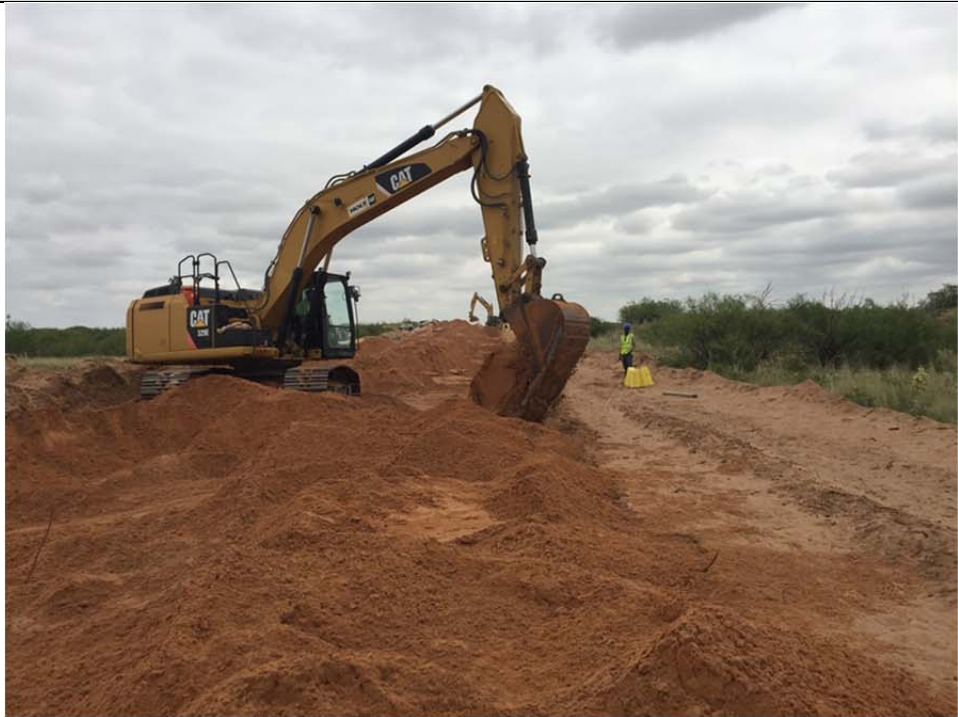
Location: Line No.
31111 Sta. 39+00
Direction of Photo:
North
Description: Backfilling
the ditch near Sta.
39+00.

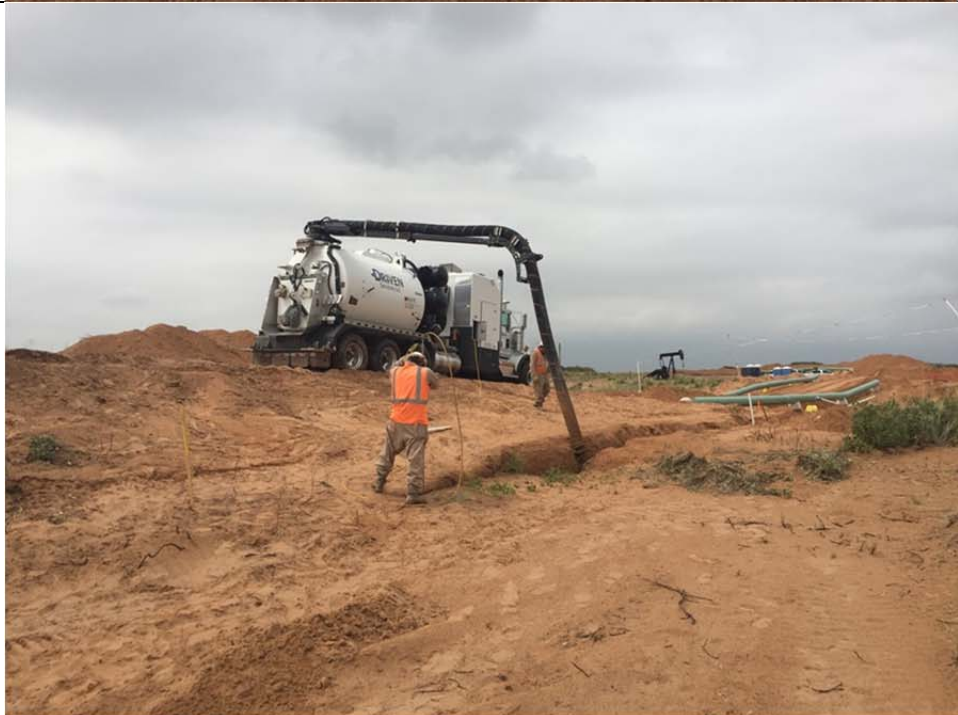
Location: Line No.
31111 Sta. 67+00
Direction of Photo:
North
Description: Potholing
for foreign lines near
Sta. 67+00.

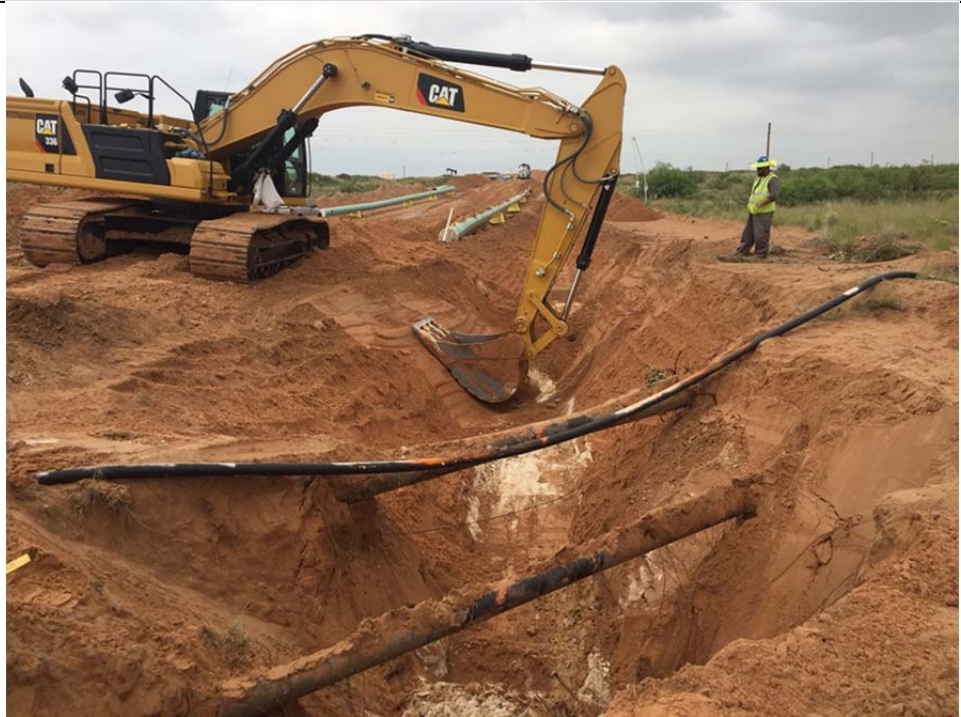
31111 Sta. 72+00

Excavating foreign lines
near Sta. 72+00.

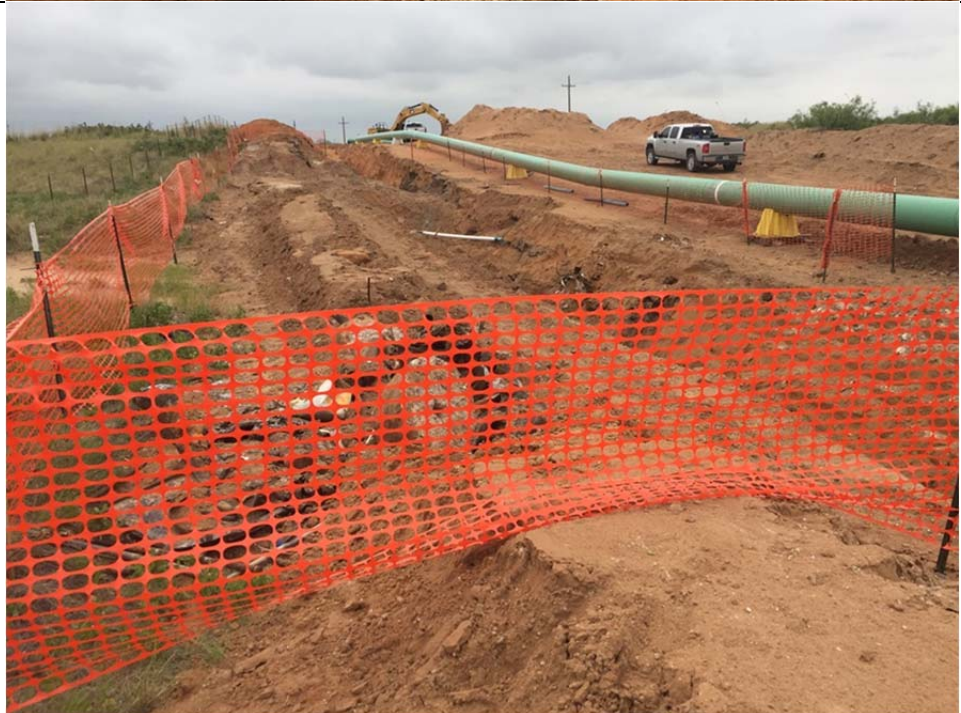
31111 Sta. 10+00

Description: An old
disposal area that was
dug through during
ditching near Sta.
10+00. Samples were
collected for testing to
see if they consist of
asbestos containing
material.
