Re: El Paso Natural Gas Company, L.L.C.;
Docket No. CP19-28-000
Northern Delaware Basin Expansion Project
Weekly Environmental Inspector Report No. 15

EPNG Weekly Environmental Inspector Report No. 15		
Docket No. CP19-28-000		
Project Name:	Northern Delaware Basin Expansion Project	
County/State:	Winkler, Ector, Crane and Upton Counties, Texas	Date: 6/13/2019
Reporting Period:	June 2, 2019 to June 8, 2019	
Environmental Inspector:	David McCullough	
<p>1. Summary of Construction Activity for Inspection Period:</p> <p>During this reporting period, mainline welding activities continued along the new loop line (Line No. 31111), with crews completing welds from Station No. 700+00 up to Wink Compressor Station at Station No. 762+38. Abrasive blasting and coating activities continued between Station No. 228+00 and Station No. 618+00. Additionally, ditching, lowering in, and backfill activities were conducted along the new loop line.</p> <p>Ditching activities were conducted between Station No. 94+00 and Station No. 212+00.</p> <p>Lowering-In activities were conducted between Station No. 62+00 and Station No. 168+00.</p> <p>Backfill activities were conducted between Station No. 62+00 and

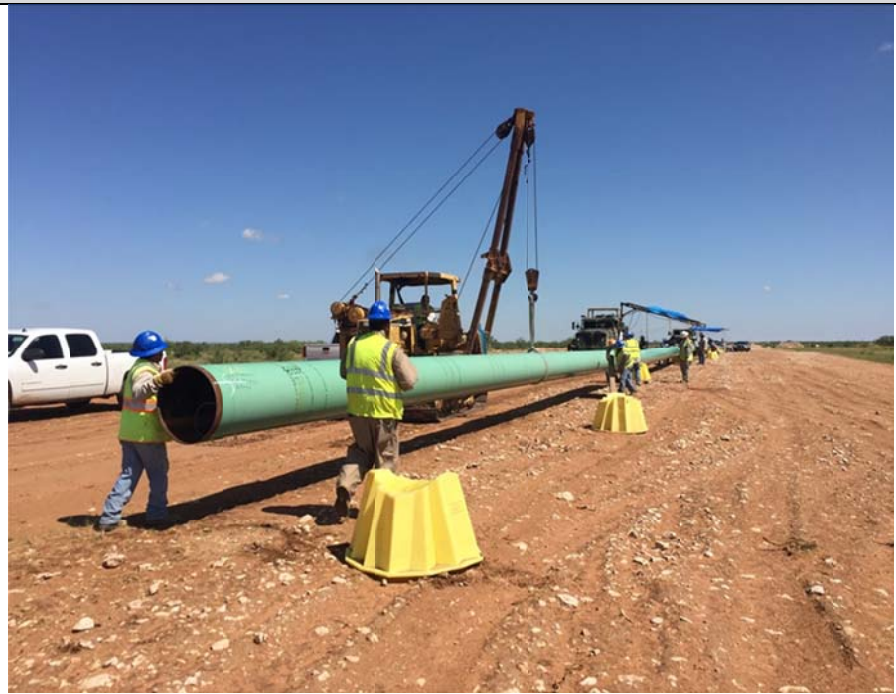
Location: Line No.
31111 ROW at Station
No. 721+00
Direction of Photo:
North
Description: Mainline
welding crew lining up a
weld.

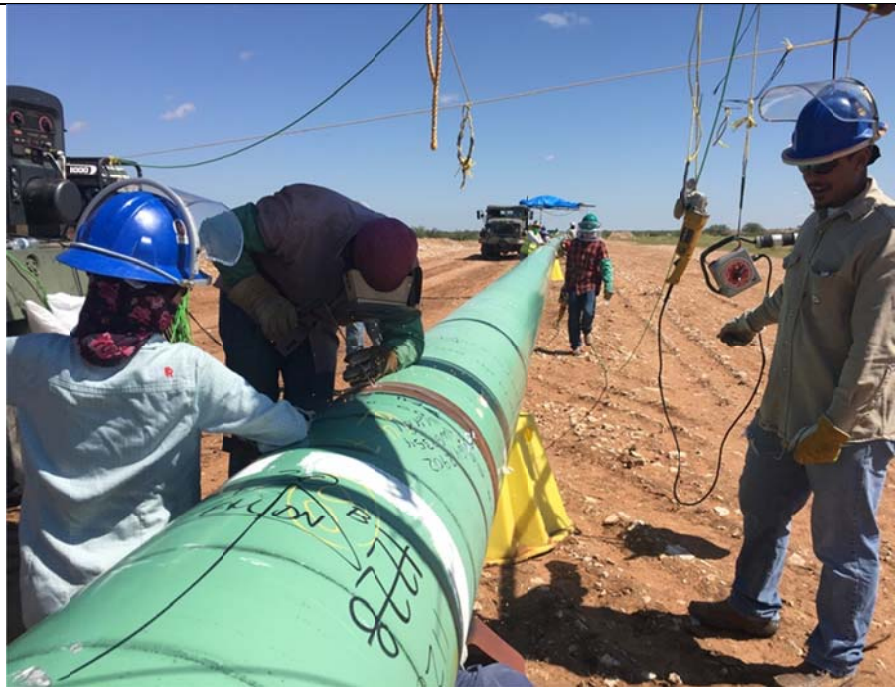
Location: Line No.
31111 ROW at Station
No. 721+00
Direction of Photo:
North
Description: Mainline
welding crew making
the bead weld.

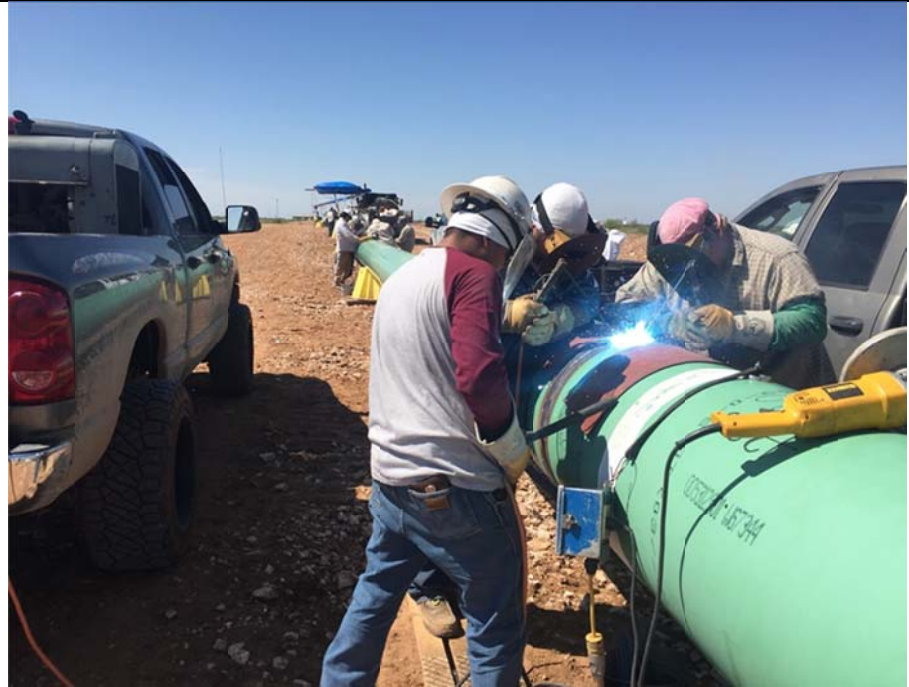
Location: Line No.
31111 ROW at Station
No. 718+00

Description: Capping
the weld.

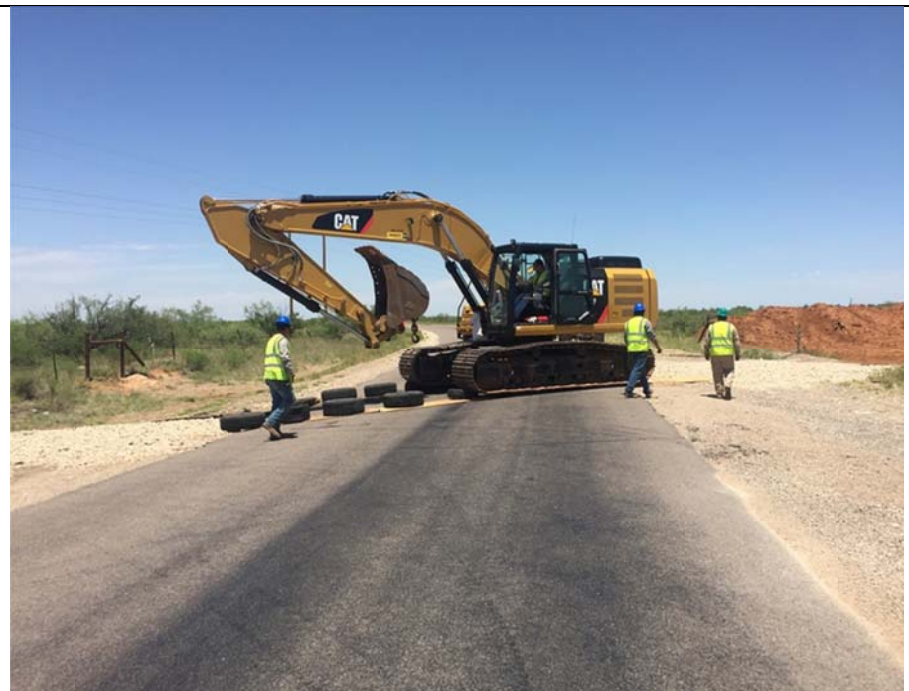
Location: Line No.
31111 ROW at Station
No. 479+00

Description: Crossing a
track hoe across Frying
Pan Ranch Road

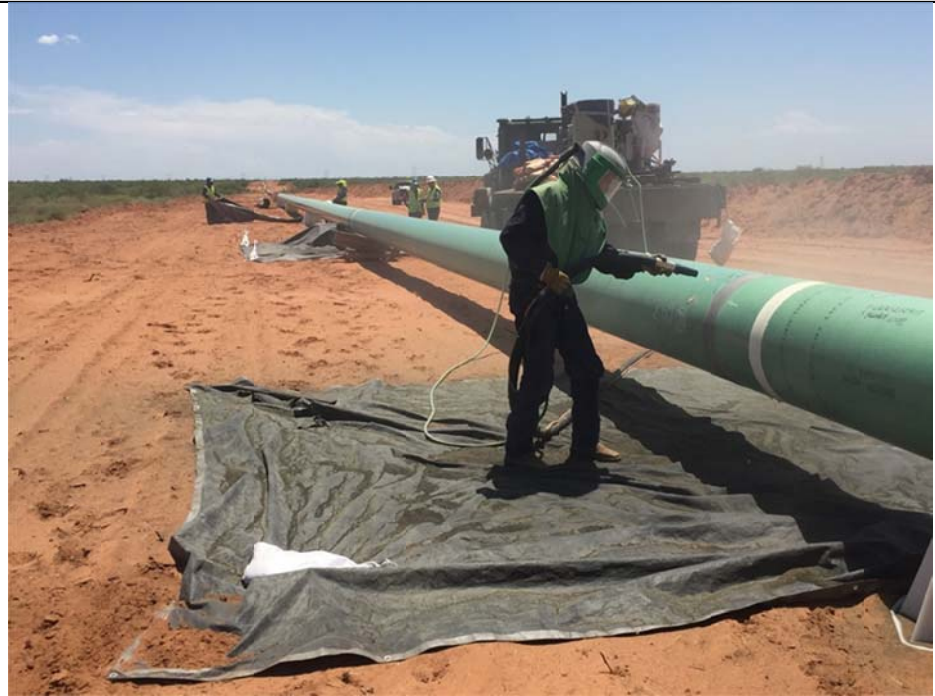
Location: Line No.
31111 ROW at Station
No. 431+00
Direction of Photo:
Southwest
Description: Abrasive
blasting a weld.

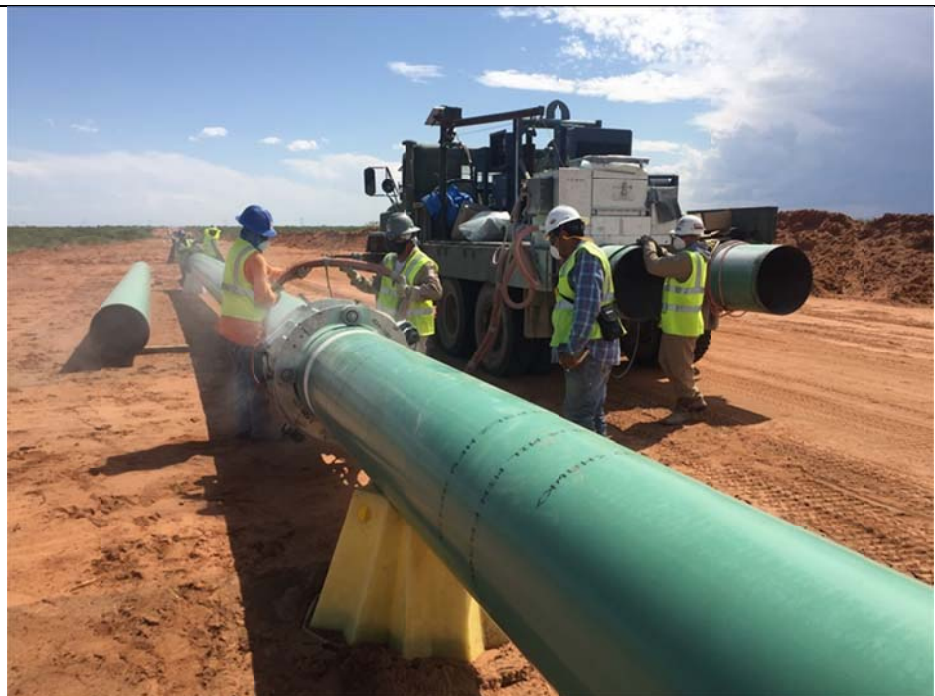
Location: Line No.
31111 ROW at Station
No. 432+00
Direction of Photo:
Southwest
Description: Coating a
weld.

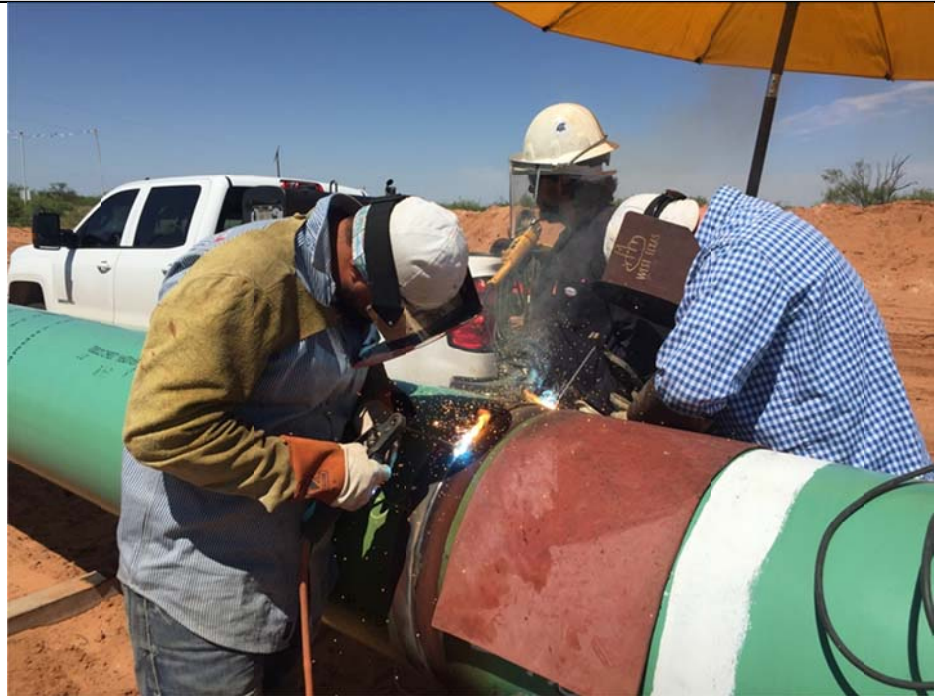
Location: Line No.
31111 ROW at Station
No. 422+00

Description: Mini
Gang crews welding
up pipe sections.

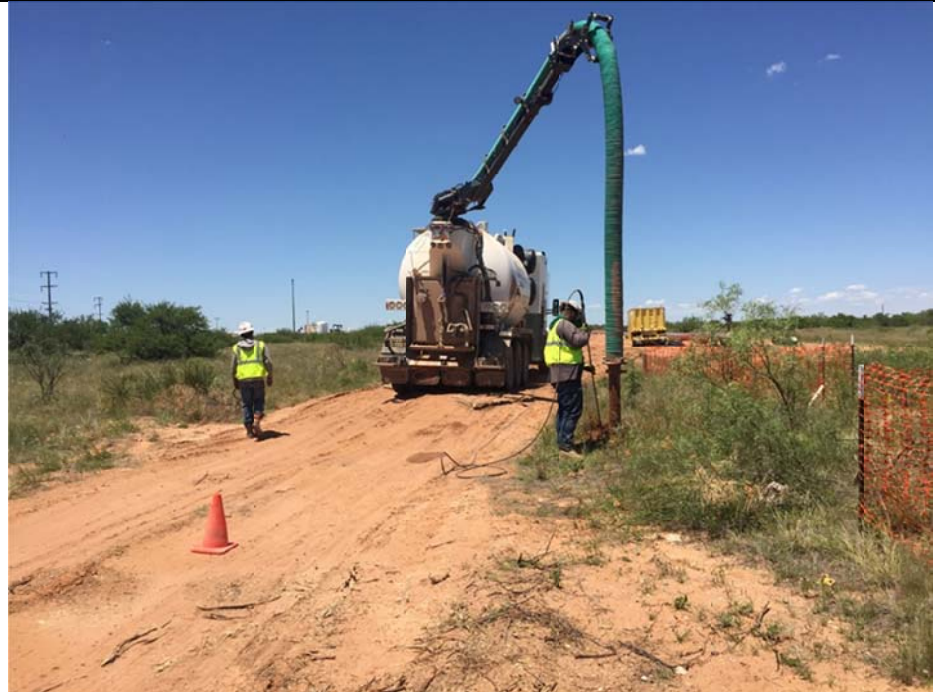
Location: Line No.
31111 ROW at Station
No. 252+00

Description: Potholing
for foreign lines.

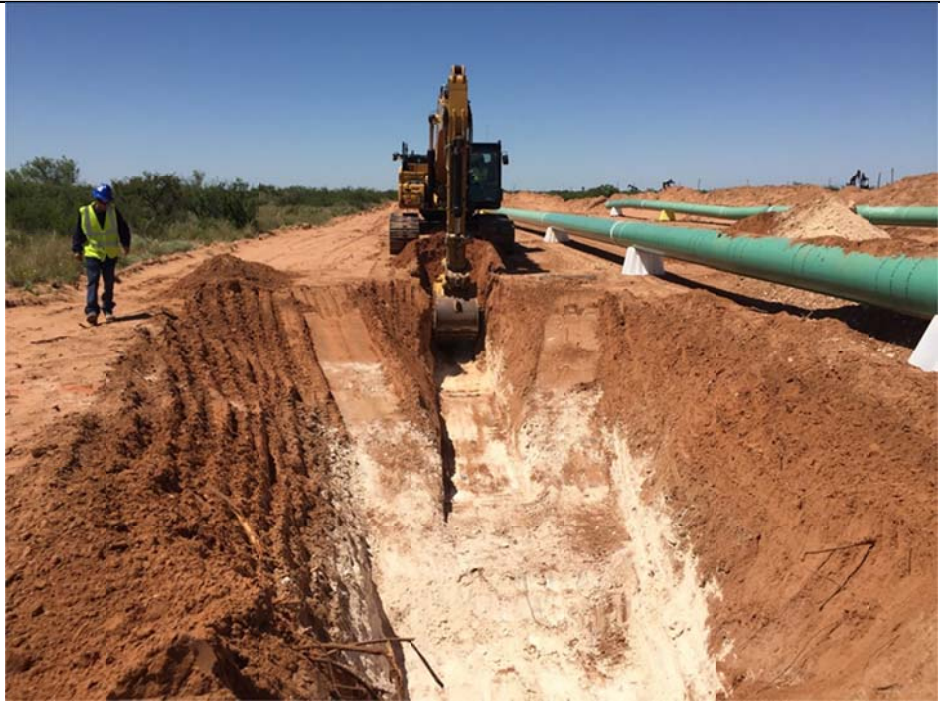
Location: Line No.
31111 ROW at
Station No. 207+00
Direction of Photo:
South
Description: Ditching
with a trackhoe.

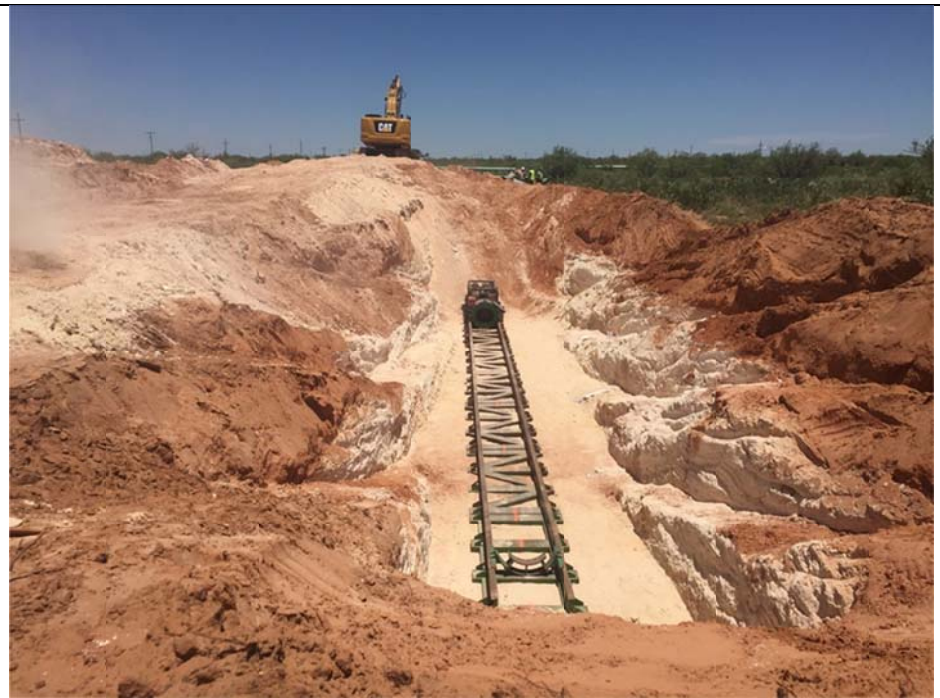
Location: Line No.
31111 ROW at
Station No. 186+00
Direction of Photo:
North
Description: Bore pit
on the north side of
Texas Highway 874
prior to beginning the
road boar.

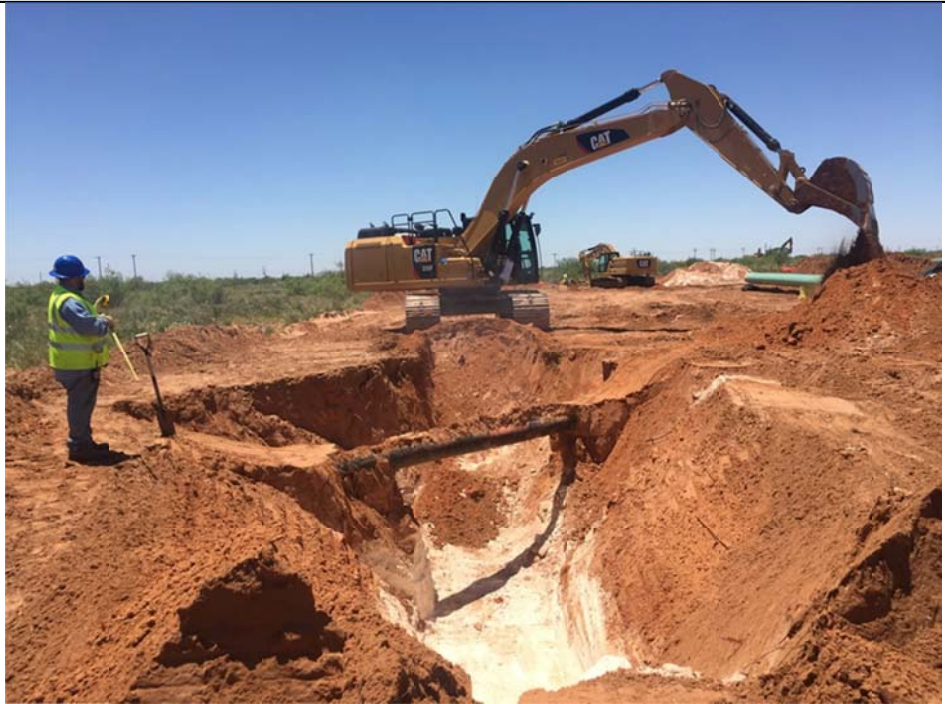
Location: Line No. 31111 ROW at Station No. 172+00
Direction of Photo: Southwest
Description: Digging the ditch near a foreign line crossing.

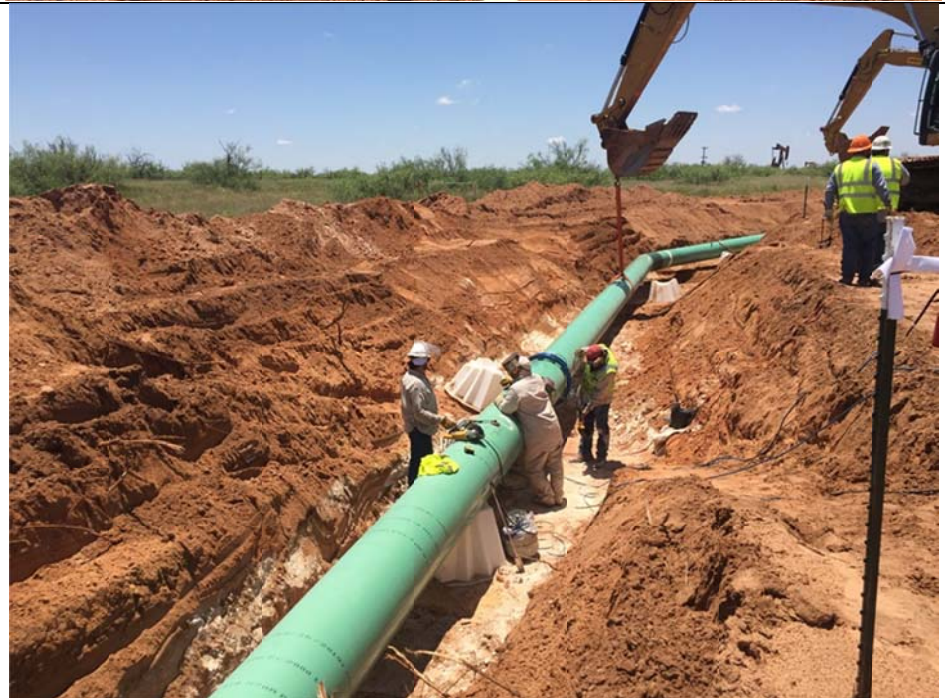
Location: Line No. 31111 ROW at Station No. 84+00
Direction of Photo: Southwest
Description: Making a tie-in weld.

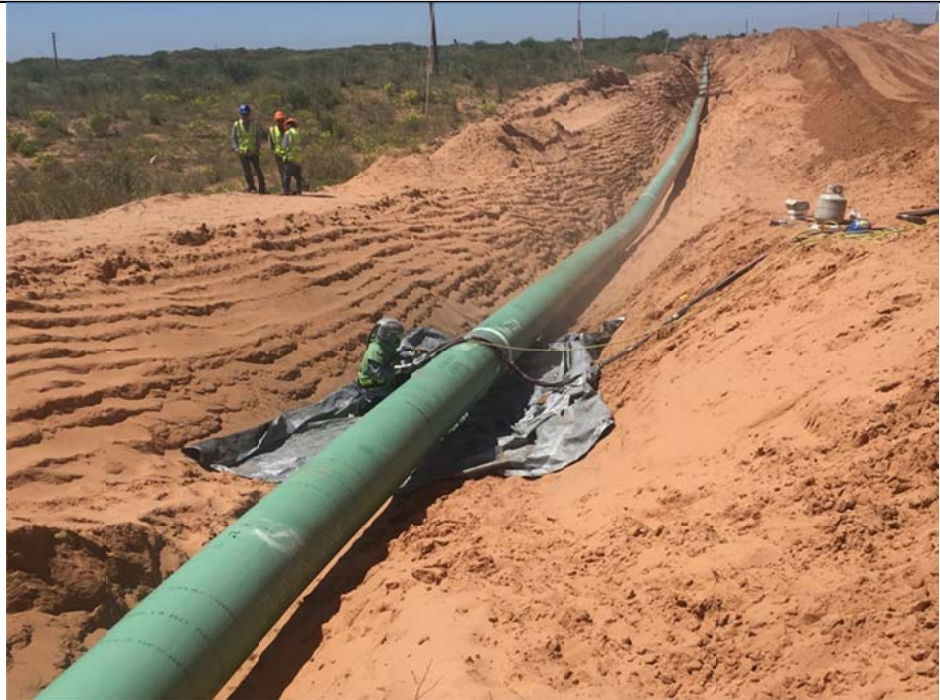
Location: Line No.
31111 ROW at Station
No. 64+00

Description: Abrasive
blasting a tie-in weld.

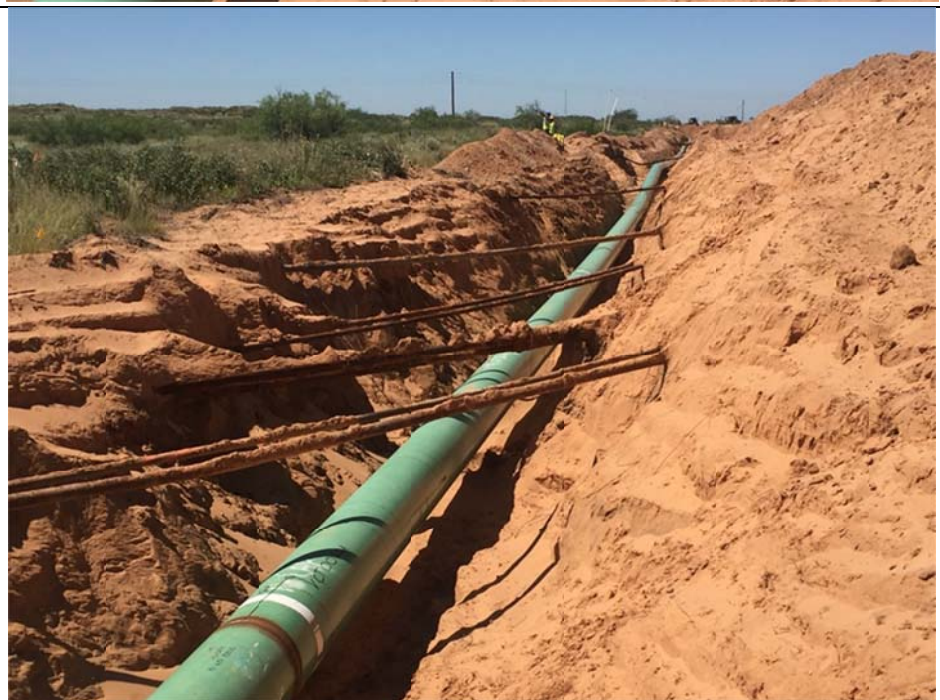
Location: Line No.
31111 ROW at Station
No. 66+00

Description: Pipeline
installed under
foreign line crossings.

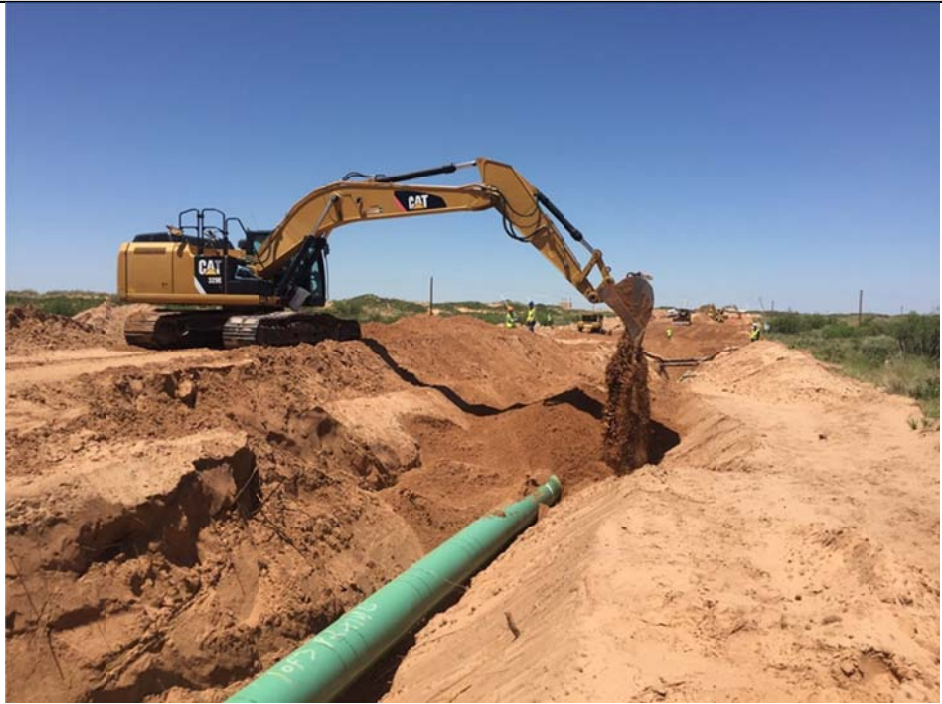
Location: Line No.
31111 ROW at
Station No. 72+00
Direction of Photo:
Northeast
Description:
Backfilling the ditch
line with a trackhoe.

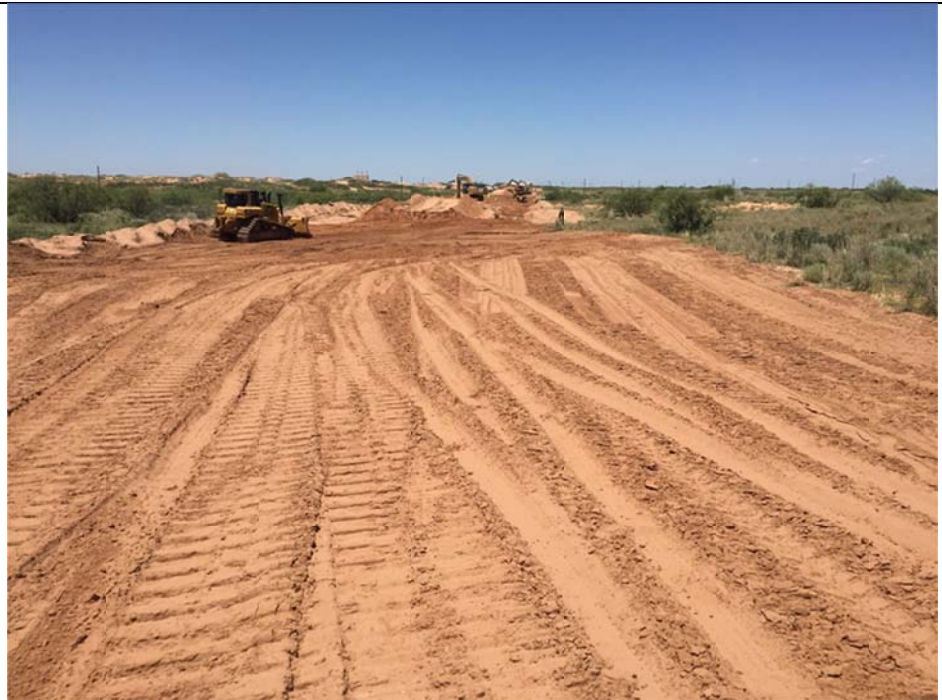
Location: Line No.
31111 ROW at
Station No. 74+00
Direction of Photo:
Northeast
Description:
Contouring the ROW
after the ditch has
been backfilled.
