Re: El Paso Natural Gas Company, L.L.C.;
Docket No. CP19-28-000
Northern Delaware Basin Expansion Project
Weekly Environmental Inspector Report No. 17

EPNG Weekly Environmental Inspector Report No. 17		
Docket No. CP19-28-000		
Project Name:	Northern Delaware Basin Expansion Project	
County/State:	Winkler, Ector, Crane and Upton Counties, Texas	Date: 6/26/2019
Reporting Period:	June 16, 2019 to June 22, 2019	
Environmental Inspector:	David McCullough

Report No. 17

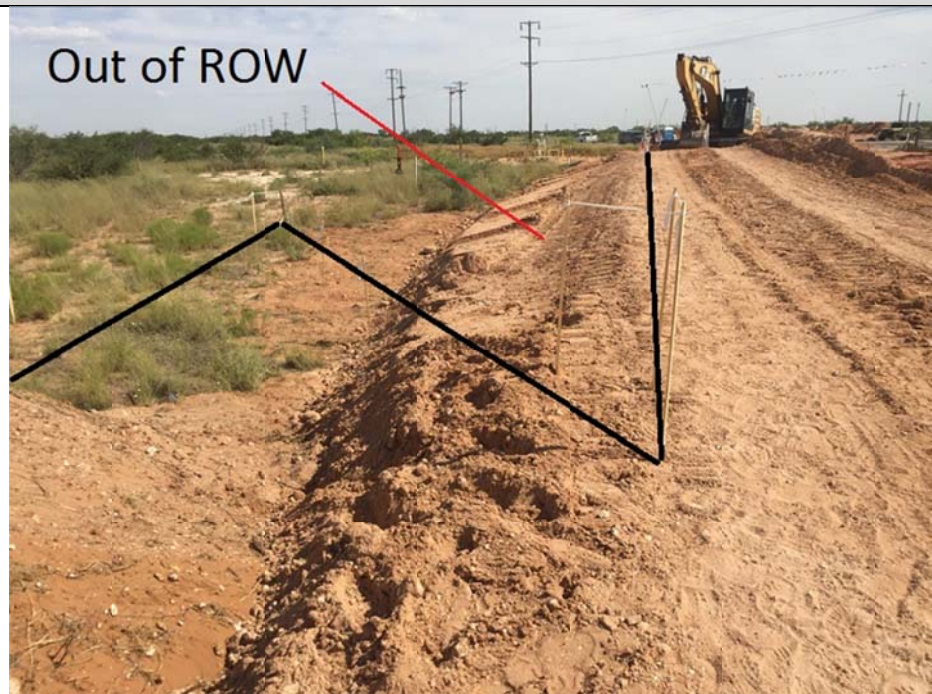
Location: Line No. 3111 ROW from Station Nos. 251+70 to 253+00

An Incident of non-compliance occurred on June 19, 2019, when soil was found to be piled out of the ROW for approximately 130-feet long by 15-feet wide near Station No. 251+70 to Station No. 253+00. Apparently, the boundary staking had been down in this area where the soil was placed. A trackhoe and dozer were tasked with bringing the soil back into the ROW and cleaning this area. After the soil was brought back into the ROW, orange safety fencing was installed along the ROW boundary. Additional checks were placed in the pre-work checklist to ensure staking is in place and the identification of the staking prior to soil being moved and remedial training was given to the operator and spotter.

Description: Area of disturbance where a Soil was placed out of the ROW for approximately 130' x 15' out.

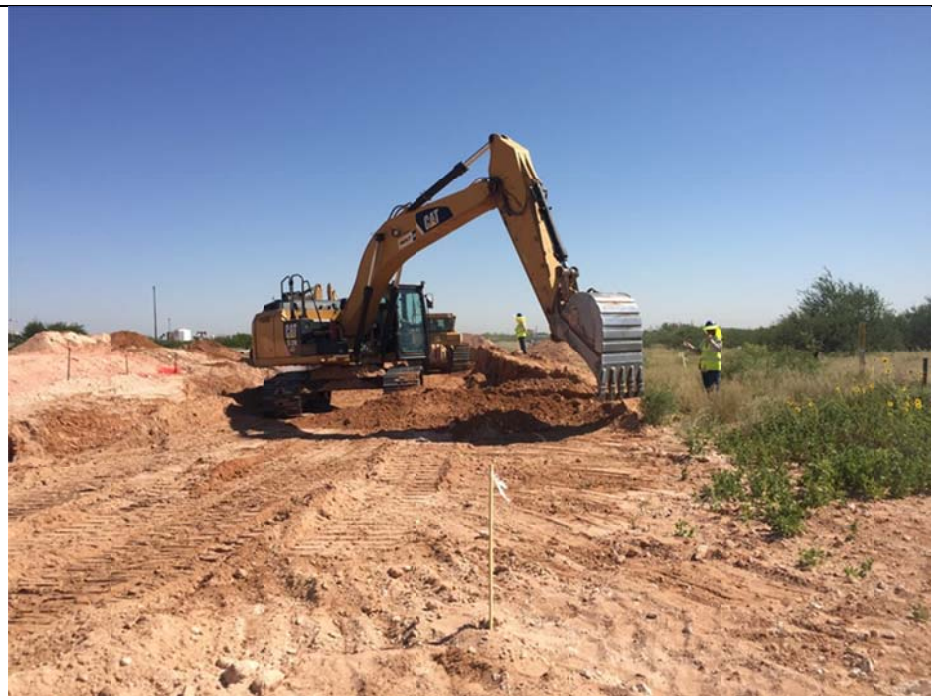
Location: Line No. 3111 ROW from Station Nos. 251+70 to 253+00

Description: Pulling material back into the ROW.

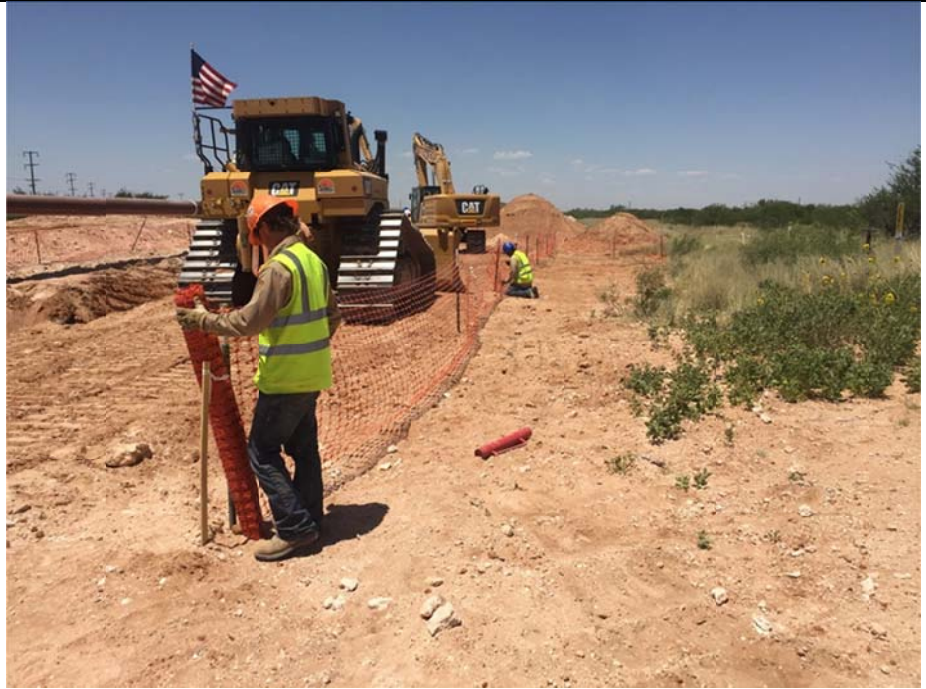
Location: Line No. 3111 ROW from Station Nos. 251+70 to 253+00

Description: Safety fencing being installed to show the boundary of the ROW.

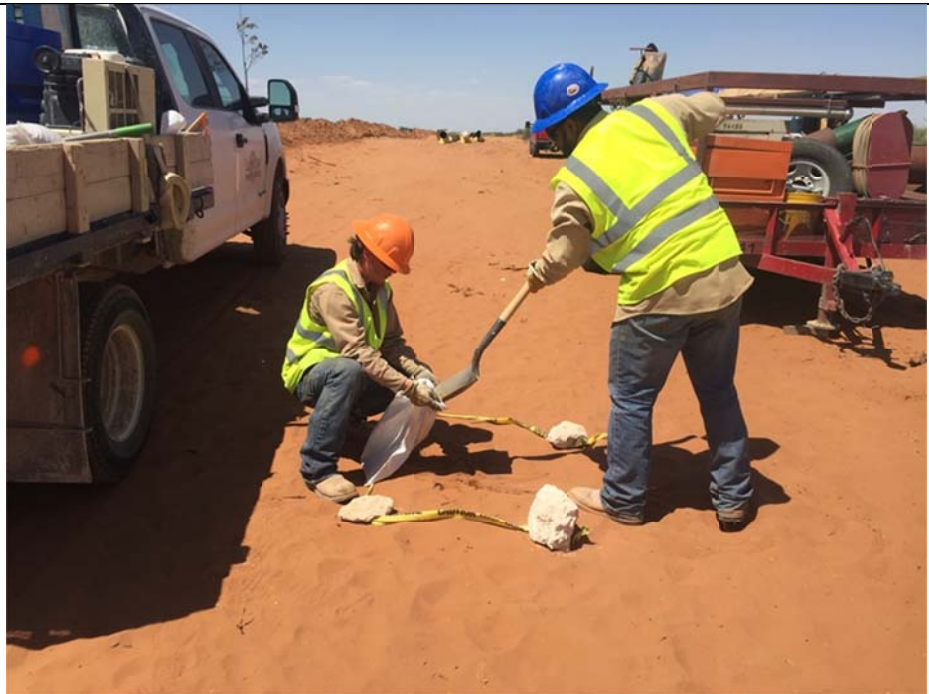
Location: Line No. 3111 ROW at Station No. 479+35

Two fluid spills were recorded during this reporting period. The first spill occurred on June 20, 2019, and consisted of approximately one cup of diesel fuel at Station No. 479+35. The cause of this spill was unknown. An area of about 1-foot by 1-foot was contaminated. This material was picked up and placed into Department of Transportation (DOT) drums to await disposal. The second spill occurred on June 20, 2019, and consisted of approximately one pint of antifreeze. It was caused by the failure of a hose on a trackhoe while digging near Station No. 480+00. The trackhoe immediately shut down and the spill was contained. An area of about 2-foot by 1-foot was contaminated. This material was picked up and placed into DOT drums to await disposal.

Description: Cleaning up a small spill on the ROW.

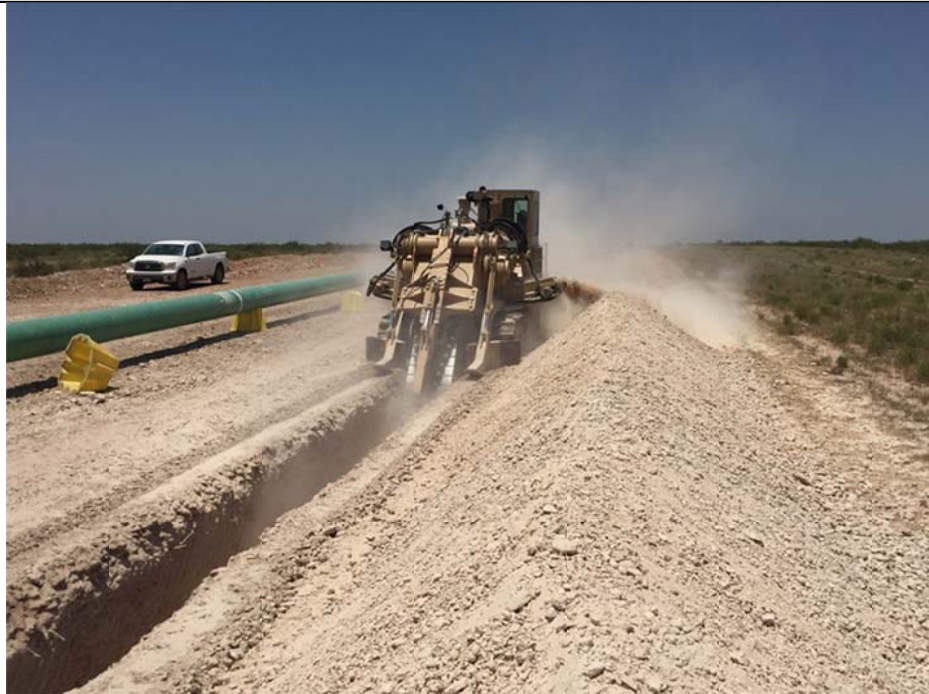
Location: Line No.
31111 ROW at
Station No. 742+00

Description: Ditching
with a trenching
machine.

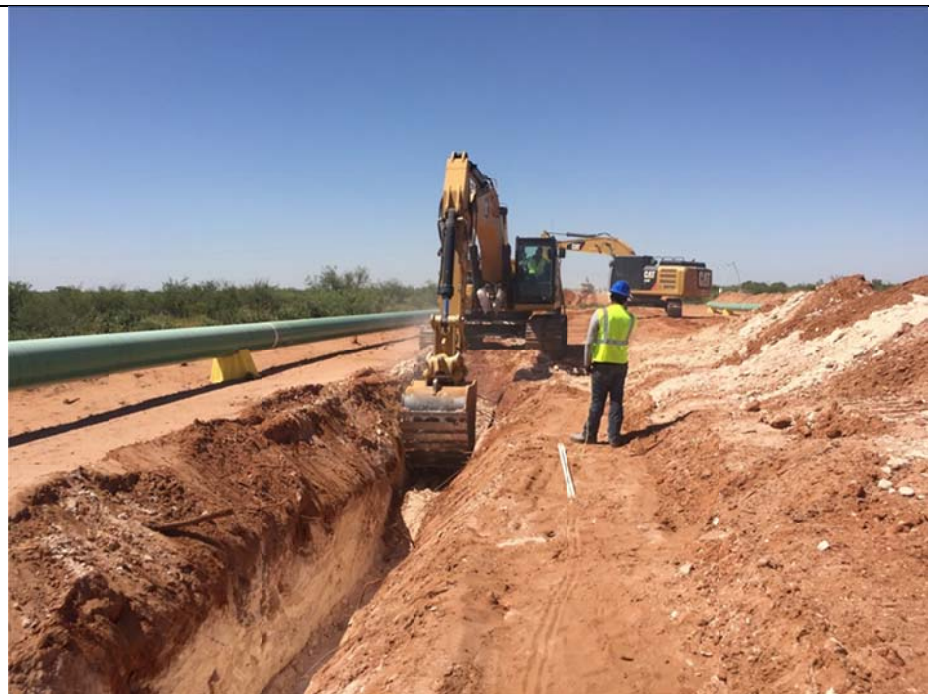
Location: Line No.
31111 ROW at
Station No. 418+00

Description: Ditching
with a trackhoe.

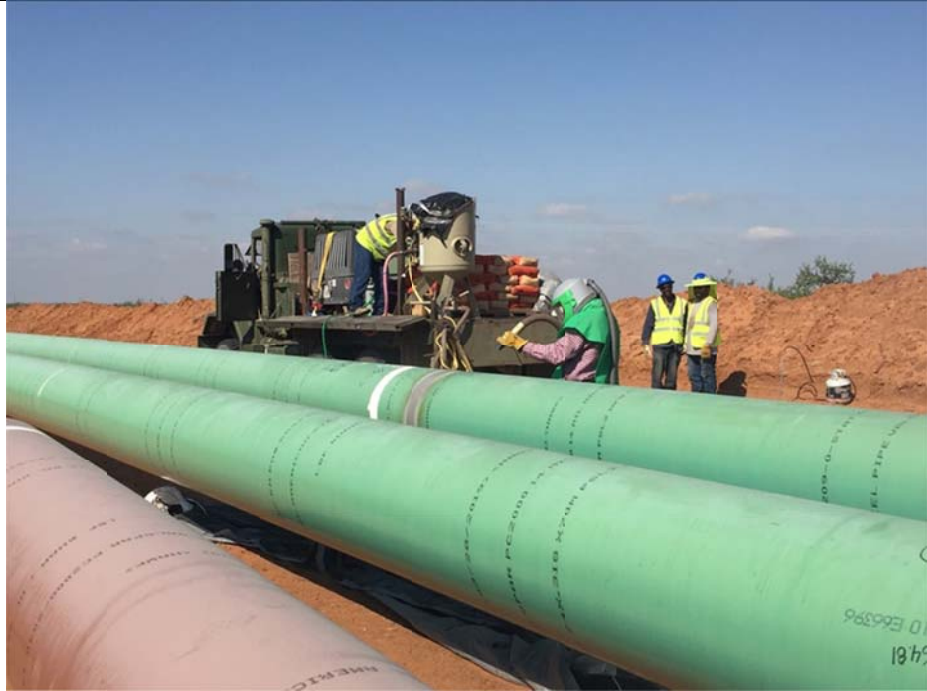
Location: Line No.
31111 ROW at
Station No. 475+00
Direction of Photo:
Southwest
Description:
Abrasive blasting a
weld on a pipe
section.

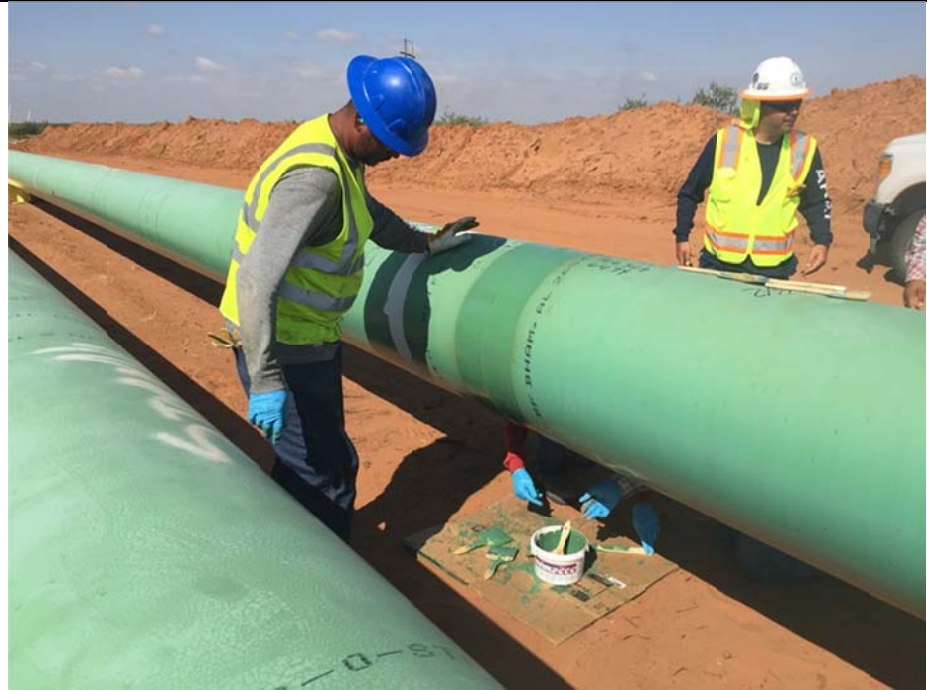
Location: Line No.
31111 ROW at
Station No. 475+00
Direction of Photo:
Southwest
Description: Coating
a weld on a pipe
section.

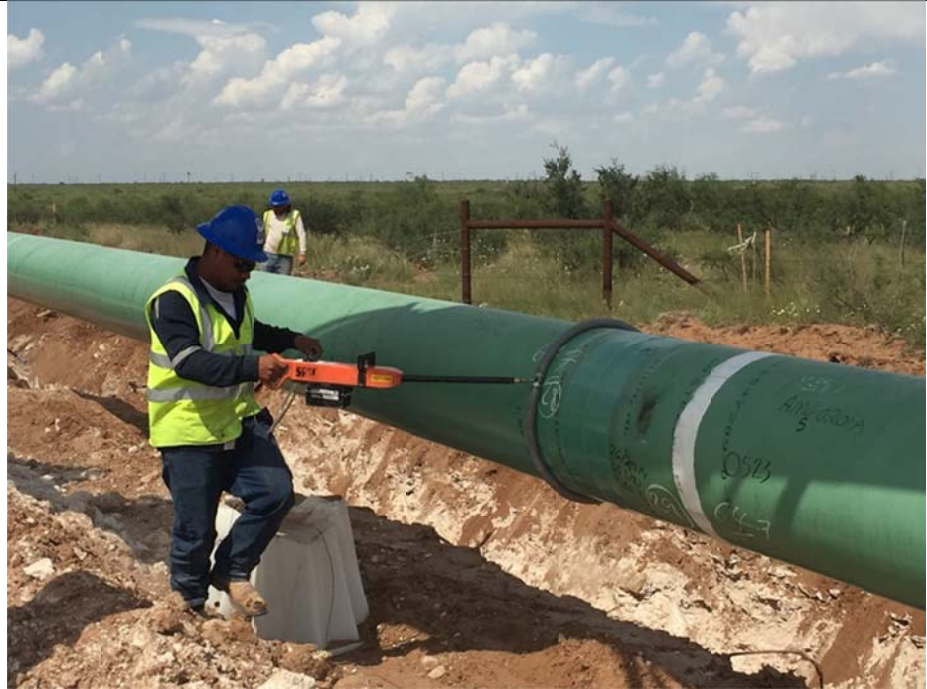
Location: Line No.
31111 ROW at
Station No. 326+00
Direction of Photo:
East
Description: Jeeping
the pipe during
lowering-in activities.

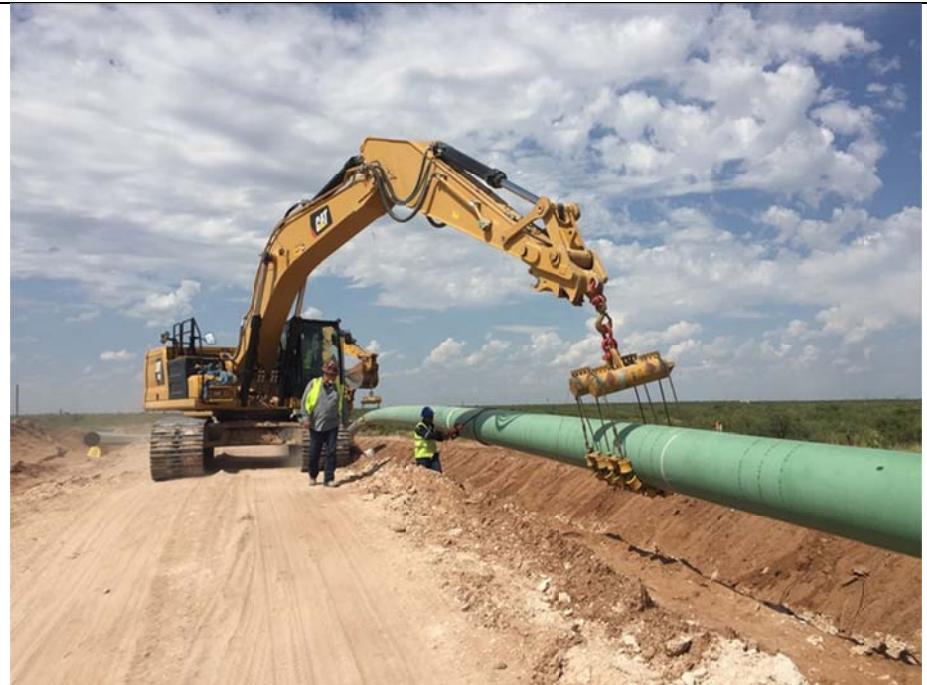
Location: Line No.
31111 ROW at
Station No. 326+00
Direction of Photo:
Northeast
Description: Lowering
the pipe into the
ditch.

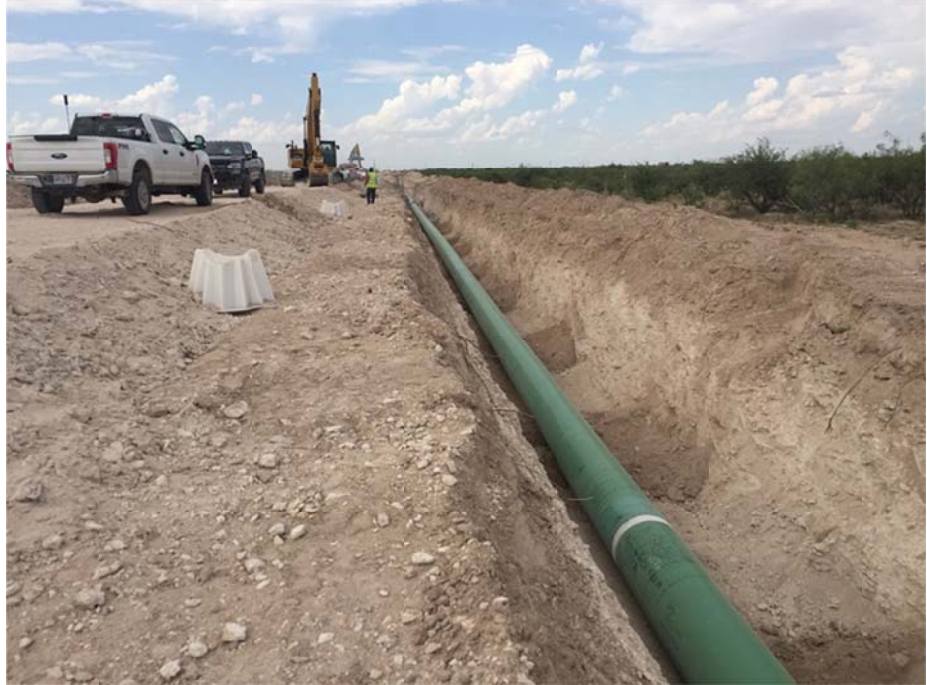
Location: Line No.
31111 ROW at Station
No. 307+00
Direction of Photo:
Northeast
Description: Pipe in
the ditch.

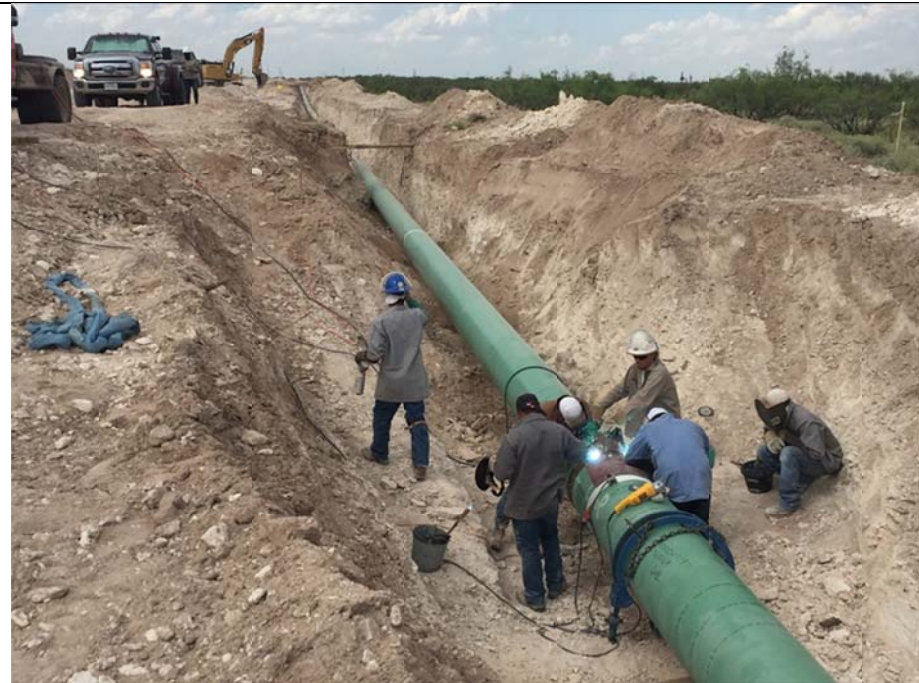
Location: Line No.
31111 ROW at Station
No. 305+00
Direction of Photo:
Northeast
Description: Making a
tie-in weld.

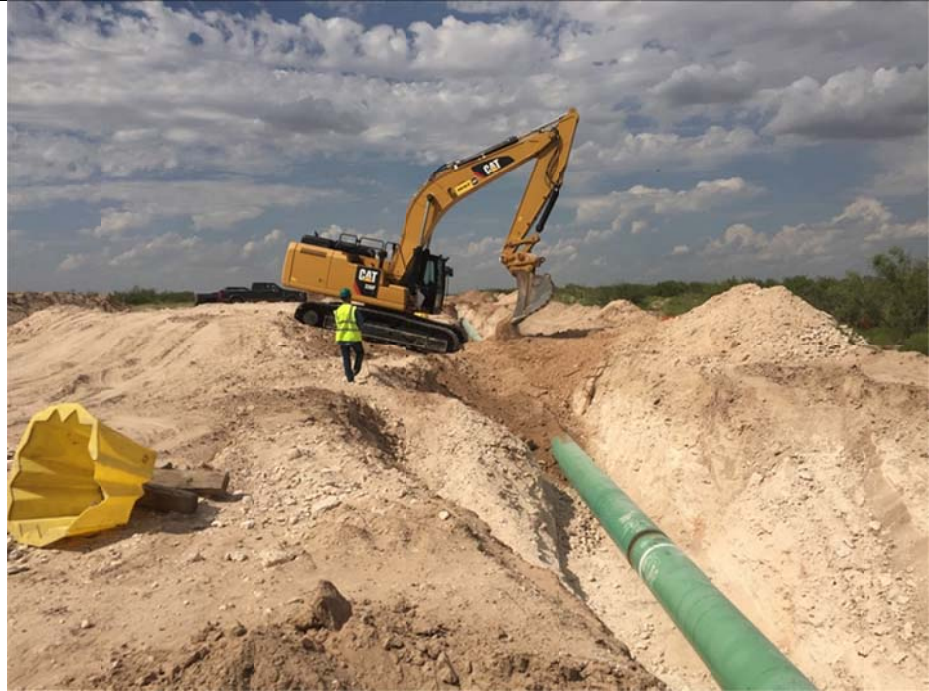
Location: Line No.
31111 ROW at Station
No. 301+00
Direction of Photo:
Northeast
Description:
Backfilling the ditch.

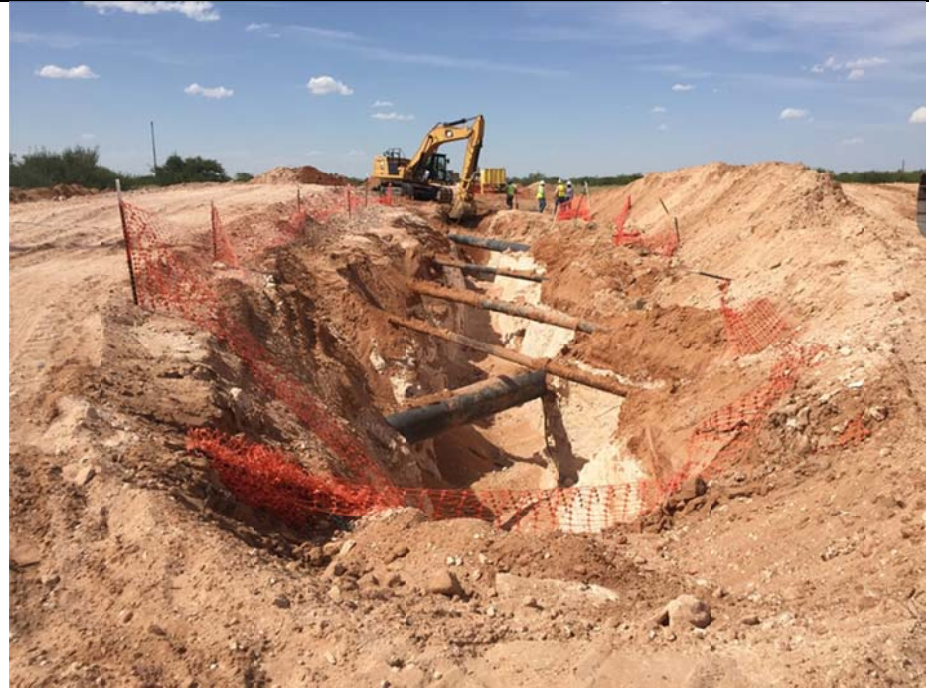
Location: Line No.
31111 ROW at Station
No. 253+00
Direction of Photo:
Northeast
Description: Foreign
lines crossing the
ditch.

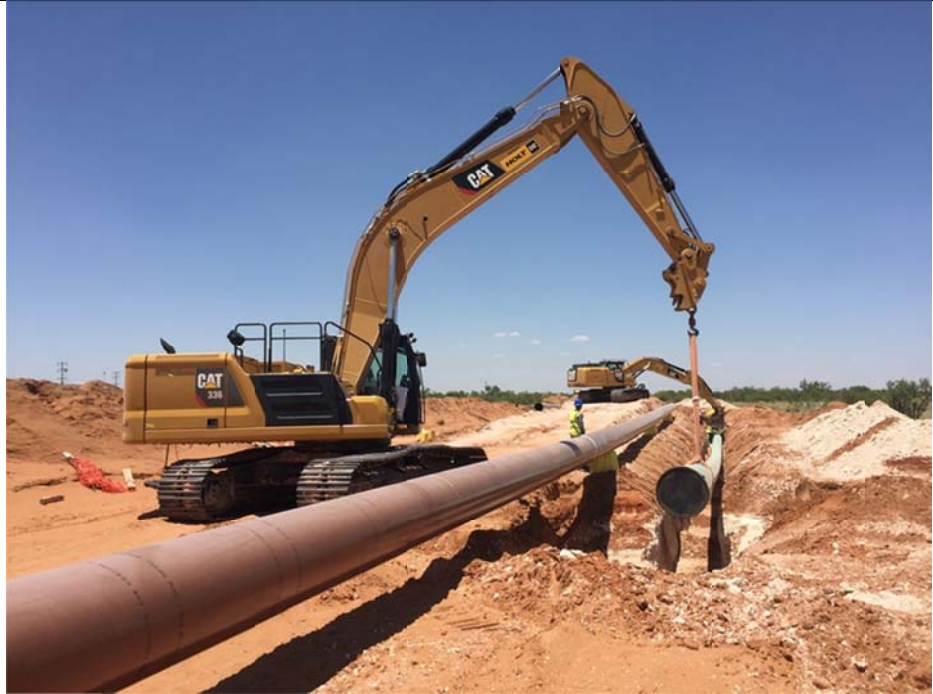
Location: Line No.
31111 ROW at Station
No. 250+00

Description: Lowering
pipe into the ditch.

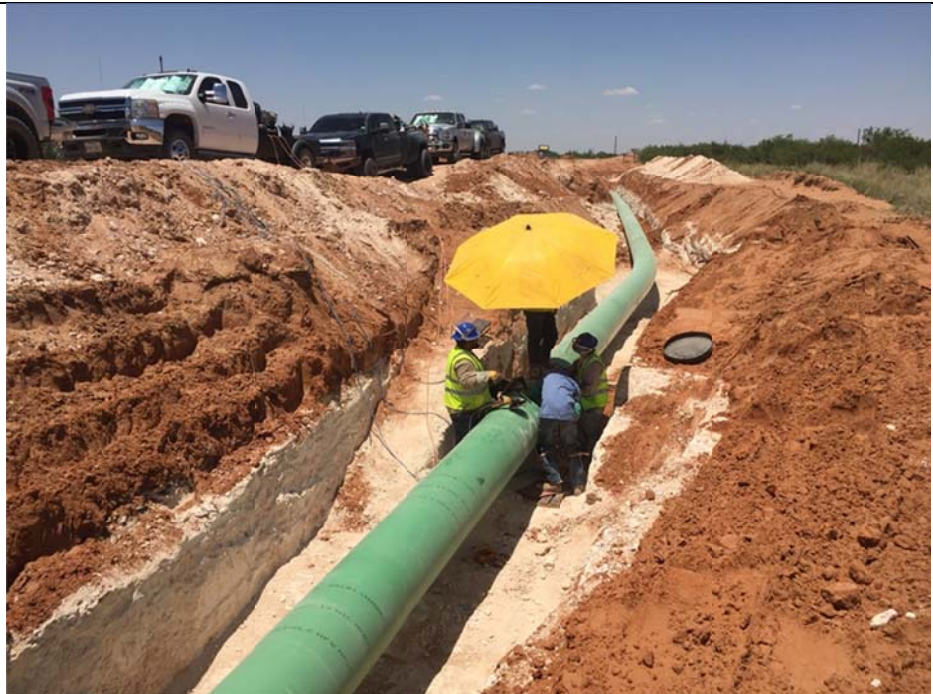
Location: Line No.
31111 ROW at Station
No. 248+00

Description: Making a
tie-in weld.

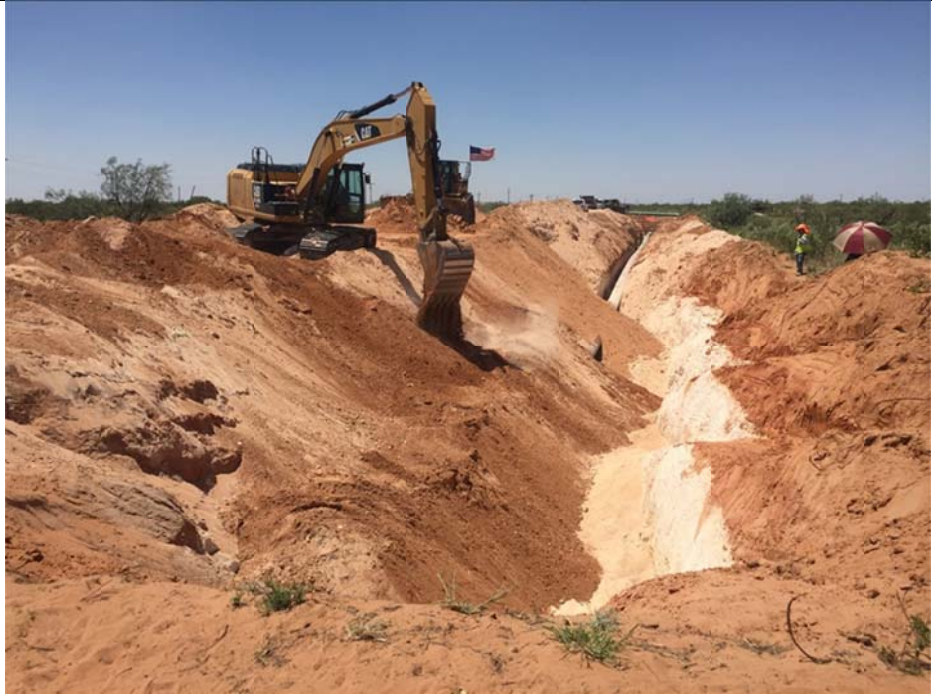
Location: Line No.
31111 ROW at Station
No. 187+00

Description:
Backfilling the bore
pit on the north side
of Texas Highway
874.

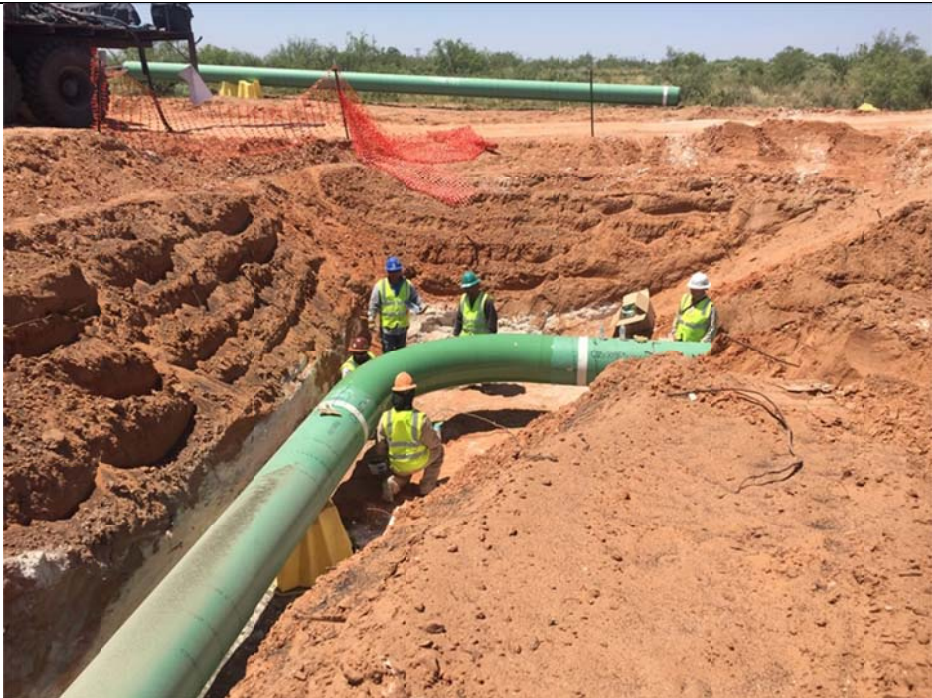
Location: Line No.
31111 ROW at Station
No. 183+00

Description: Coating
a bend.

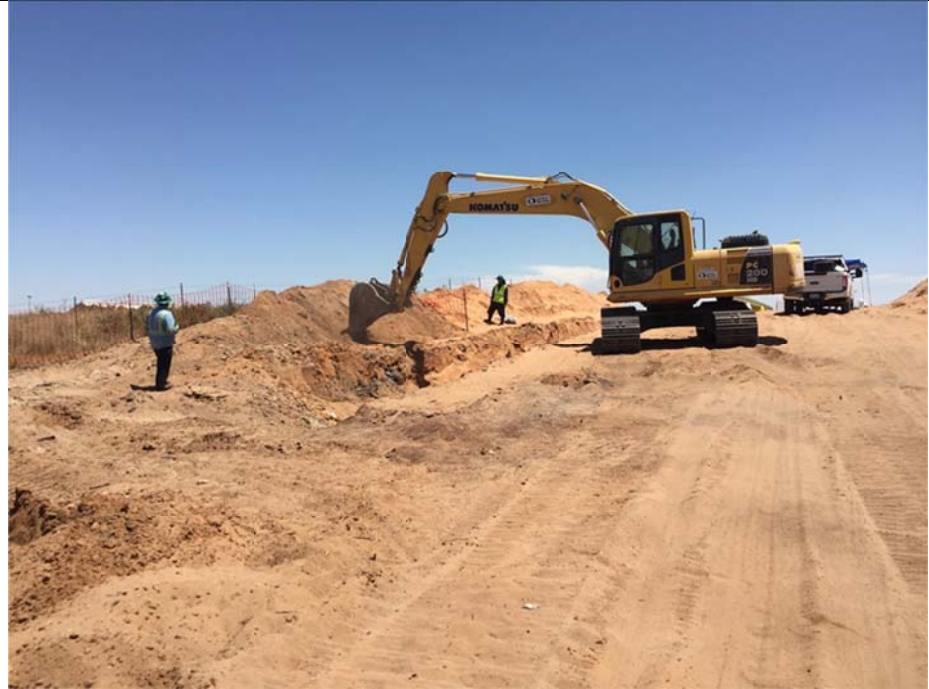
Location: Line No.
31111 ROW at Station
No. 10+00

2. Relevant Environmental Activities:		
<p>During this reporting period, fifteen (15) people received environmental training. A total of four-hundred eighteen (418) people have received environmental training on the Northern Delaware Basin Expansion Project.</p> <p>All equipment was checked for noxious weeds and found to be clean. All open ditch was walked on a daily basis to ensure that no animals had become entrapped. No animals were noted in the ditch during this reporting period.</p> <p>As a follow-up to the weekly Environmental Inspector Report No. 15, representatives from the company AMPOL were onsite during this reporting period to clean up and dispose of the asbestos containing material from the trash pit encountered during trenching activities at Station No. 10+00.</p>

Description:
Removing asbestos
containing materials
from the spoil pipe.

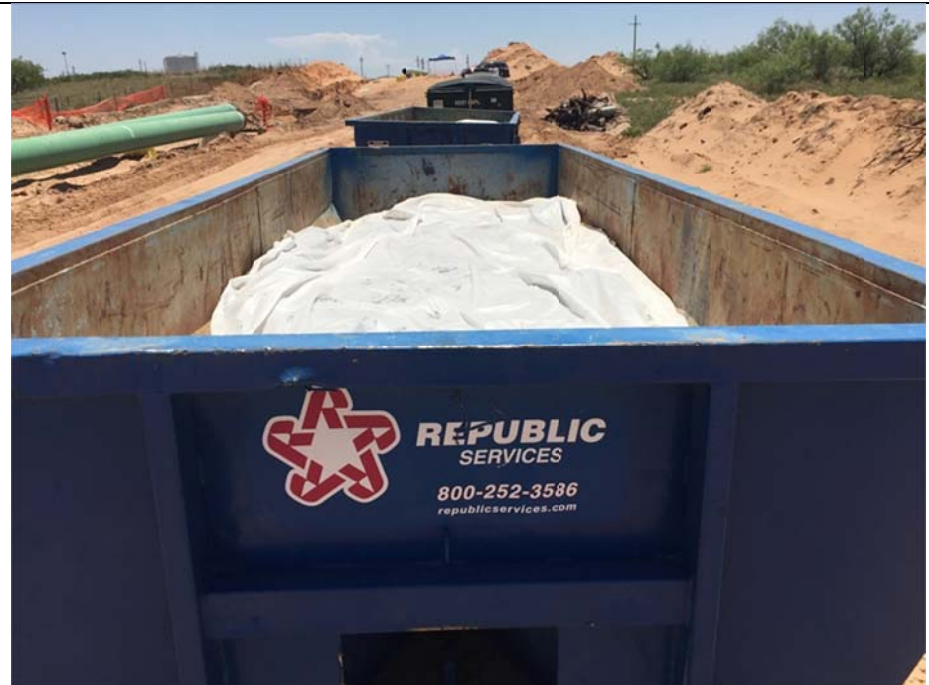
Location: Line No.
31111 ROW at Station
No. 10+00

Description: Roll-off
bin of asbestos
containing materials
prepped for removal
from the ROW.
