Re: El Paso Natural Gas Company, L.L.C.;
Docket No. CP19-28-000
Northern Delaware Basin Expansion Project
Weekly Environmental Inspector Report No. 18

EPNG Weekly Environmental Inspector Report No. 18		
Docket No. CP19-28-000		
Project Name:	Northern Delaware Basin Expansion Project	
County/State:	Winkler, Ector, Crane and Upton Counties, Texas	Date: 7/3/2019
Reporting Period:	June 23, 2019 to June 29, 2019	
Environmental Inspector:	David McCullough

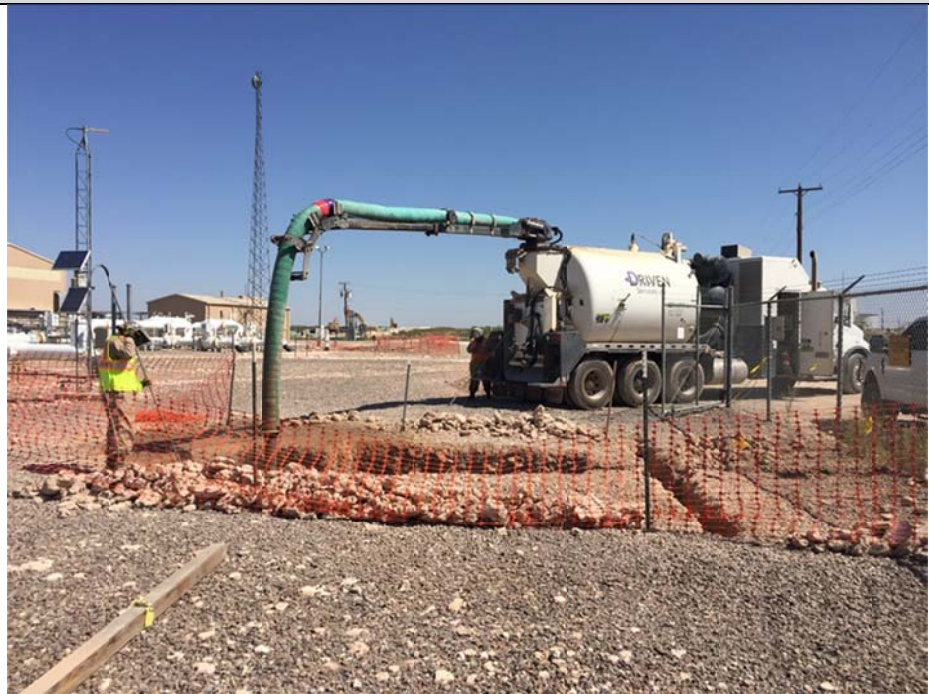
Location: Wink
Compressor Station
Direction of Photo:
North
Description:
Potholing for foreign
lines in Wink
Compressor Station.

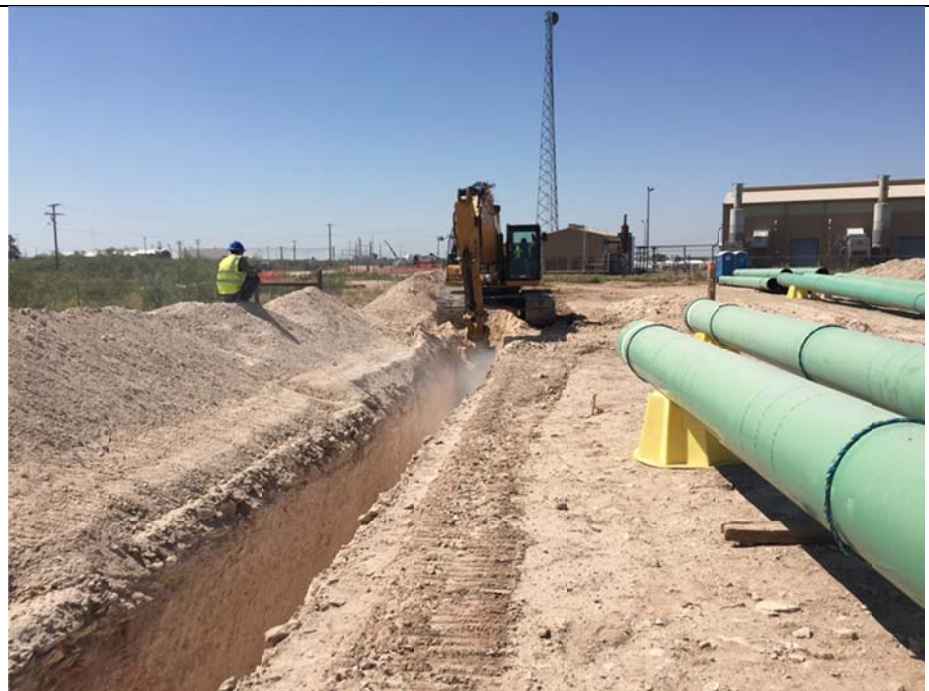
Location: Line No.
31111 ROW at
Station No. 759+00
Direction of Photo:
South
Description:
Ditching with a
trackhoe.

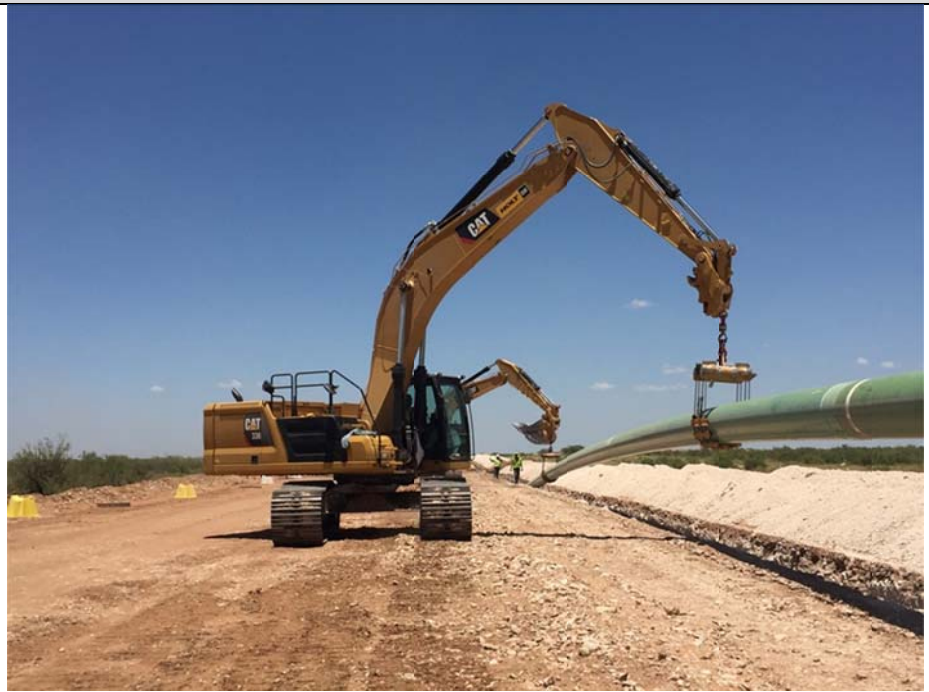
Location: Line No.
31111 ROW at
Station No. 729+00
Direction of Photo:
North
Description:
Lowering pipe into
the ditch.

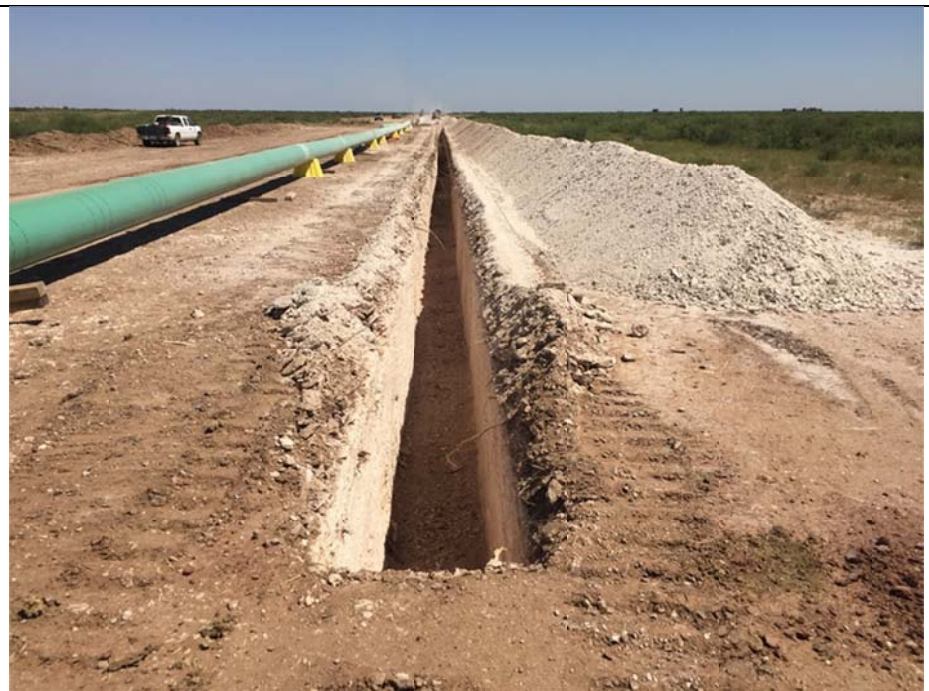
Location: Line No.
31111 ROW at
Station No. 701+00
Direction of Photo:
North
Description: Open
ditch prepped for
pipe lowering in.

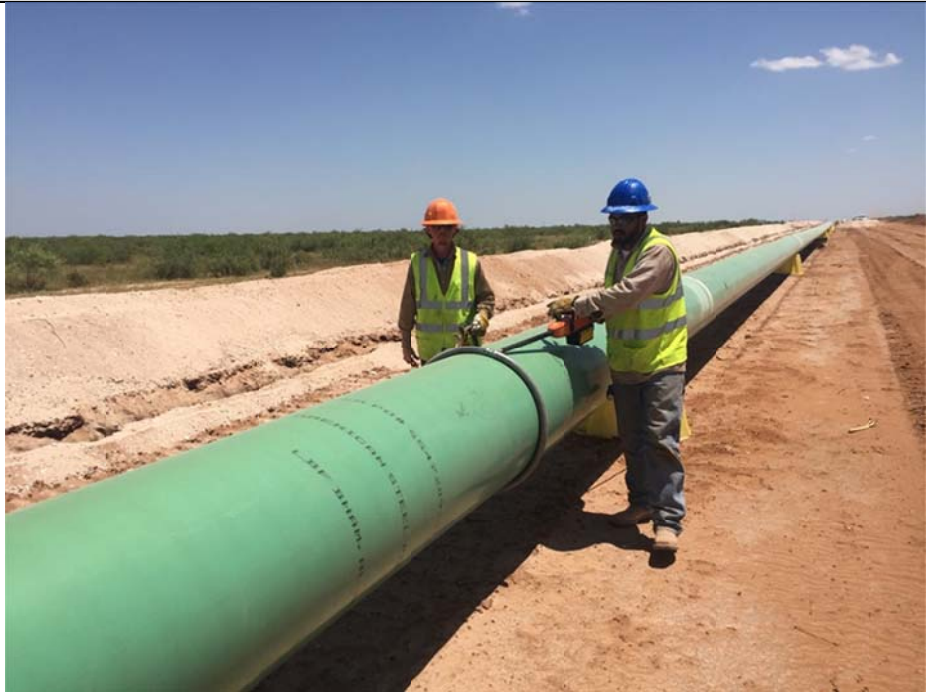
Location: Line No.
31111 ROW at
Station No. 664+00

Description: Pre-
jeeping the pipe prior
to lowering the pipe
into the ditch.

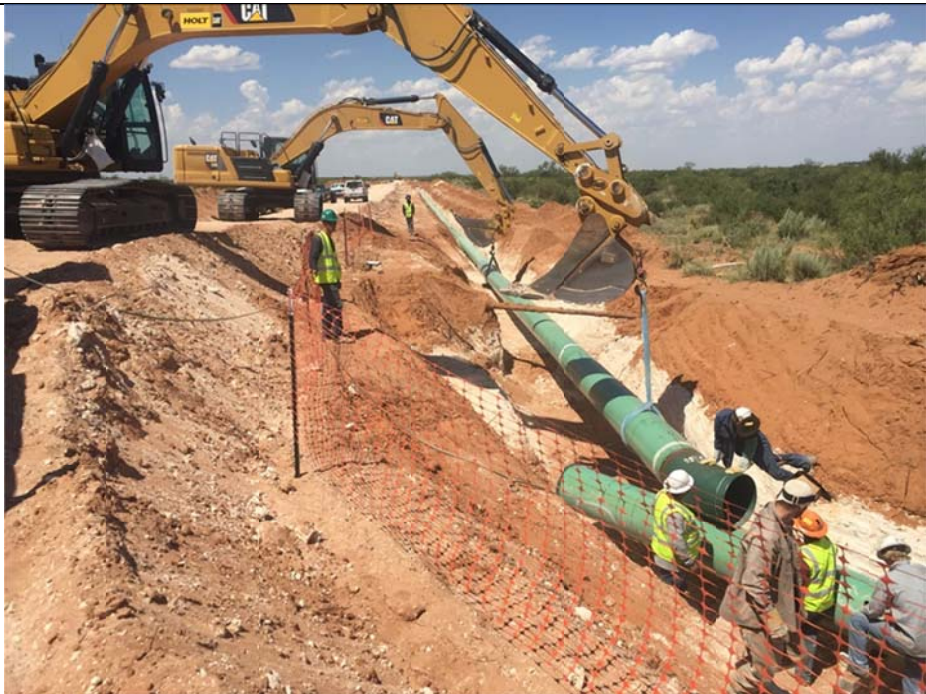
Location: Line No.
31111 ROW at
Station No. 389+00

Description:
Lowering the pipe
into the ditch under a
foreign line crossing.

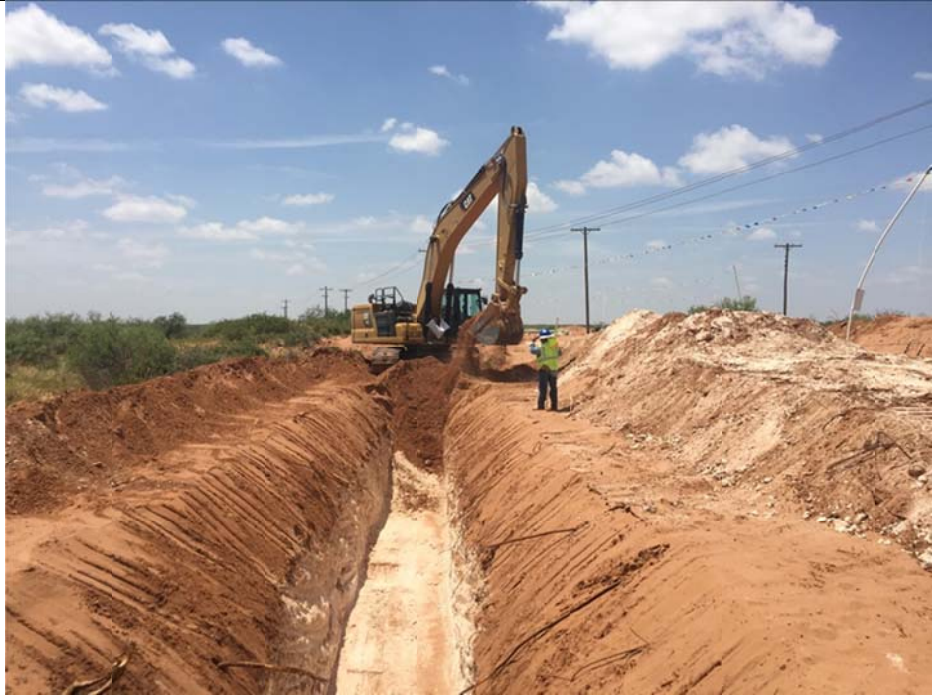
Location: Line No.
31111 ROW at
Station No. 530+00
Direction of Photo:
Southwest
Description:
Ditching with a
trackhoe.

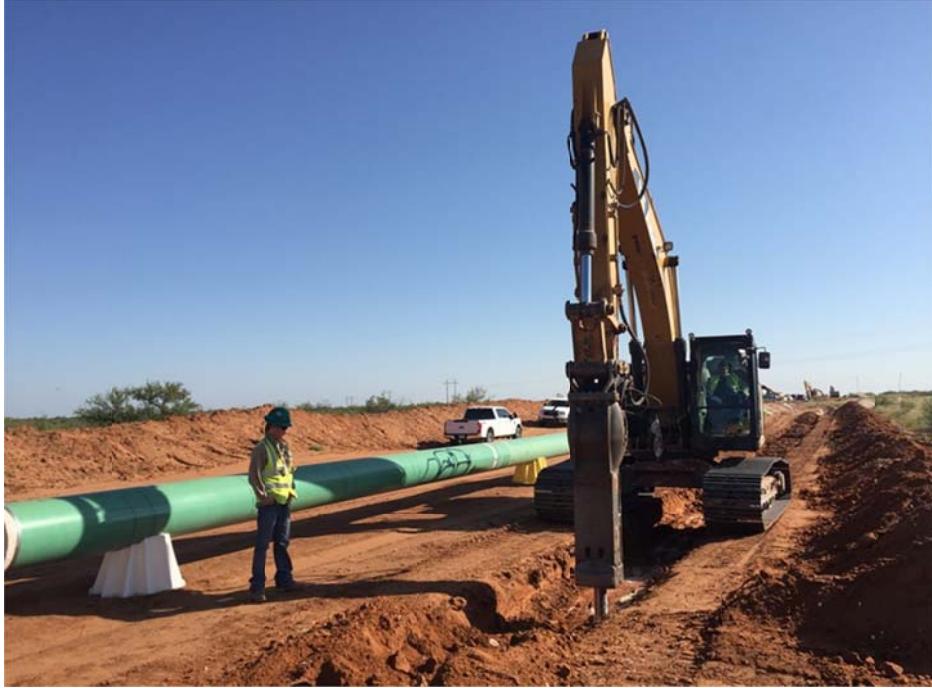
Location: Line No.
31111 ROW at
Station No. 487+00
Direction of Photo:
Northeast
Description:
Breaking up hard
caliche with a
hammer hoe.

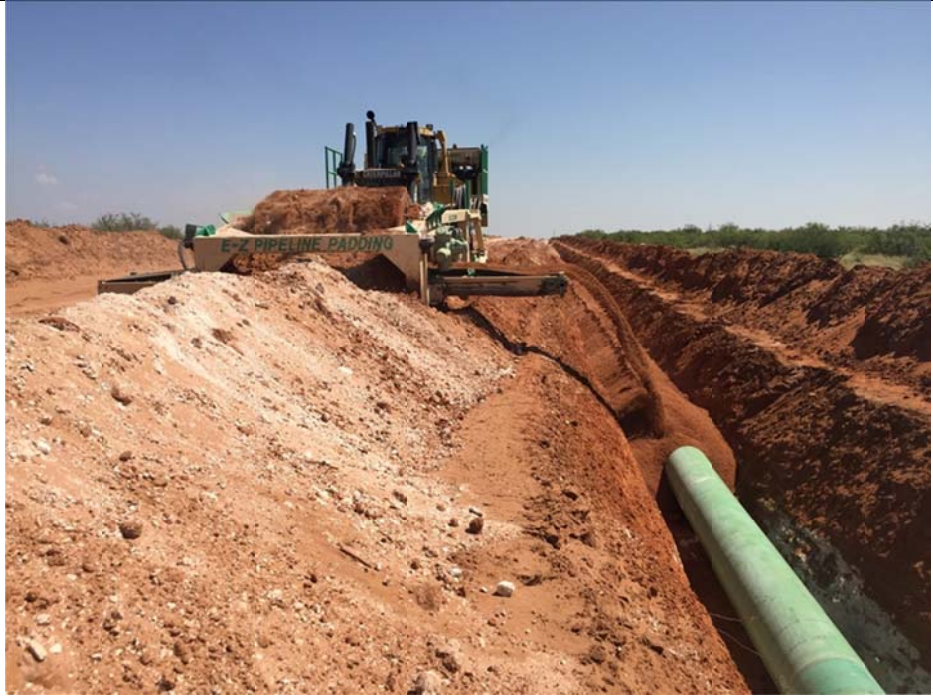
Location: Line No.
31111 ROW at
Station No. 440+00

Description: Padding
the pipe with the
padding machine
prior to backfilling.

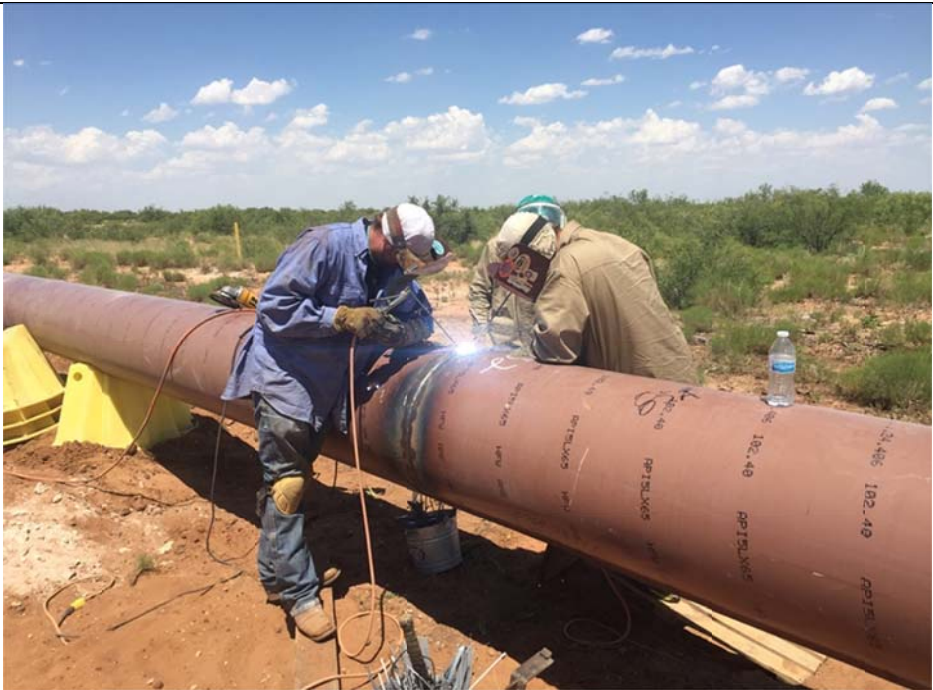
Location: Line No.
31111 ROW at
Station No. 397+00

Description: Making a
weld on a pipe
section.

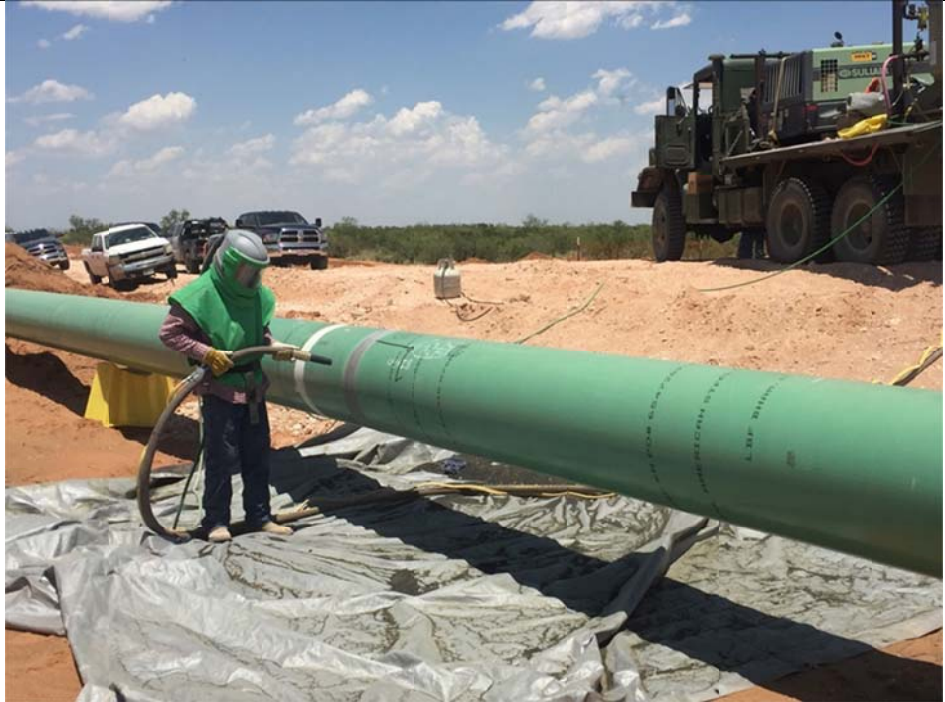
Location: Line No.
31111 ROW at
Station No. 389+00
Direction of Photo:
East
Description: Abrasive
blasting a weld.

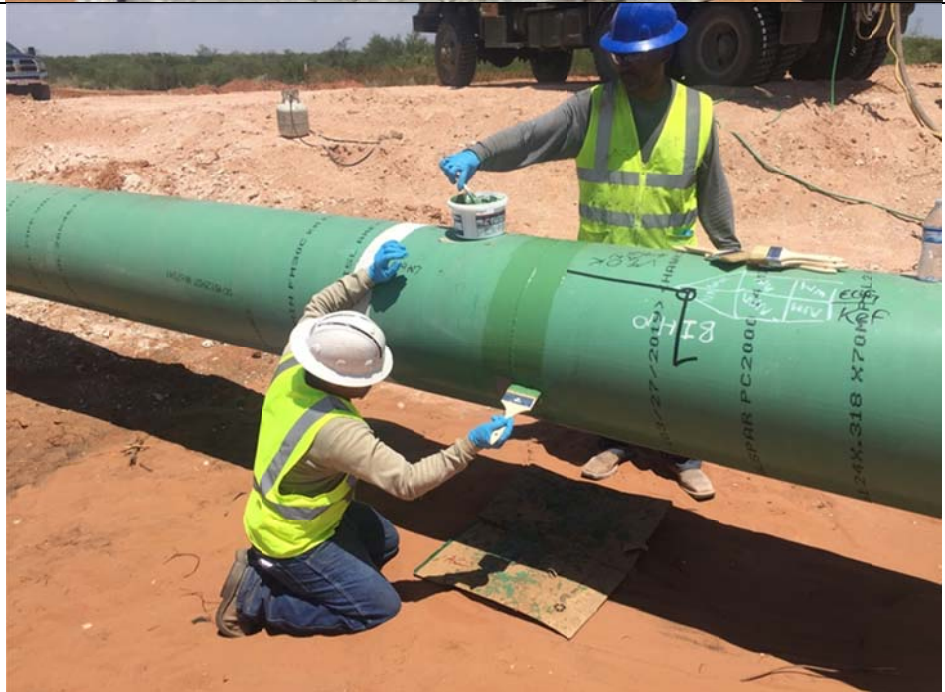
Location: Line No.
31111 ROW at
Station No. 389+00
Direction of Photo:
East
Description: Coating
the weld.

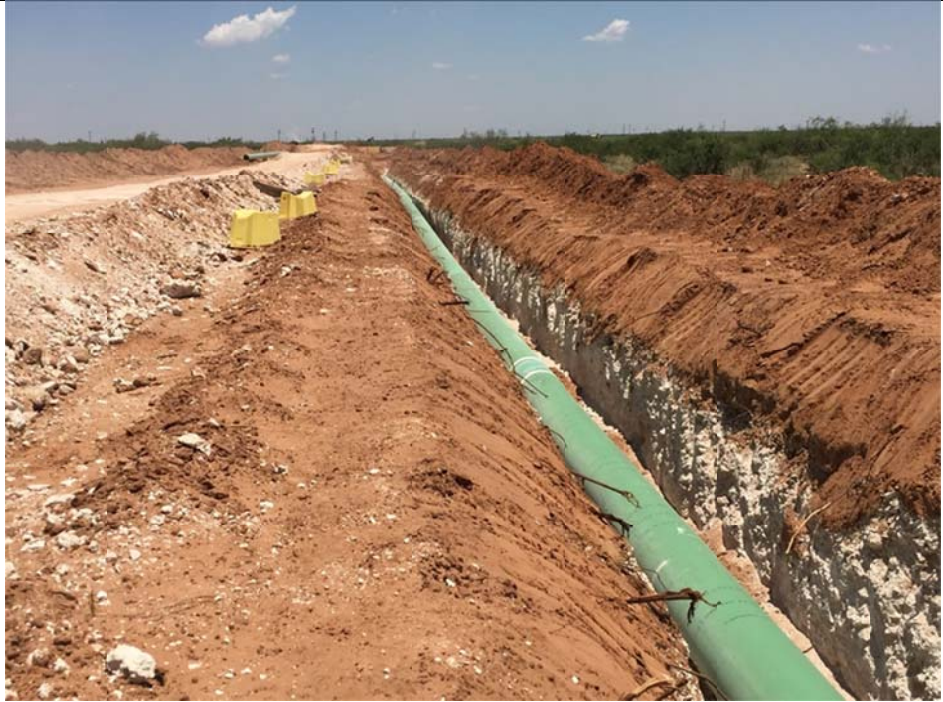
Location: Line No.
31111 ROW at
Station No. 366+00
Direction of Photo:
Northeast
Description: Pipe in
the ditch.

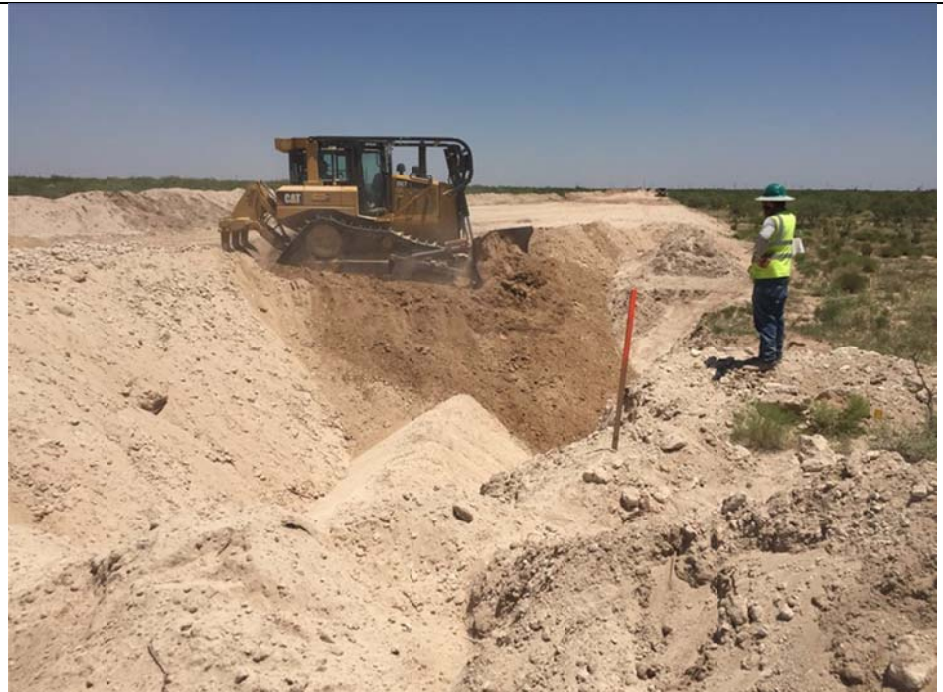
Location: Line No.
31111 ROW at
Station No. 311+00
Direction of Photo:
Northeast
Description:
Backfilling the ditch.

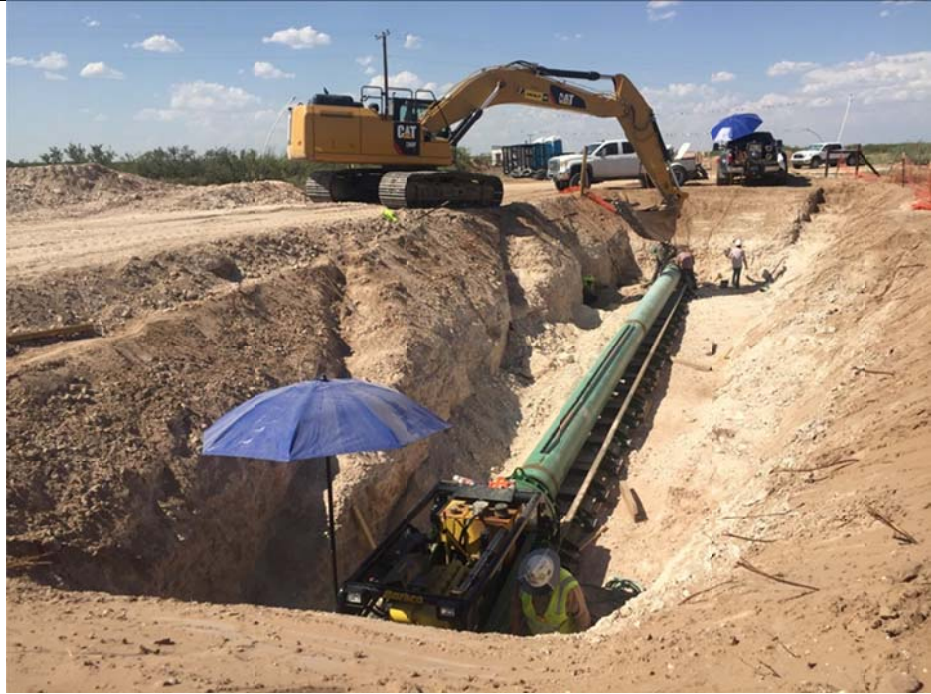
Location: Line No.
31111 ROW at Station
No. 342+00

Description:
Preparing to bore
under County Road
105.

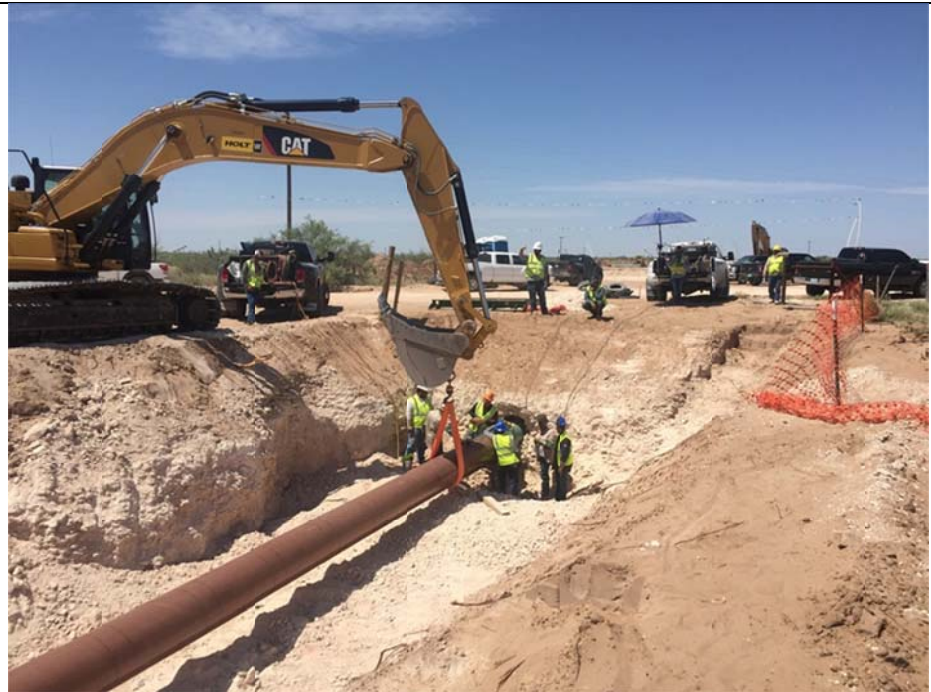
Location: Line No.
31111 ROW at Station
No. 342+00

Description: Welding
on the pipe section
prior to the pull at
County Road 105.

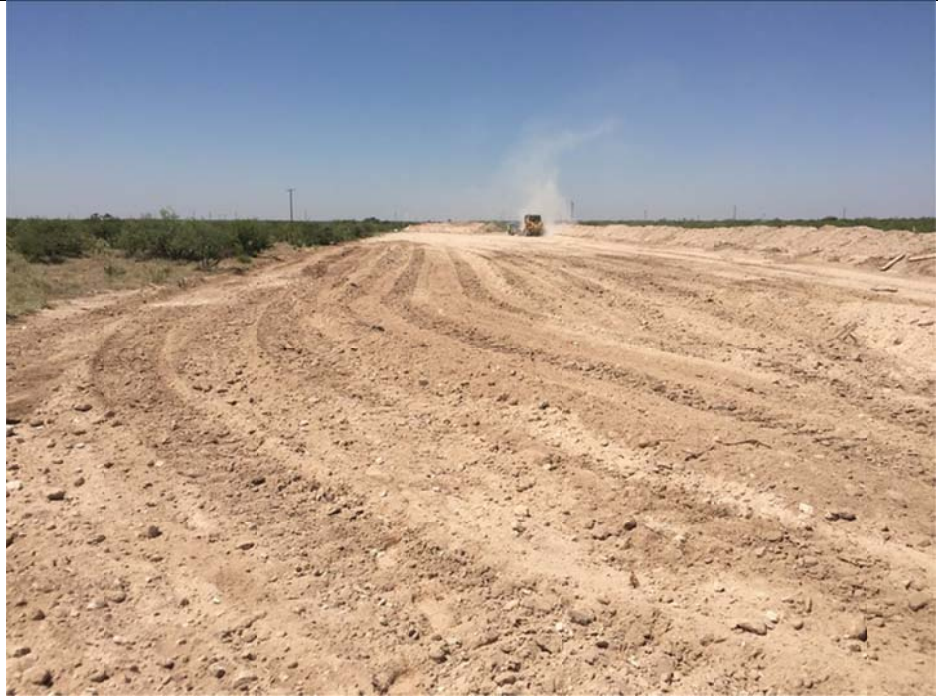
Location: Line No.
31111 ROW at Station
No. 305+00

Description:
Backfilling the ditch
and contouring the
ROW.

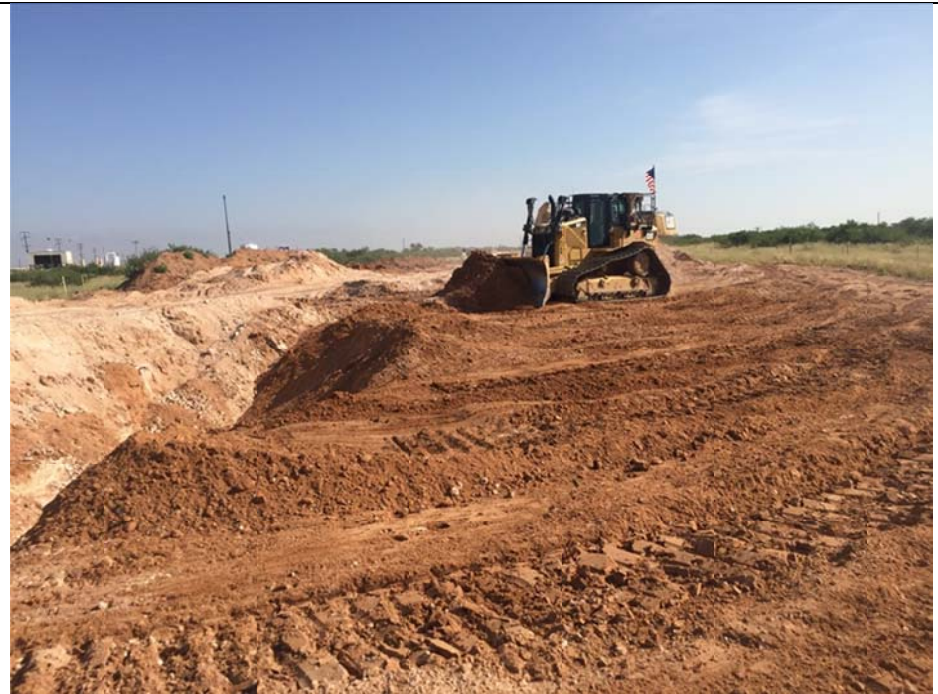
Location: Line No.
31111 ROW at Station
No. 251+00

Description:
Backfilling the ditch.
