Re: El Paso Natural Gas Company, L.L.C.;
Docket No. CP19-28-000
Northern Delaware Basin Expansion Project
Weekly Environmental Inspector Report No. 19

| EPNG Weekly Environmental Inspector Report No. 19 | | |
| Project Name: | Northern Delaware Basin Expansion Project | |
| Reporting Period: | June 30, 2019 to July 6, 2019 | |

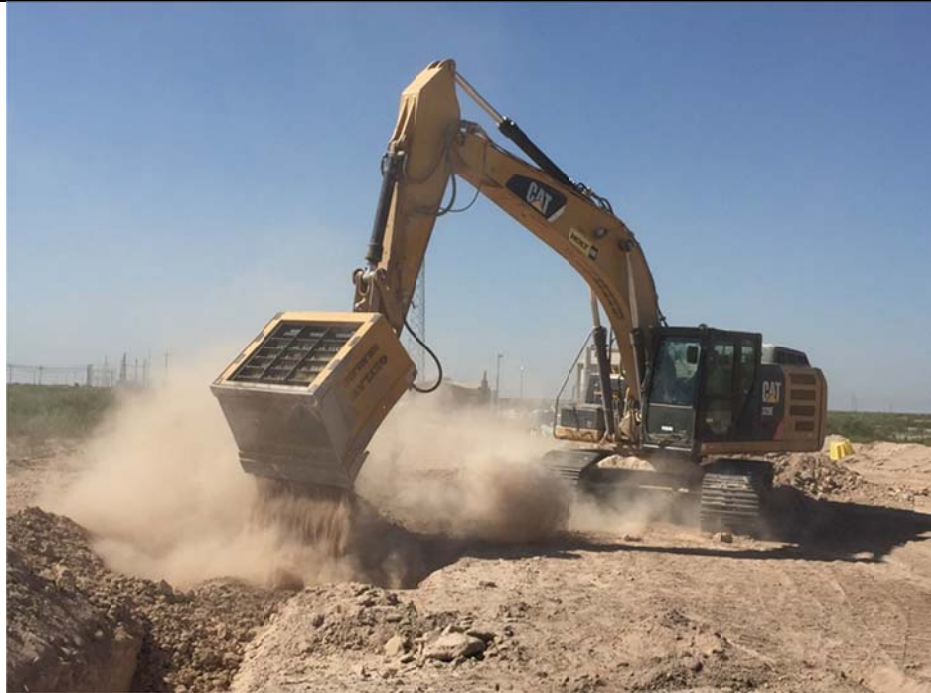
Location: Line No.
31111 ROW at
Station No. 756+00
Direction of Photo:
South

Description:
Backfilling the ditch
after padding the
pipeline.

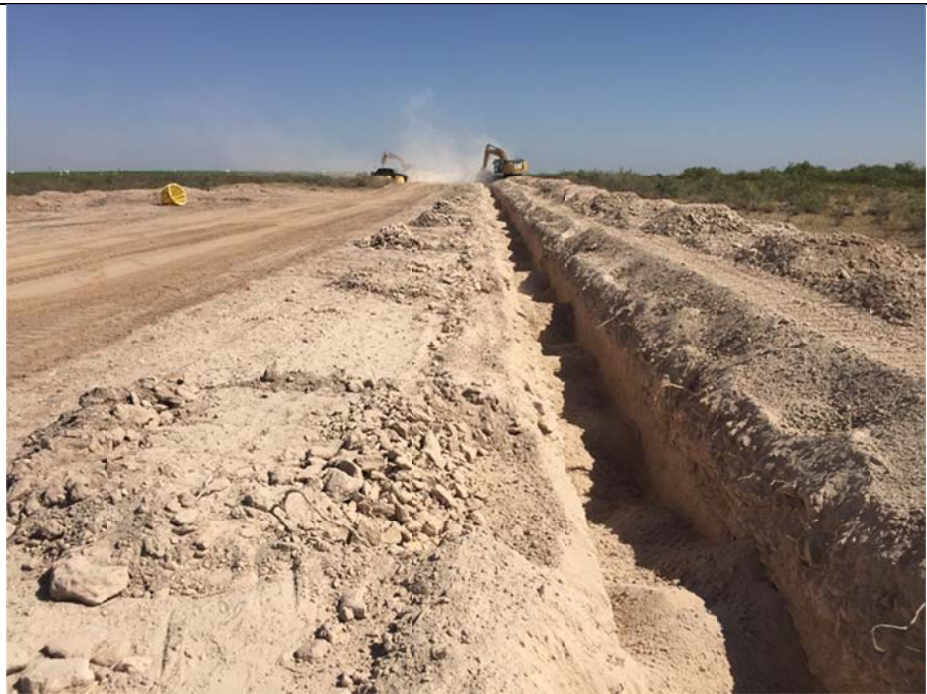
Location: Line No.
31111 ROW at
Station No. 754+00
Direction of Photo:
North
Description: Padded
ditch.

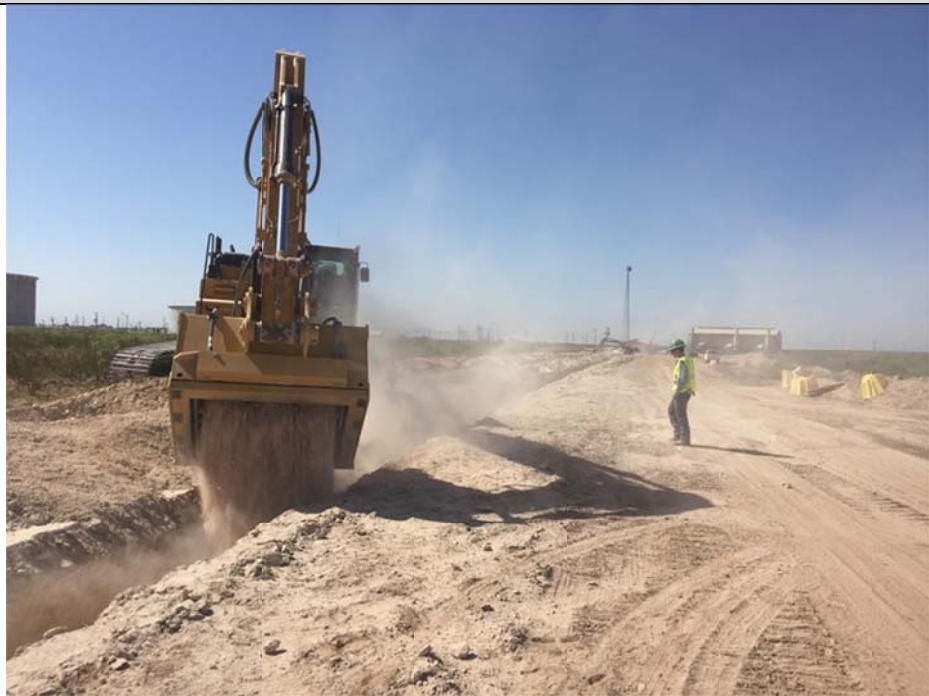
Location: Line No.
31111 ROW at
Station No. 752+00
Direction of Photo:
South
Description: Padding
the pipe in the ditch.

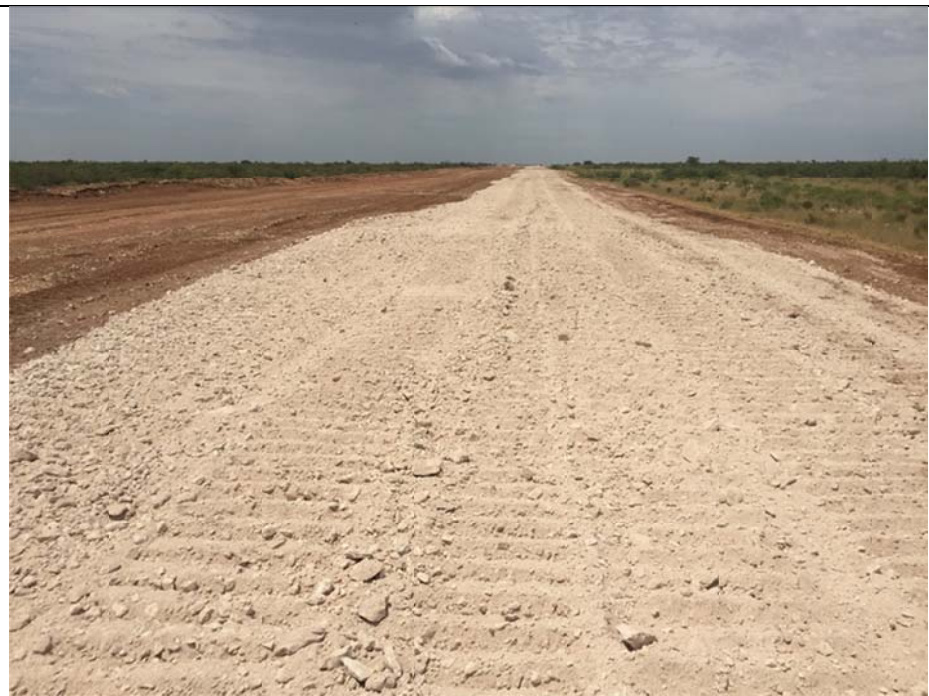
Location: Line No.
31111 ROW at
Station No. 734+00
Direction of Photo:
North
Description: North
along the backfilled
ditch.

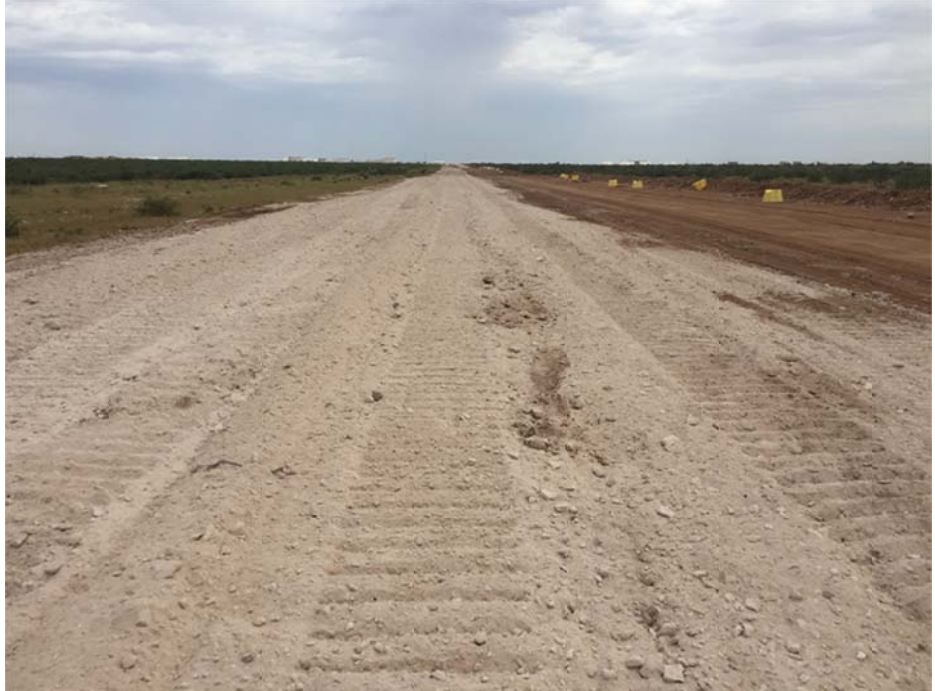
Location: Line No.
31111 ROW at
Station No. 680+00
Direction of Photo:
South
Description:
Backfilled ditch.

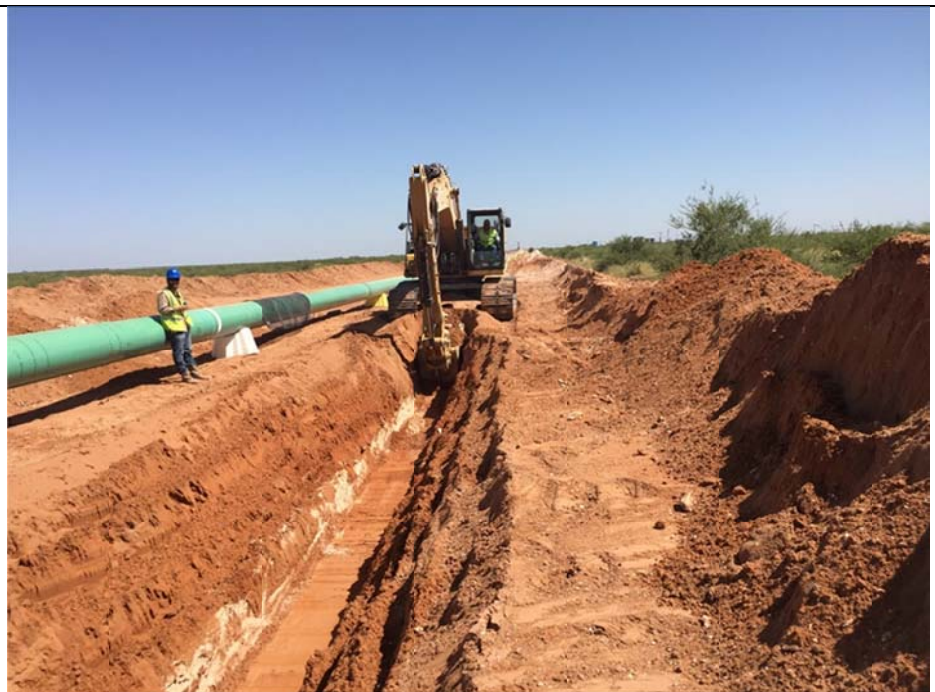
Location: Line No.
31111 ROW at
Station No. 646+00
Direction of Photo:
North
Description: Ditching
with a trackhoe.

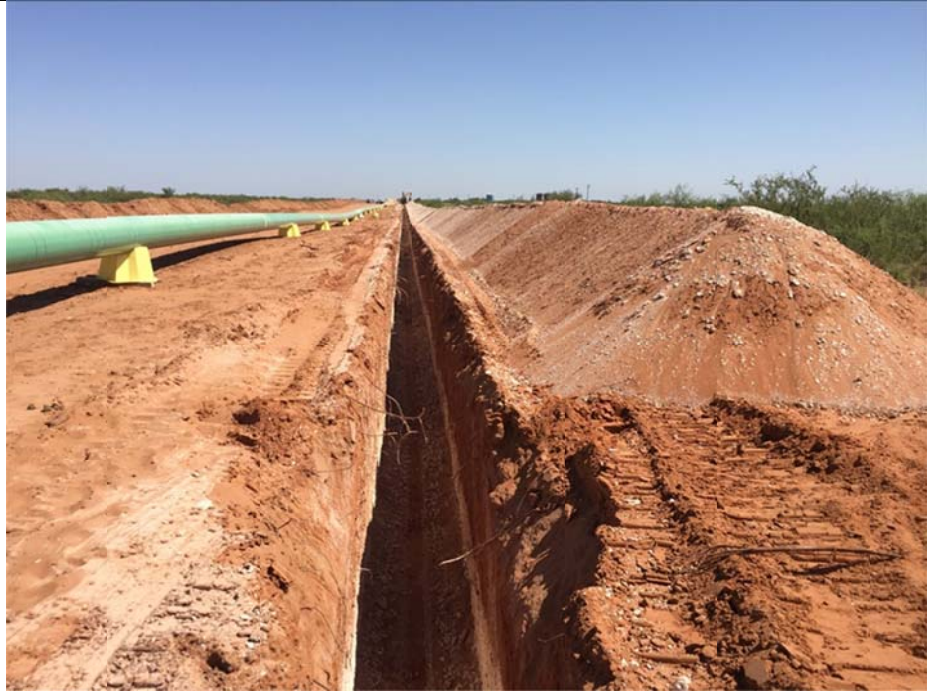
Location: Line No.
31111 ROW at
Station No. 642+00
Direction of Photo:
North
Description: Open
ditch.

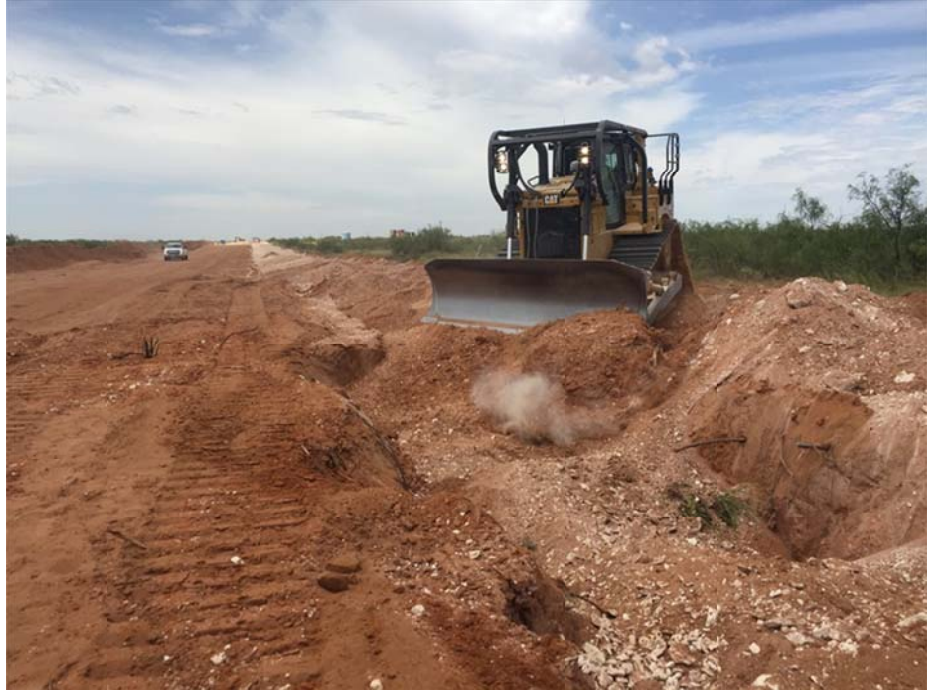
Location: Line No.
31111 ROW at
Station No. 642+00
Direction of Photo:
North
Description:
Backfilling the ditch.

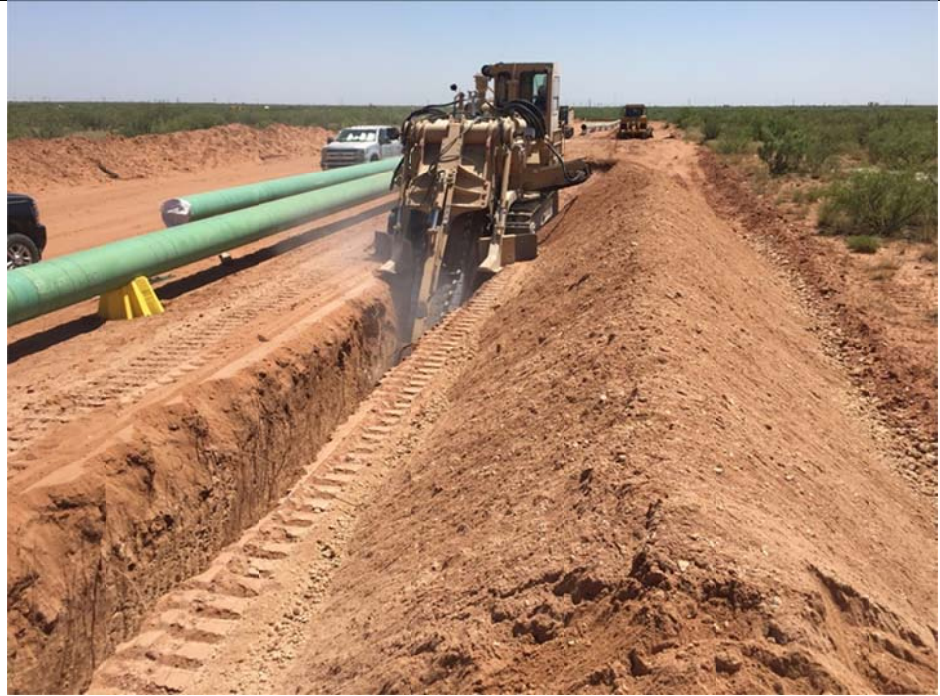
Location: Line No.
31111 ROW at
Station No. 573+00

Description:
Trenching the ditch
line with a trenching
machining.

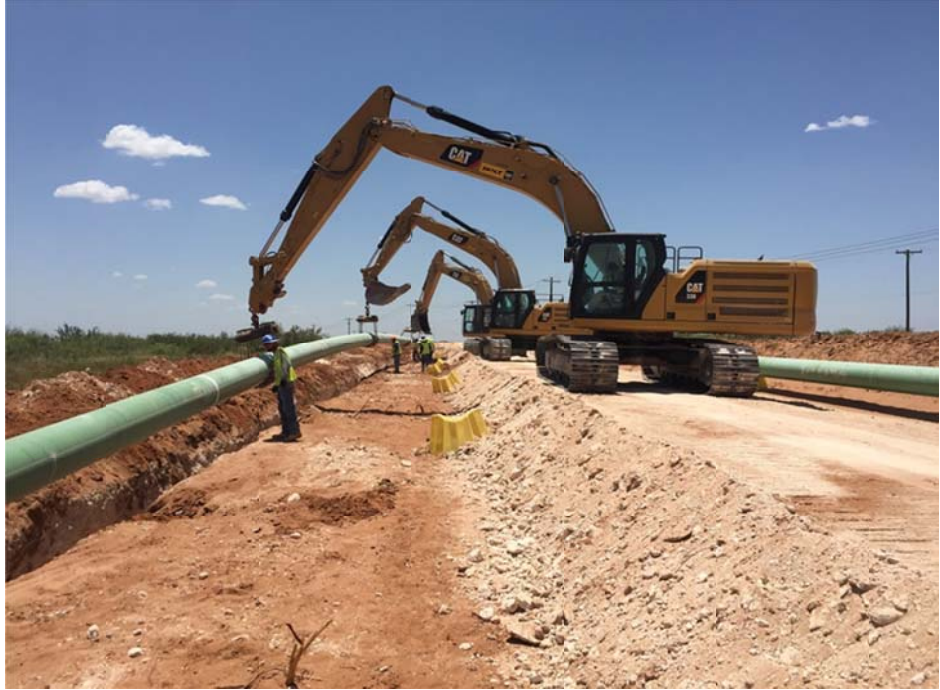
Location: Line No.
31111 ROW at
Station No. 524+00

Description:
Lowering pipe into
the ditch.

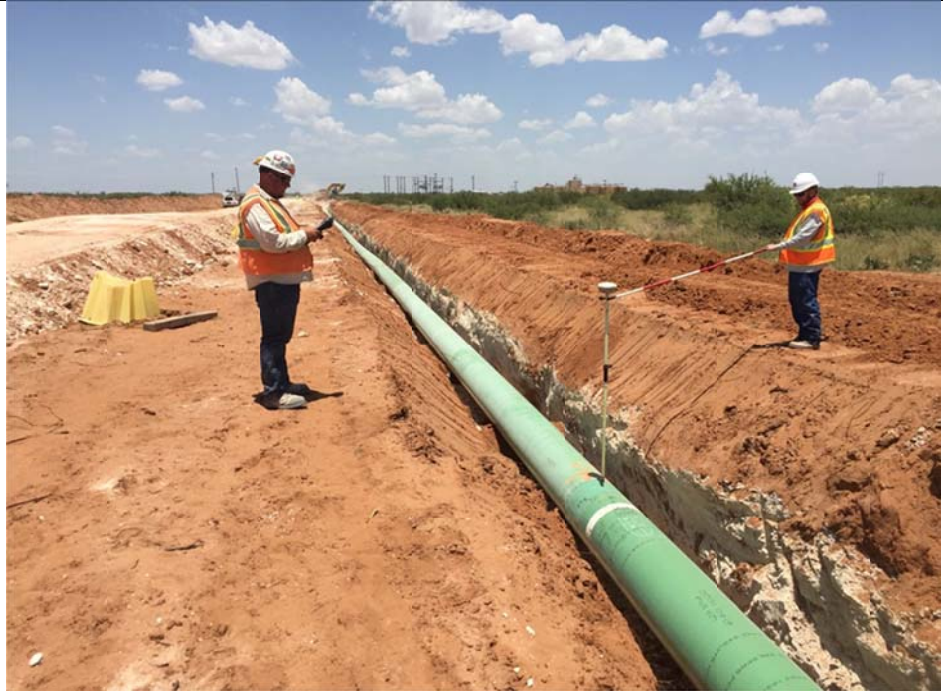
Location: Line No.
31111 ROW at Station
No. 523+00

Description:
Surveying in the weld
locations.

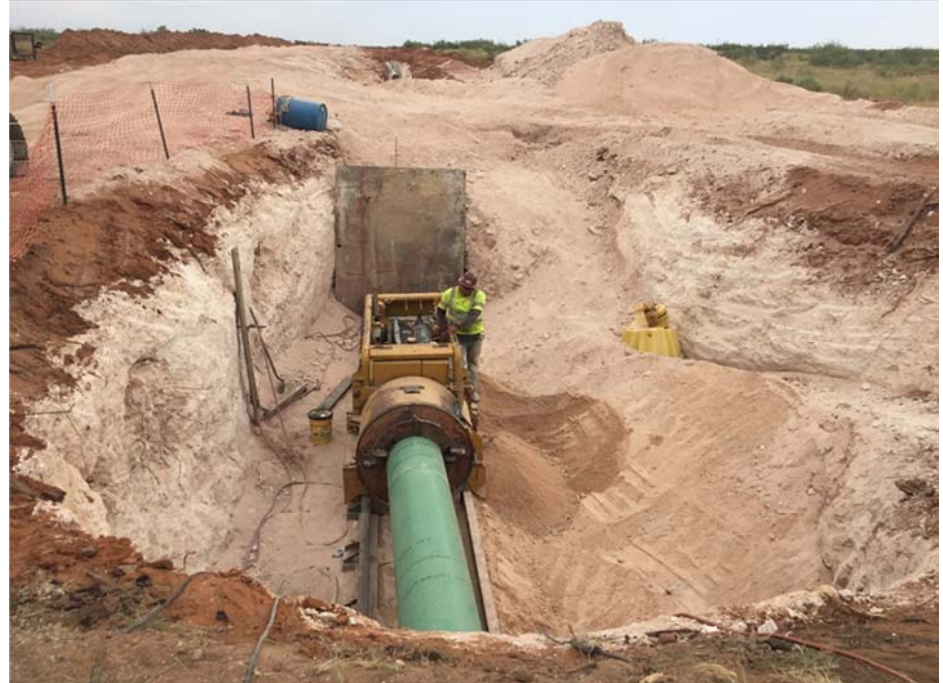
Location: Line No.
31111 ROW at Station
No. 478+00

Description: Boring
County Road 101 with
the boring machine.

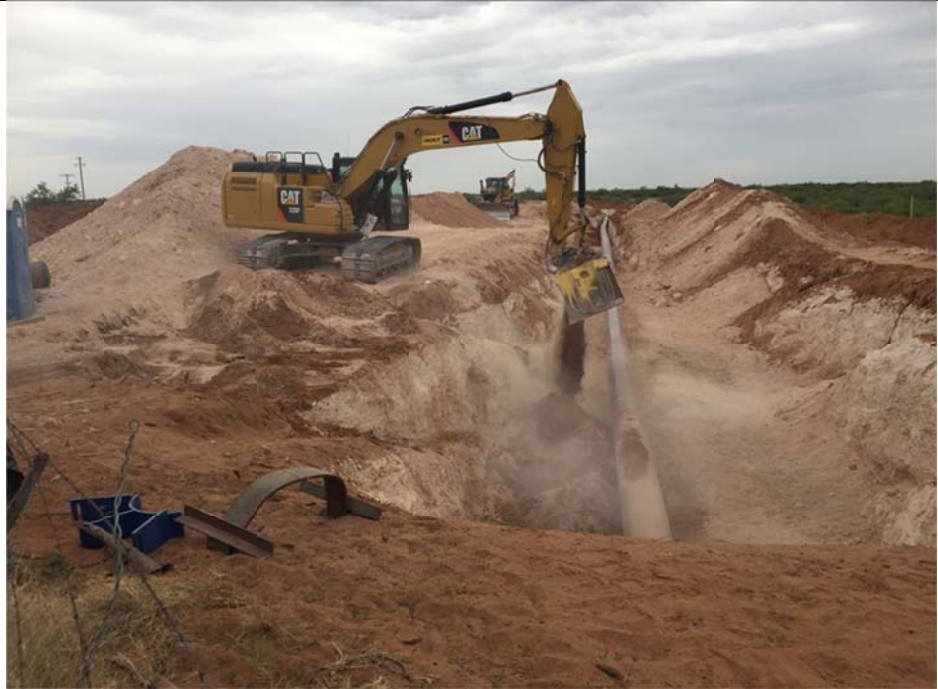
Location: Line No.
31111 ROW at Station
No. 400+00

Description:
Backfilling the bore
pit on the north side
of Texas 874.

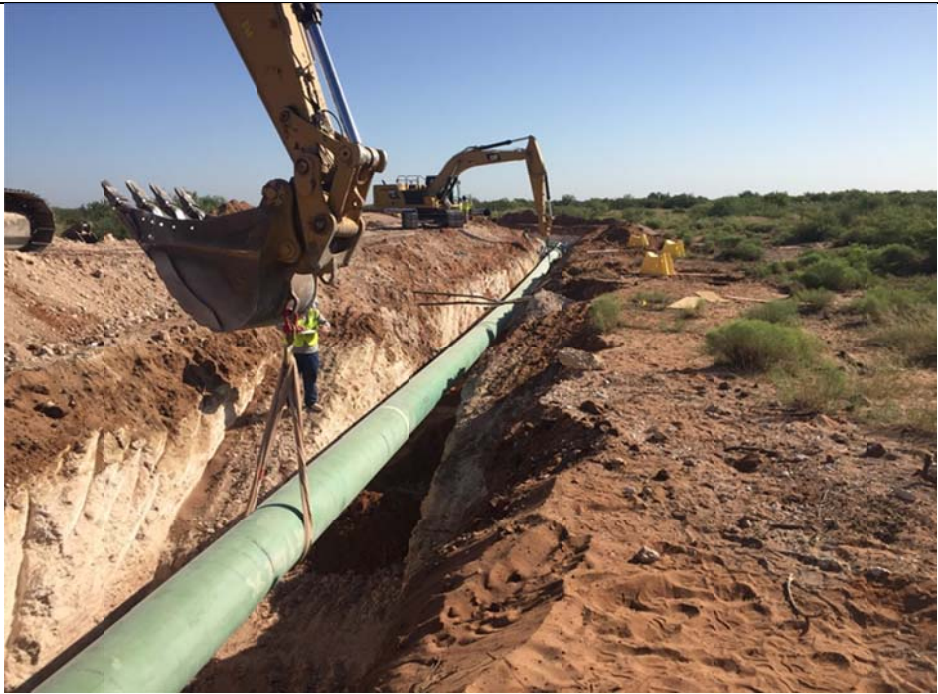
Location: Line No.
31111 ROW at Station
No. 398+00

Description: Lowering
the pipe into the
ditch.

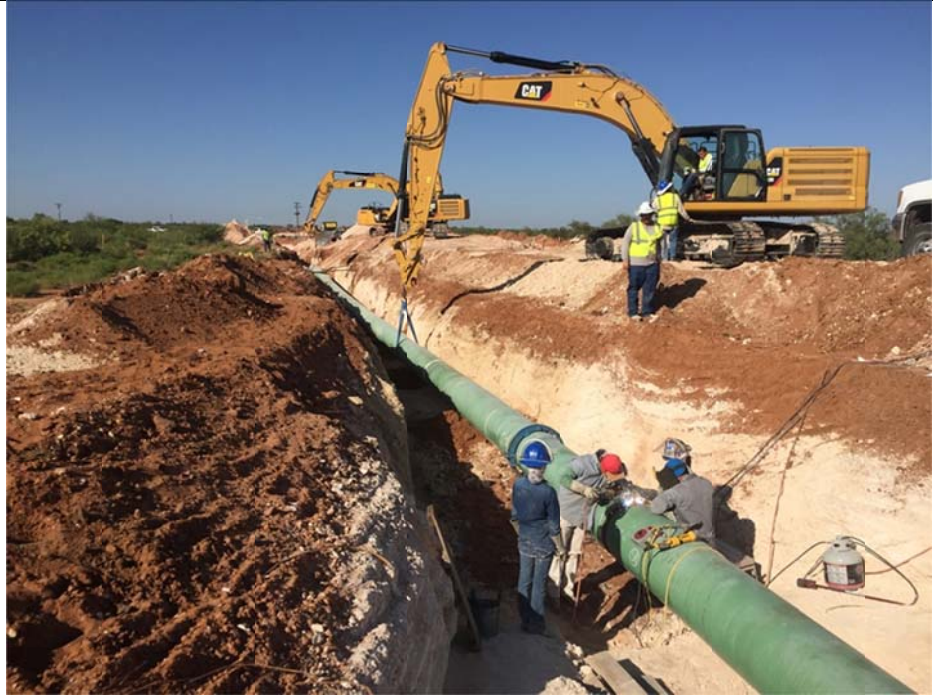
Location: Line No.
31111 ROW at Station
No. 395+00

Description: Making a
tie-in weld.

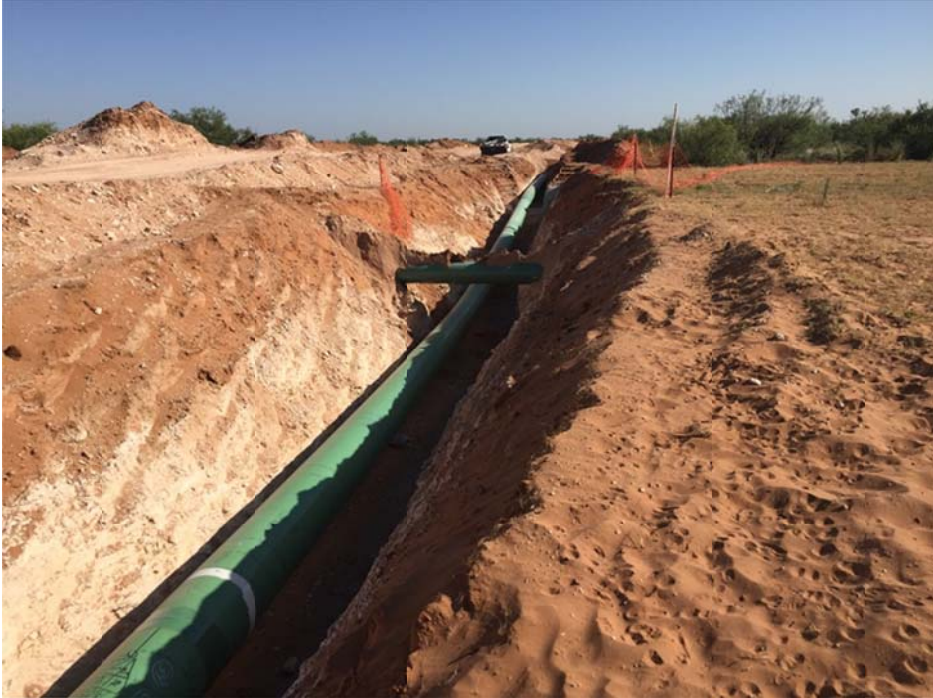
Location: Line No.
31111 ROW at Station
No. 394+00

Description: Pipe in
the ditch under a
foreign line.

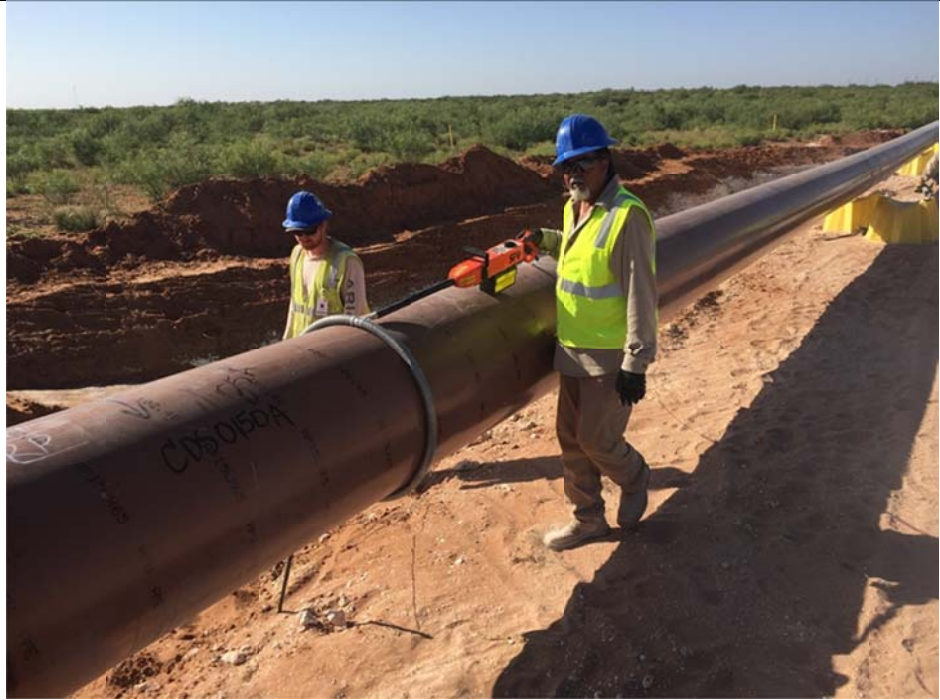
Location: Line No.
31111 ROW at Station
No. 394+00

Description: Pre-
jacking the pipe.

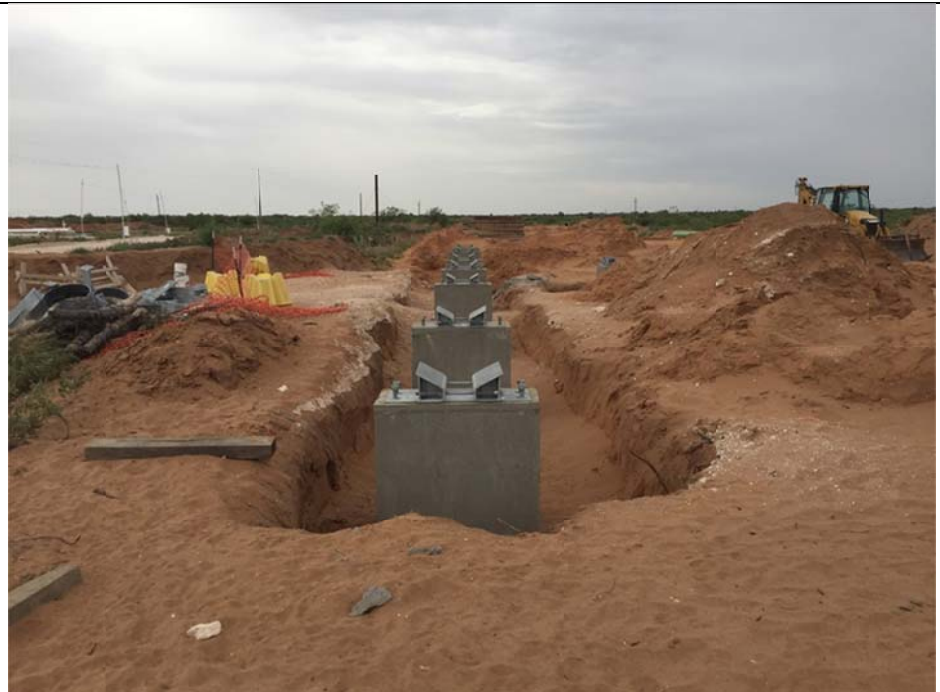
Location: Line No.
31111 ROW at Station
No. 0+00

Description: Concrete
piers at the kick-off
site.
