Re: El Paso Natural Gas Company, L.L.C.;
Docket No. CP19-30-000
Kiwanis Delivery Meter Station Project
Weekly Environmental Inspector Report No. 1

| EPNG's Biweekly Environmental Inspector Report No. 1 | | |
| Project Name: | Carlsbad South Project | |
| Reporting Period: | 08/25/2020 – 8/30/2020 | |

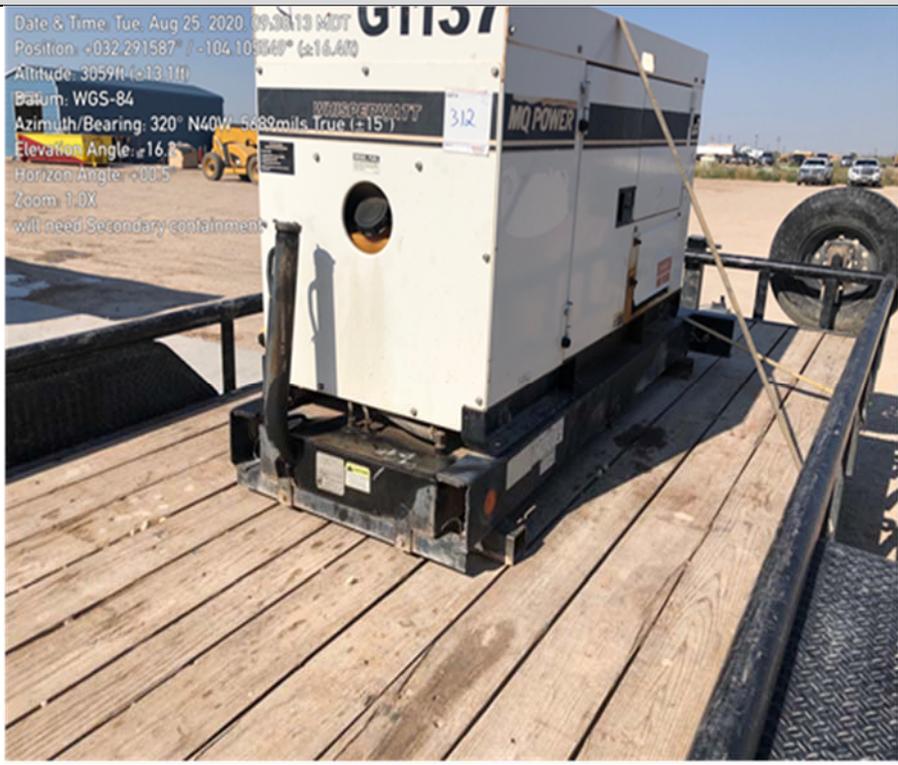
Location:
Contractor yard

Description:
Inspecting generator that will be running office trailer

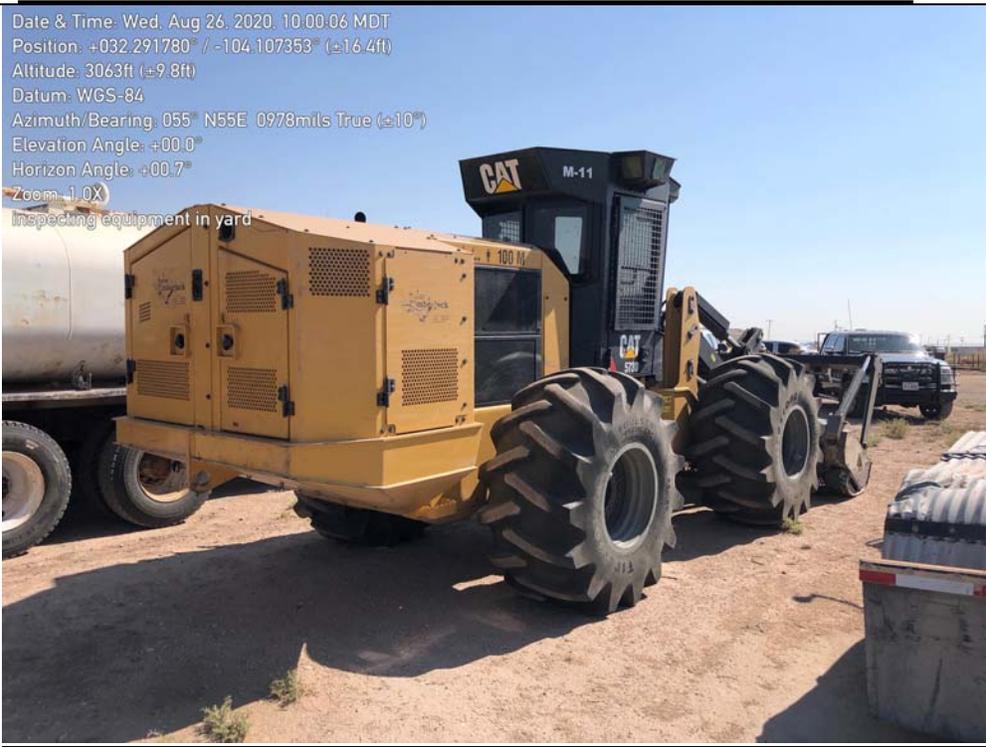
Location:
Contractor yard

Description:
Inspecting equipment before being allowed on the ROW

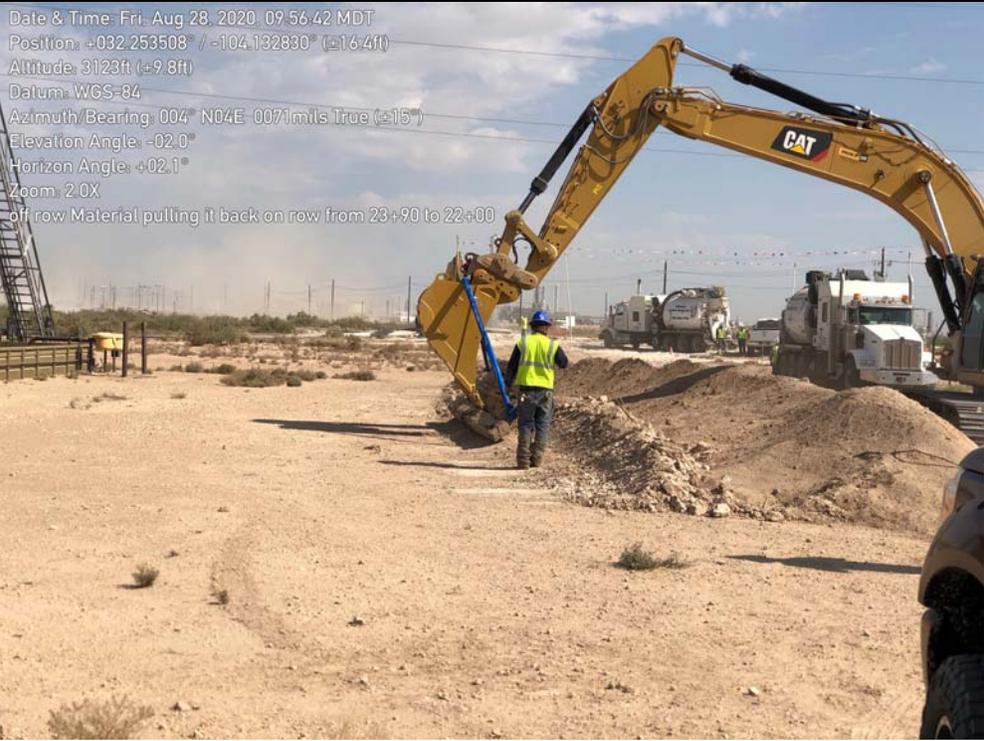
Location:
Station
24+00
**Direction of
Photo:**
North
Description:
Pulling back
topsoil and
rock that is
off ROW.

Date & Time: Fri, Aug 28, 2020, 09:56:42 MDT
Position: +032.253508° / -104.132830° (±16.4ft)
Altitude: 3123ft (±9.8ft)
Datum: WGS-84
Azimuth/Bearing: 004° N04E 0071mils True (±15°)
Elevation Angle: -02.0°
Horizon Angle: +02.1°
Zoom: 2.0X
off row Material pulling it back on row from 23+90 to 22+00

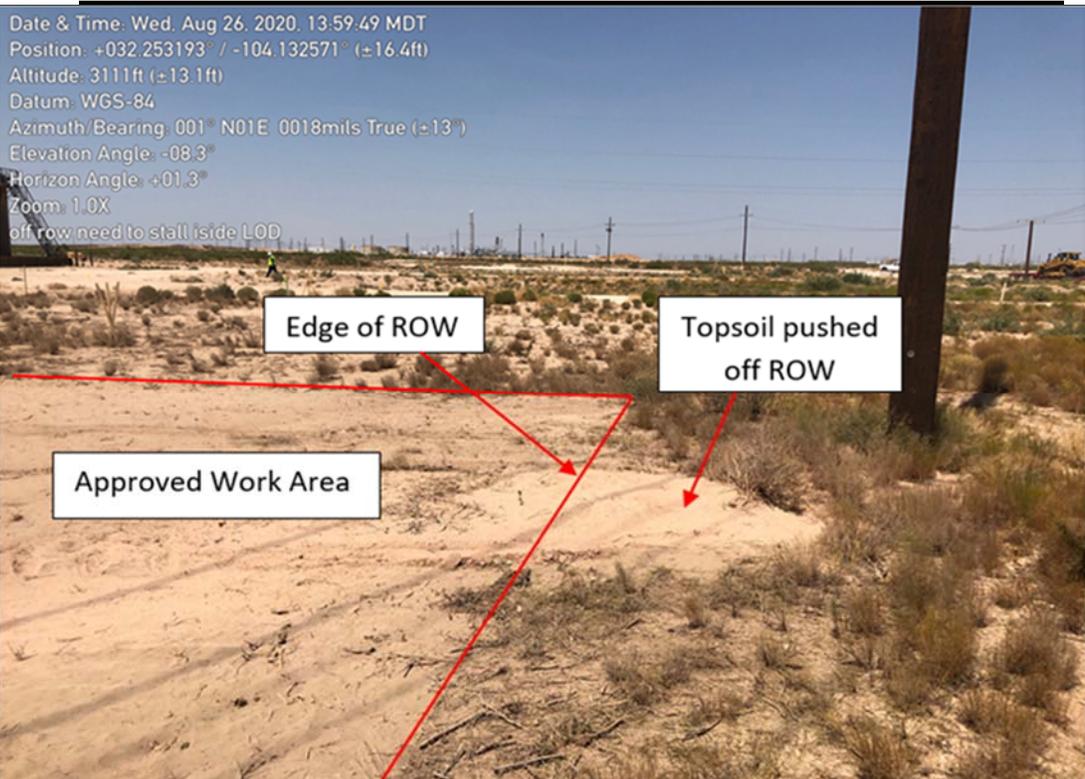
Location:
Station
26+00
**Direction of
Photo:** East
Description:
Off ROW
with topsoil
and rock

Date & Time: Wed, Aug 26, 2020, 13:59:49 MDT
Position: +032.253193° / -104.132571° (±16.4ft)
Altitude: 3111ft (±13.1ft)
Datum: WGS-84
Azimuth/Bearing: 001° N01E 0018mils True (±13°)
Elevation Angle: -08.3°
Horizon Angle: +01.3°
Zoom: 1.0X
off row need to stall inside LOD
