Re: El Paso Natural Gas Company, L.L.C.;

Docket No. CP20-483-000 Carlsbad South Project

Weekly Environmental Inspector Report No. 12

EPNG's Weekly Environmental Inspection Report No. 12 Docket No. CP20-483-000		
County/State:	Eddy and Lea Counties, New Mexico	Date: 11/20/2020
Reporting Period:	11/09/2020 – 11/15/2020	
Environmental Inspection:	Raymond Patton, Lead Environmental Inspector	
	Environmental Inspectors:	
	Michael Connors; Mark Cosby; Daniel Day; Adam Eddy

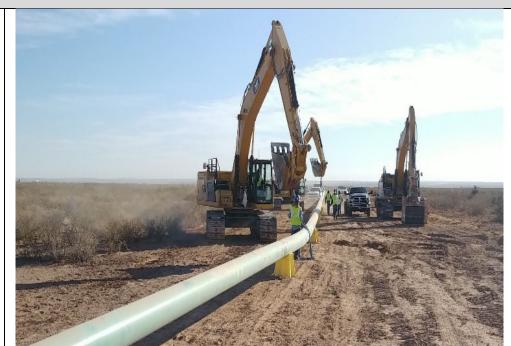
Location: Station Number 480+00

Direction of Photo: East **Description:** Tie in crew preparing pipe for

installation.

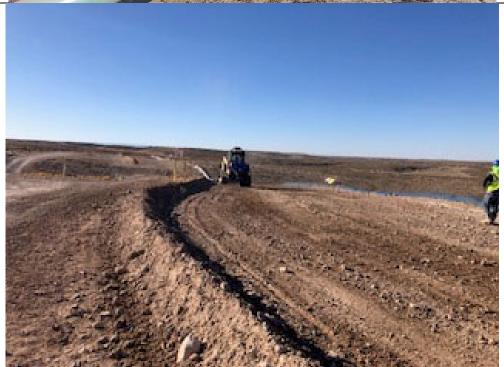
Location: Station Number 888+00 Direction of Photo:

Description: ROW being

seeded.

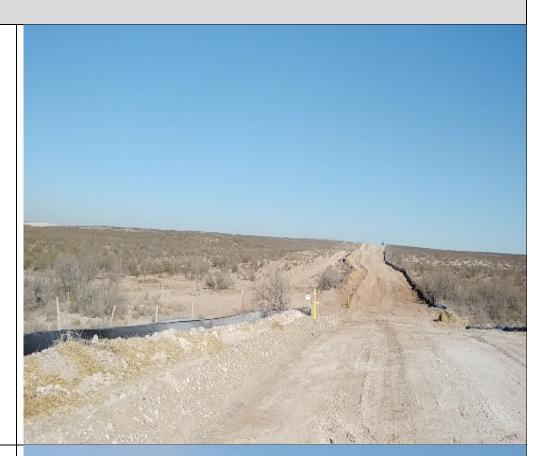
Location: Station Number 694+00 Direction of Photo: Northwest

Description: Backfilled trench with crown and adjacent topsoil pile. **Date:** 11/11/2020

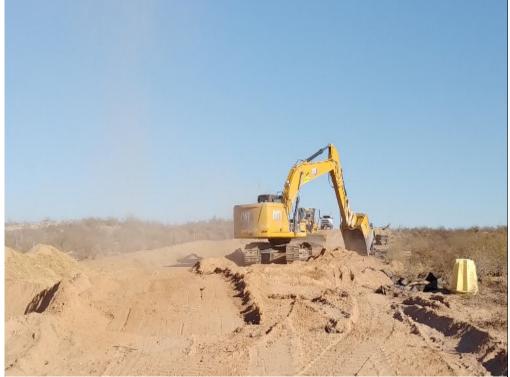
Location: Station Number 513+00 Direction of Photo:

Description: Crew padding and backfilling

trench.

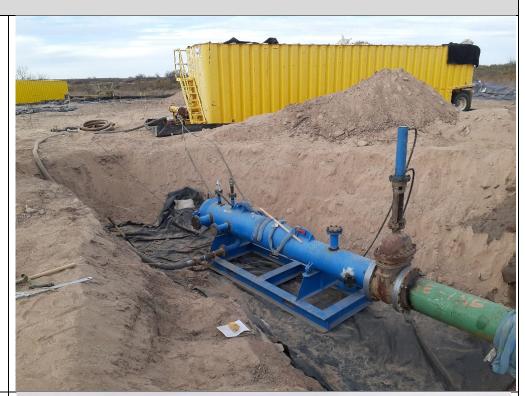
Location: Station Number 180+00 Direction of Photo:

Description: New pig receiver and dust mitigation system installed on pipe. **Date:** 11/12/2020

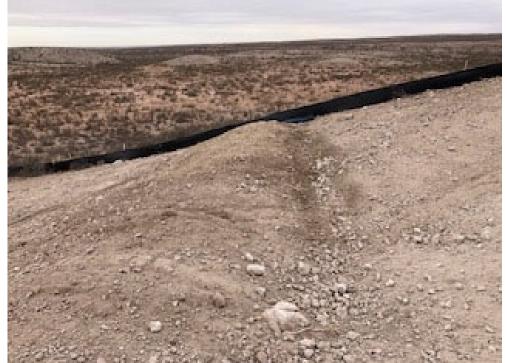
Location: Station Number 846+57 Direction of Photo: East Description: View slope

breaker installed on ROW.

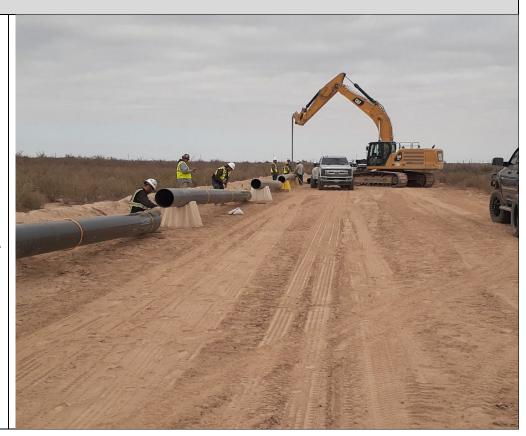
Location: Station Number 87+00 **Direction of Photo:**

Description: Crew preparing for welds near Black River HDD area. **Date:** 11/13/2020
