Re: El Paso Natural Gas Company, L.L.C.;
Docket No. CP20-483-000
Carlsbad South Project
Weekly Environmental Inspector Report No. 19

EPNG's Weekly Environmental Inspection Report No. 19		
Docket No. CP20-483-000		
Project Name:	Carlsbad South Project	
County/State:	Eddy and Lea Counties, New Mexico	Date: 01/08/2021
Reporting Period:	12/28/2020 – 01/03/2021	
Environmental Inspection:	Raymond Patton, Lead Environmental Inspector Environmental Inspectors: Michael Connors; Mark Cosby; and Daniel Day.	
<p>1. SUMMARY OF CONSTRUCTION ACTIVITY FOR INSPECTION PERIOD:</p> <p><u>Line No. 31113:</u></p> <ul style="list-style-type: none"> • Restoration continued on the north spread and is mostly complete on south spread. • General maintenance of erosion control devices continue on both spreads. • Water truck operation continues on ROW and access roads on both spreads. <p><u>Eunice Compressor Station Modifications:</u> Eunice Compressor Station modifications work completed.</p> <p><u>Ancillary Facilities:</u> No updates during this reporting period.</p> <p>2. RELEVANT ENVIRONMENTAL ACTIVITIES: During this reporting period one (1) additional staff received environmental training. In total seven

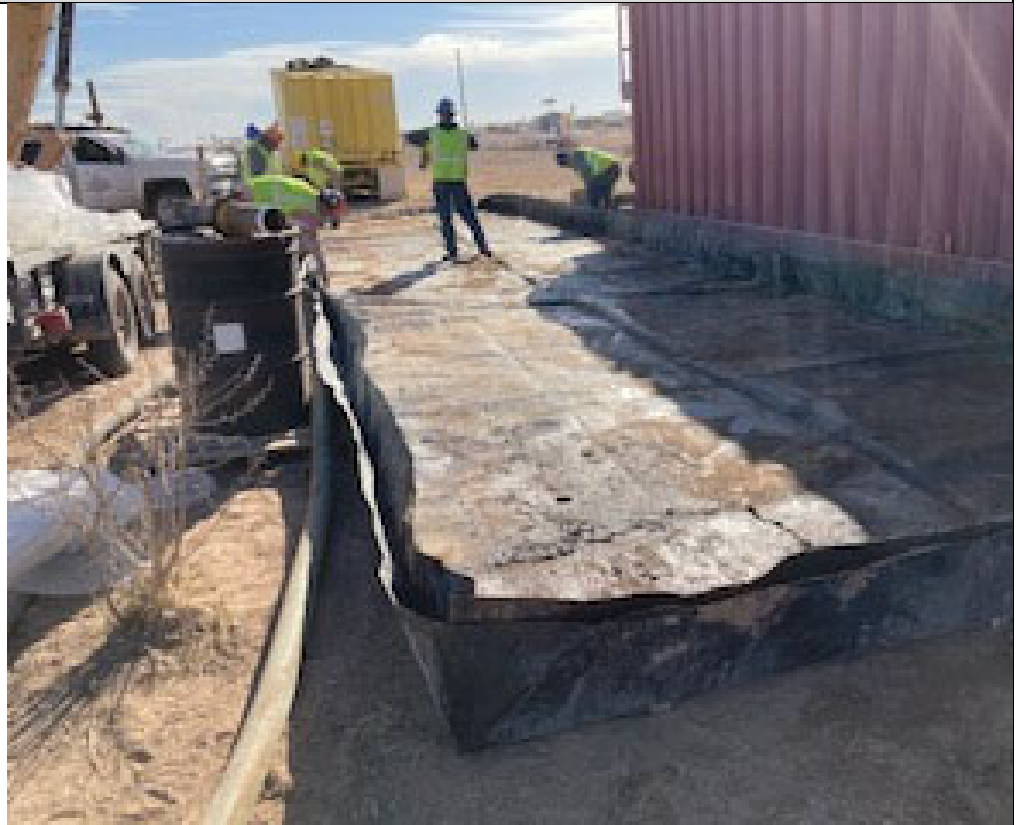
Location: Station Number 906+00
Direction of Photo: East
Description Second secondary containment placed for frac tank.
Date: 12/28/2020

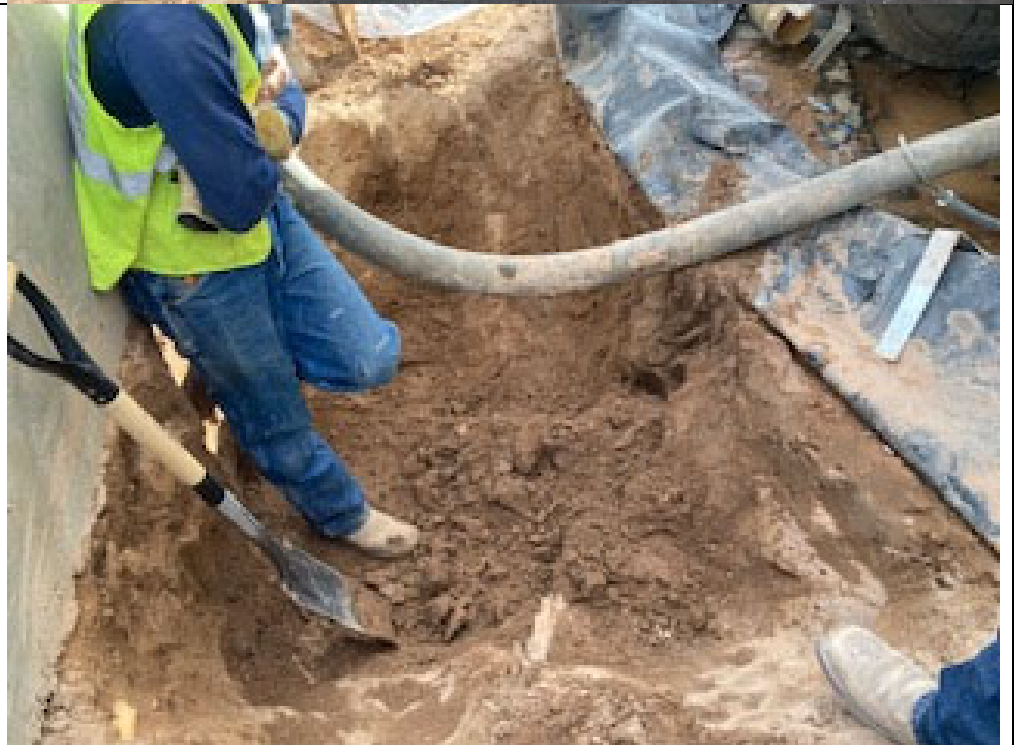
Location: Station Number 906+00
Direction of Photo: South
Description: Dirt affected by frac tank removed.
Date: 12/28/2020

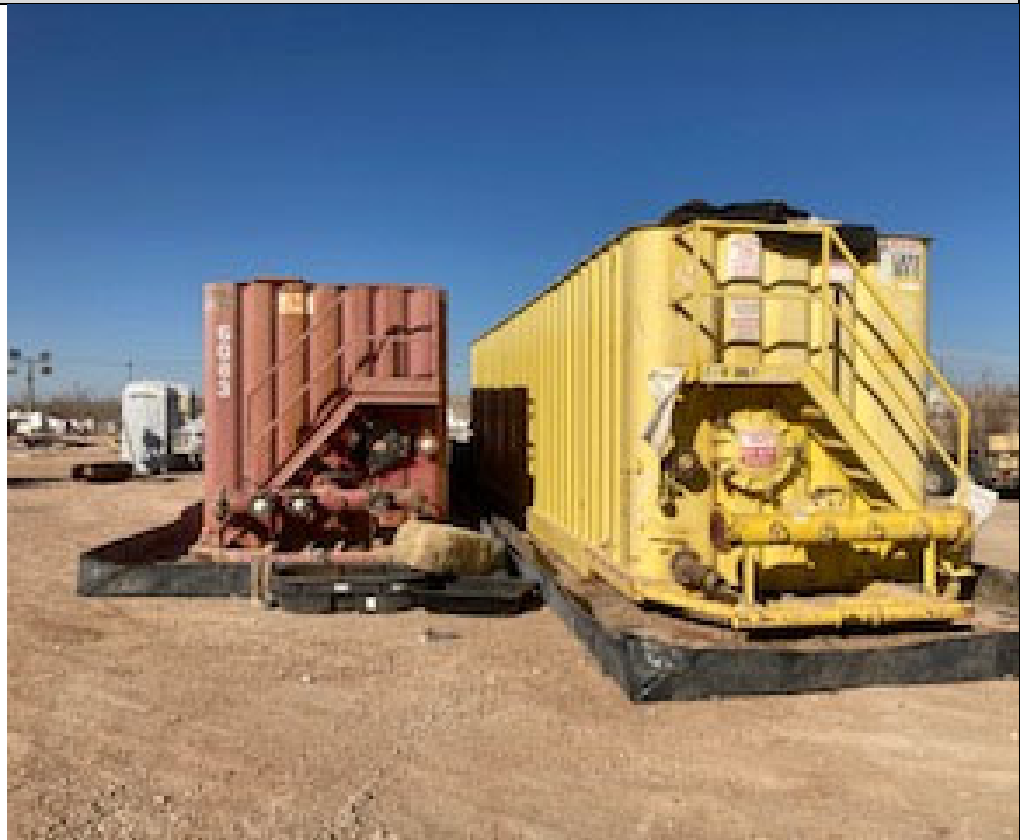
Location: Station Number 906+00
Direction of Photo: East
Description Frac tank placed back in secondary containment.
Date: 12/28/2020

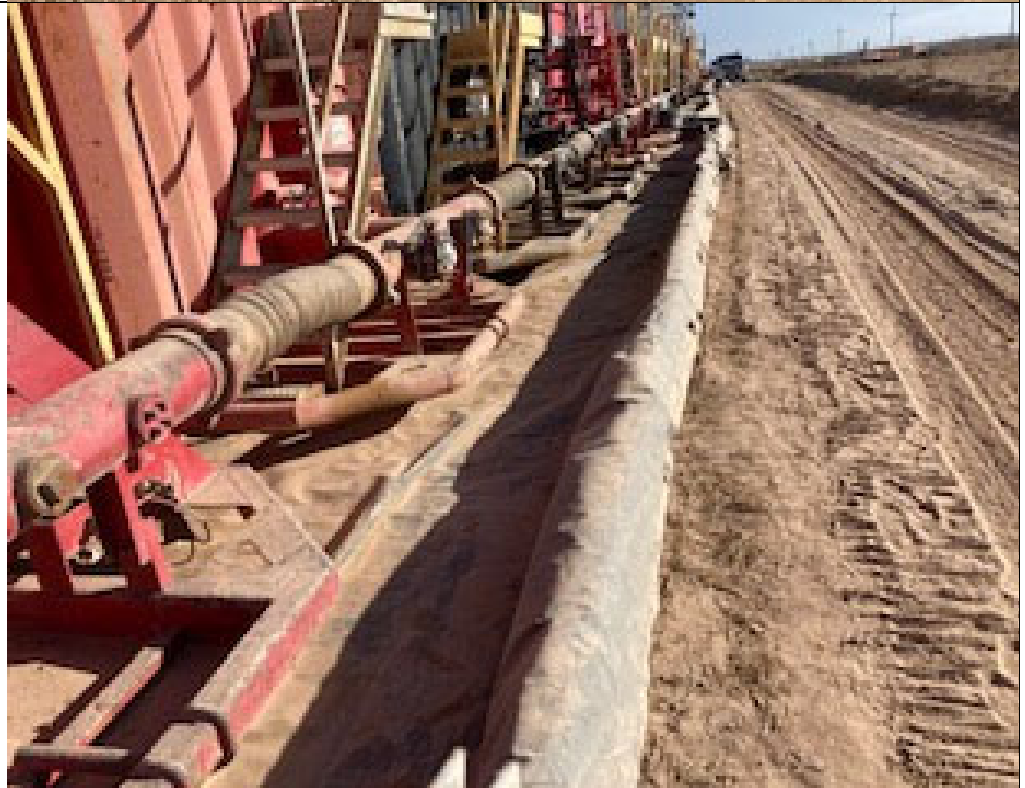
Location: Station Number 906+00
Direction of Photo: East
Description: Frac tanks and secondary containment.
Date: 12/28/2020

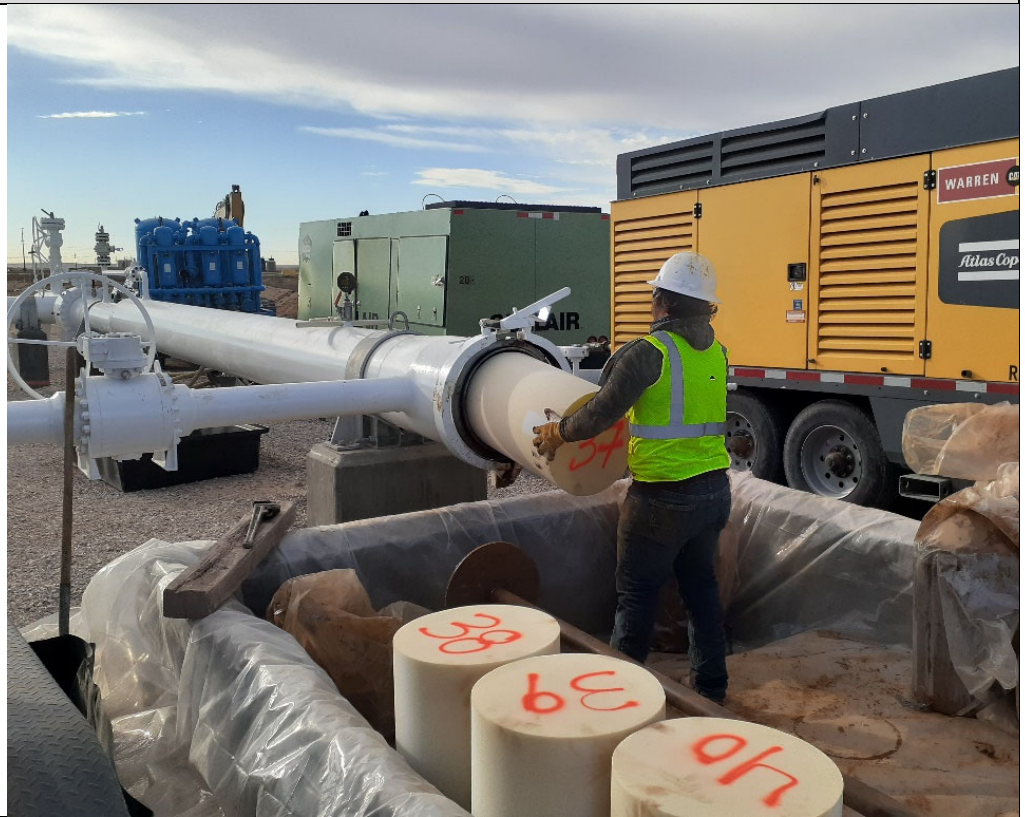
Location: Station Number 0+00
Direction of Photo: North
Description Contractor loading pigs into pig launcher.
Date: 12/28/2020

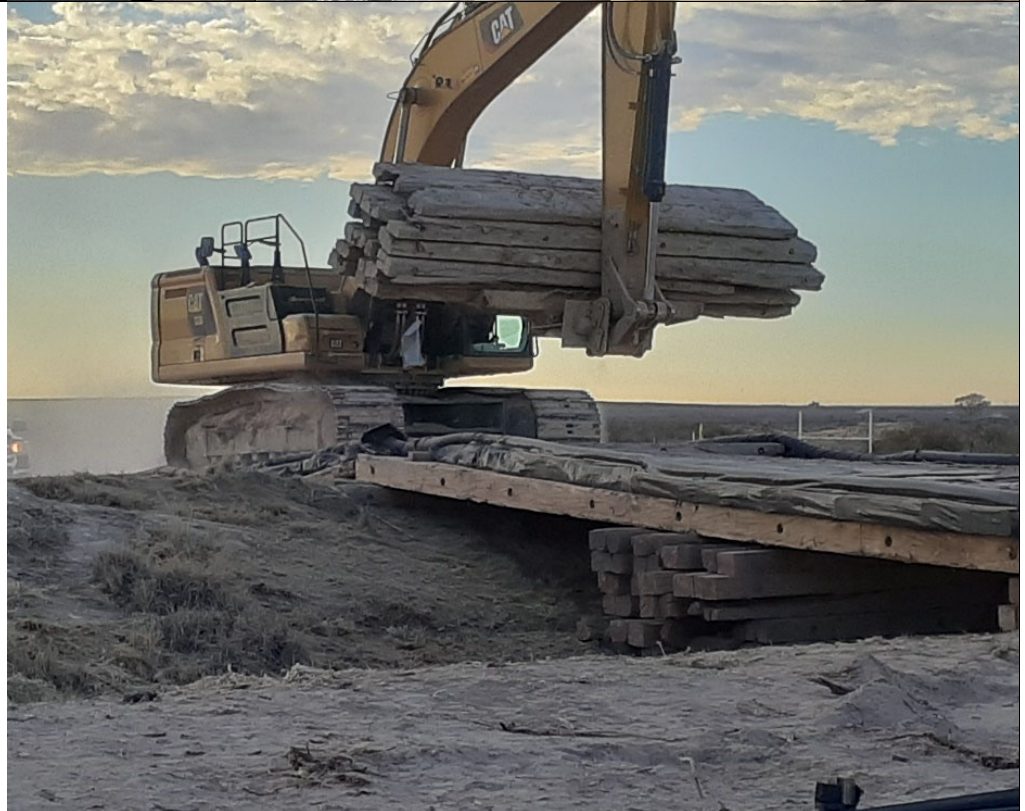
Location: Station Number 34+00
Direction of Photo: West
Description: Mats being removed from ROW.
Date: 12/28/2020

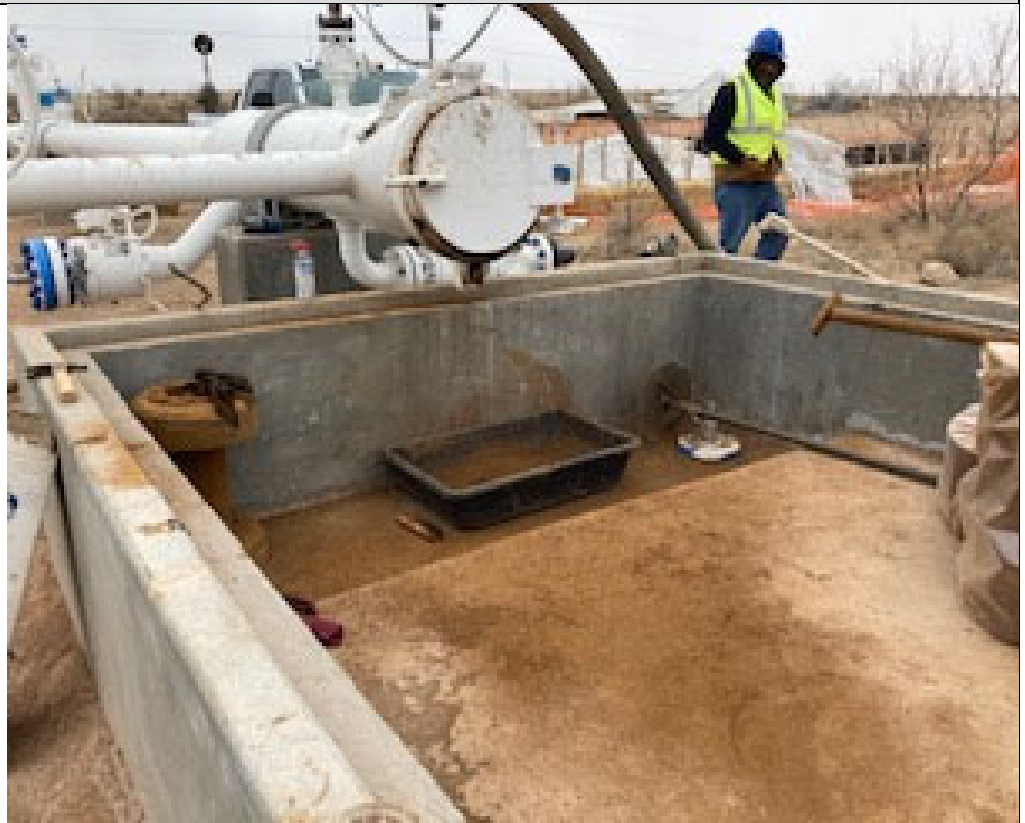
Location: Station Number 906+00
Direction of Photo: Southeast
Description: Catch basin for receiver.
Date: 12/30/2020

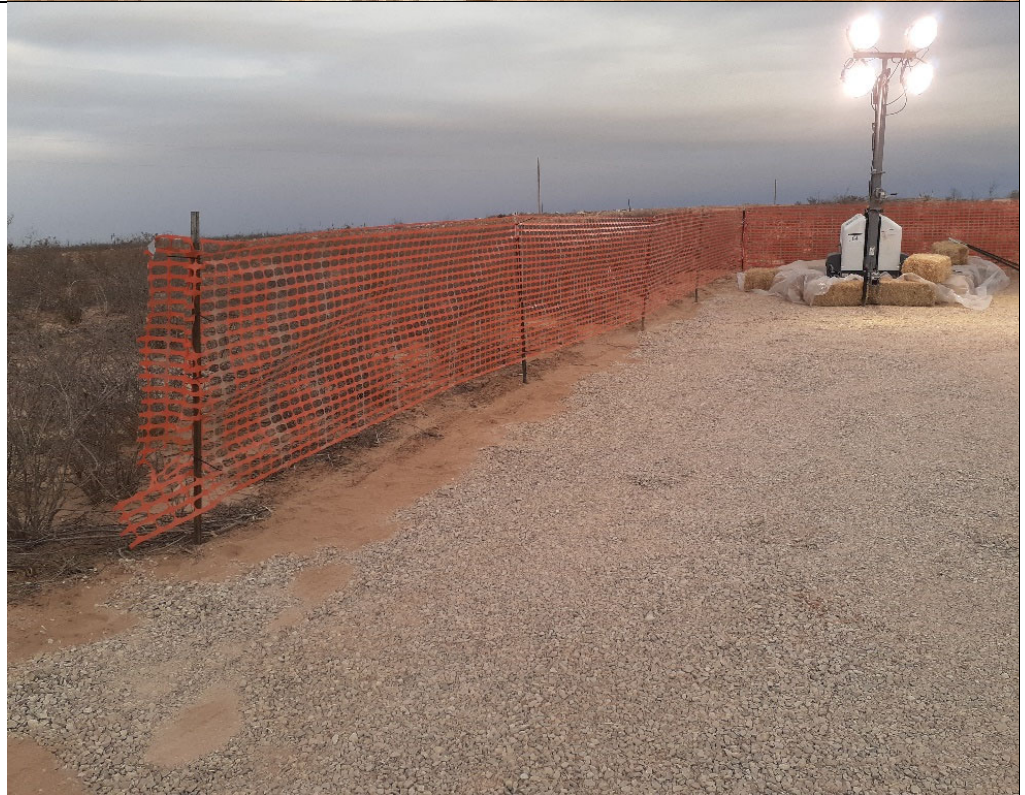
Location: Station Number 0+00
Direction of Photo: North
Description: View of safety fence installed at launcher site.
Date: 12/30/2020

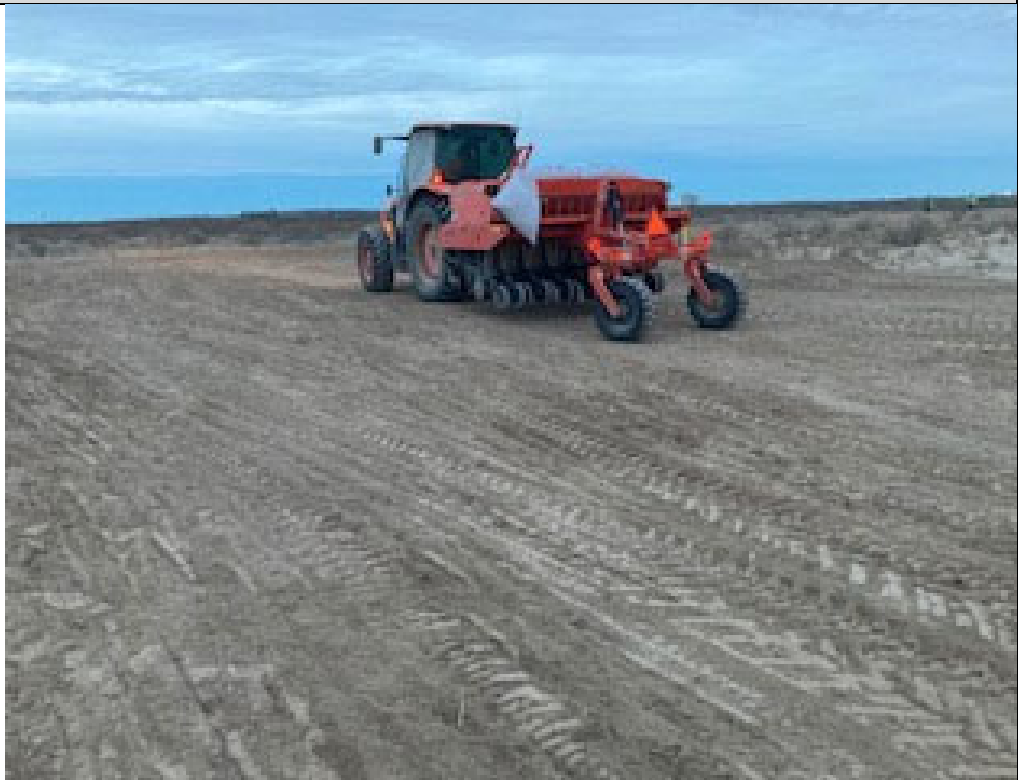
Location: Station Number 144+00
Direction of Photo: Southeast
Description Seeding by Black River Road access.
Date: 12/31/2020

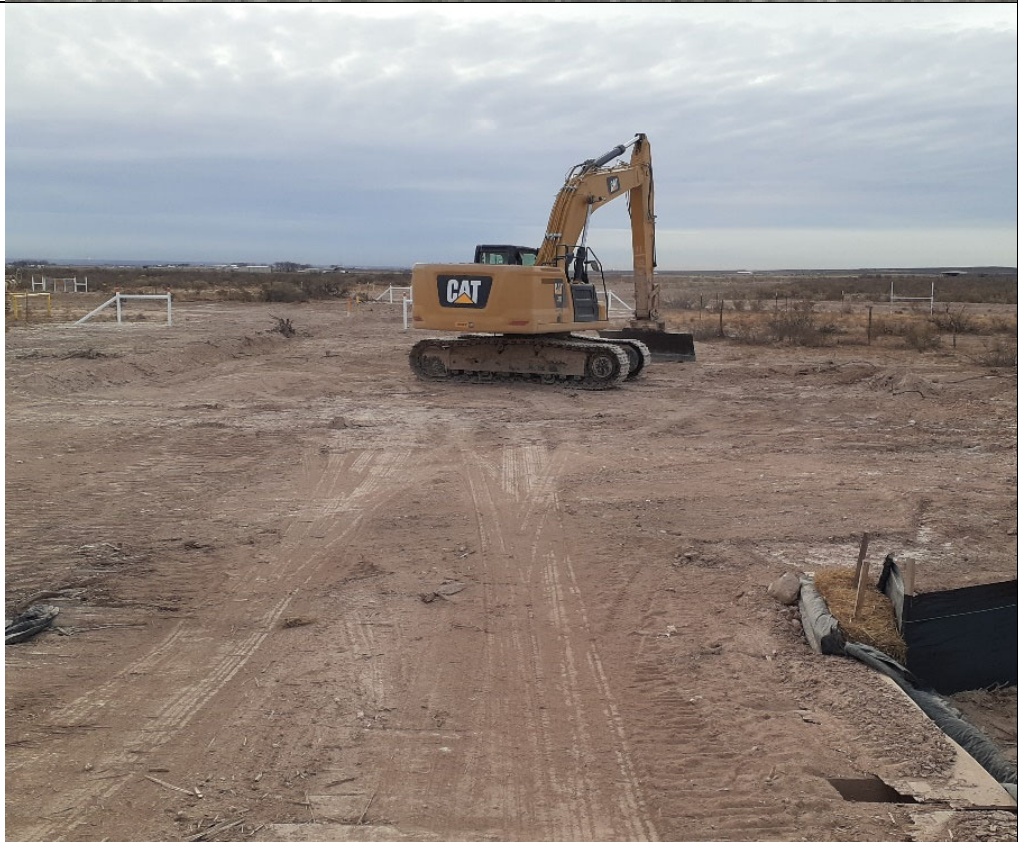
Location: Station Number 43+00
Direction of Photo: West
Description: Topsoil grading.
Date: 12/31/2020
