Docket No. CP20-483-000 Carlsbad South Project

Weekly Environmental Inspector Report No. 27

EPNG's Weekly Environmental Inspection Report No. 27		
Docket No. CP20-483-000		
Project Name:	Carlsbad South Project	
County/State:	Eddy and Lea Counties, New Mexico	Date: 03/05/2021
Reporting Period:	02/22/2021 – 02/28/2021	
Environmental	Raymond Patton, Lead Environmental Inspector.	
Inspection:	Daniel Day, Environmental Inspector.

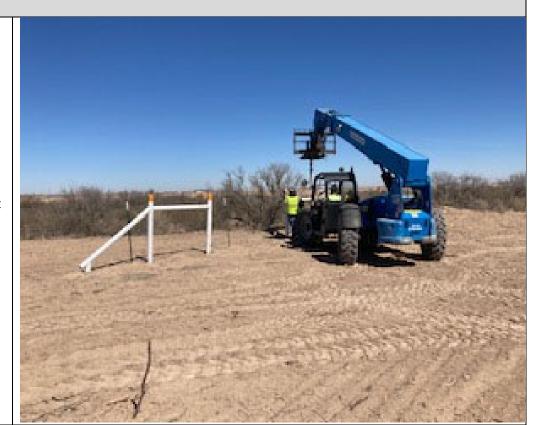
Location: Station Number 122+50

Direction of Photo: East **Description:** Moving H braces to install new

gates.

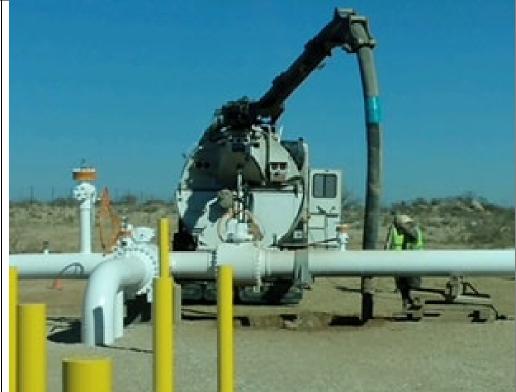
Location: Station Number 906+00 Direction of Photo:

Description: Removing soil from around concrete pier from under pig receiver. **Date:** 02/24/2021

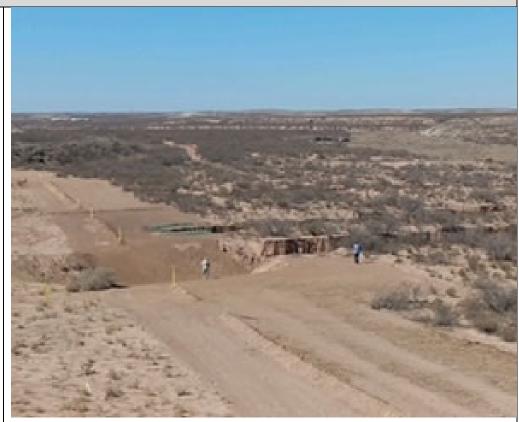
Location: Station Number 882+00 **Direction of Photo:**

Description: Hand seeding ROW by contractor where soil was disturbed while installing sub-mar mats. Date: 02/24/2021

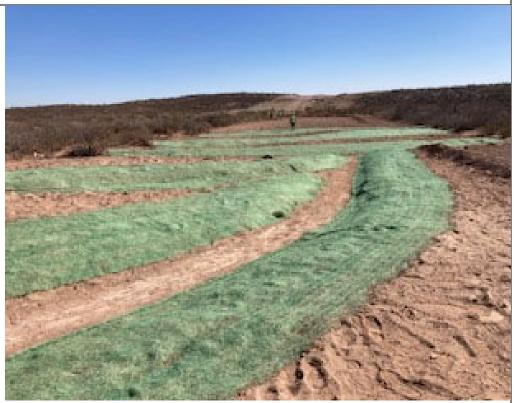
Location: Station Number 238+00

Direction of Photo: East **Description:** Erosion Control Blankets at Dry Wash at Access Road 5.

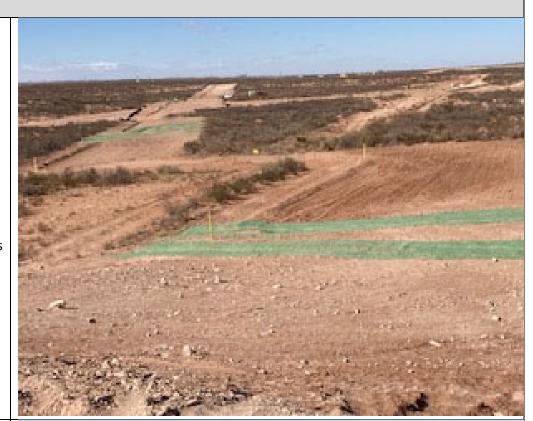
Location: Station Number 330+00 Direction of Photo:

Description: Erosion control blanket on banks

of dry wash.

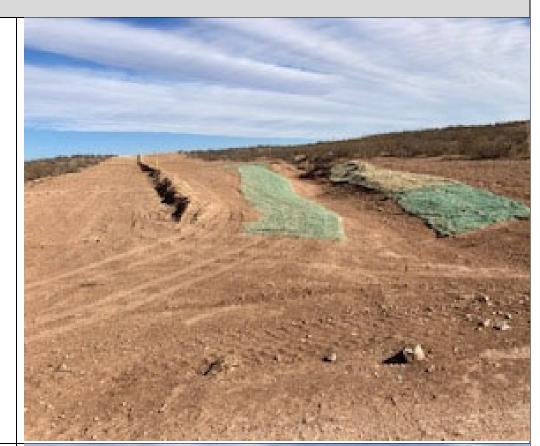
Location: Station Number 511+00 Direction of Photo:

Description: Dry wash with erosion control blanket at Access Road

#7.

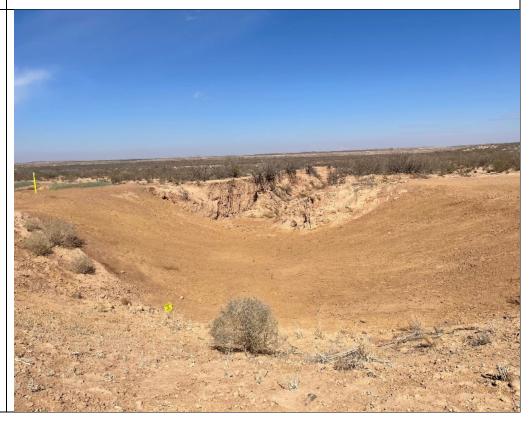
Location: Station Number 878+00 Direction of Photo: East Description: Dry wash after sub-mar mats were

installed.
