Re: El Paso Natural Gas Company, L.L.C.;  
Docket No. CP20-483-000  
Carlsbad South Project  
Weekly Environmental Inspector Report No. 5

<b>EPNG's Weekly Environmental Inspector Report No. 5</b>		
<b>Docket No. CP20-483-000</b>		
<b>Project Name:</b>	<b>Carlsbad South Project</b>	
<b>County/State:</b>	Eddy and Lea Counties, New Mexico	<b>Date: 10/02/2020</b>
<b>Reporting Period:</b>	09/21/2020 – 09/27/2020	
<b>Environmental Inspectors:</b>	Raymond Patton, Mark Cosby, Danny Day, Adam Eddy	
<p><b>1. SUMMARY OF CONSTRUCTION ACTIVITY FOR INSPECTION PERIOD:</b></p> <p><u>Line No. 31113:</u> Fencing, grading and grubbing activities continued. Erosion control devices (ECD) were installed along ROW. Ditching of pipeline trench continued. HDD at Longhorn Road (Station No. 888+75) started. Additional construction spread was added.</p> <p><u>Eunice Compressor Station Modifications:</u> Eunice Compressor Station modifications work continued.</p> <p><u>Ancillary Facilities:</u> No updates during this reporting period.</p> <p><b>2. RELEVANT ENVIRONMENTAL ACTIVITIES:</b> During this reporting period, sixty-eight (68) people received environmental training. A total of three-hundred thirty-one (3

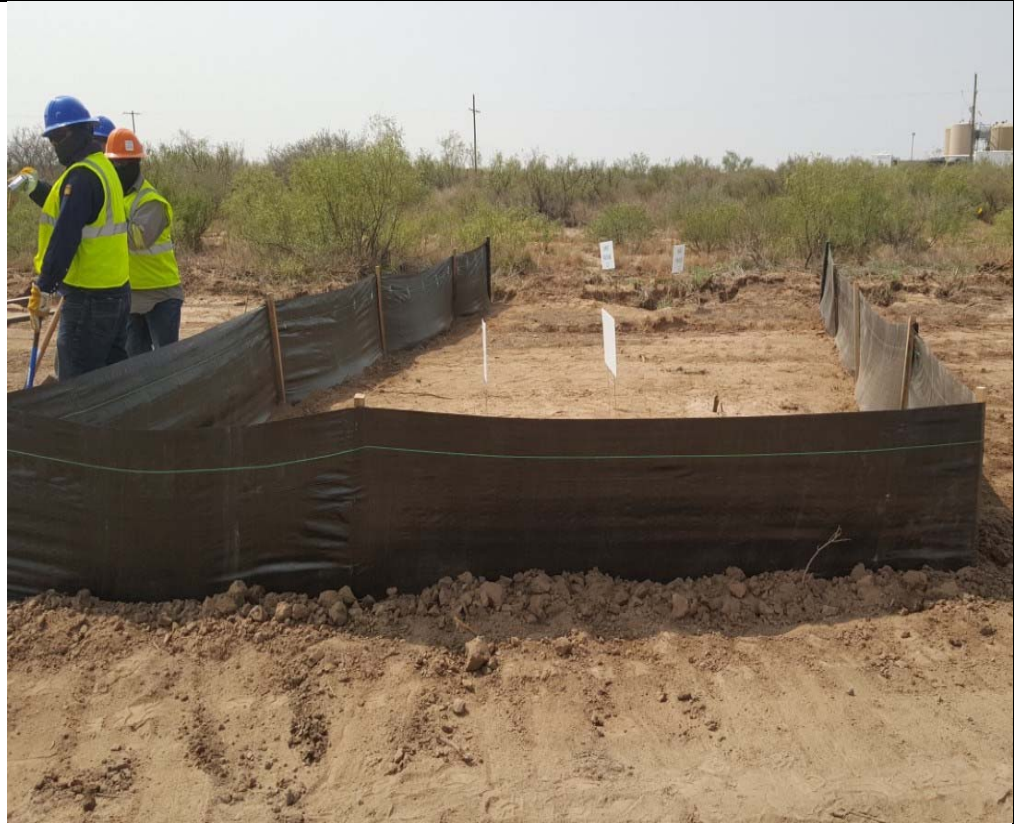
**Location:** Station Number 189+00 and 188+74

**Description:** Karst area with ECDs and signs.

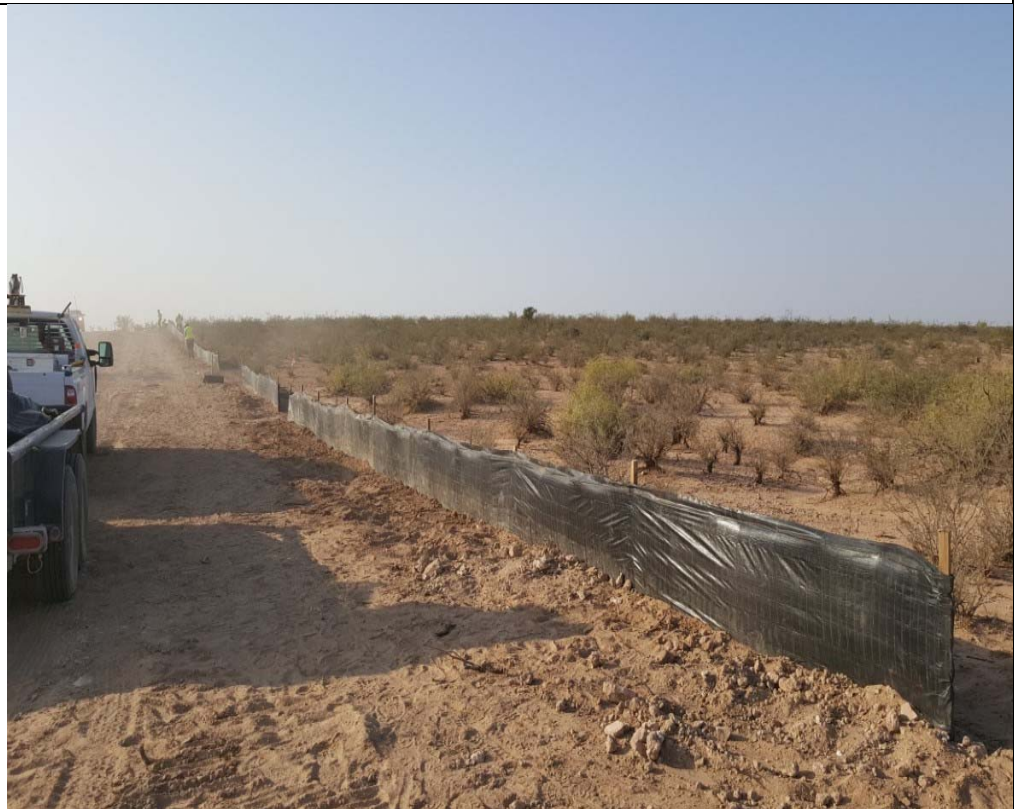
**Location:** PAR 03 Access Road. Station No. 218+00

**Description:** Crew installing silt fence along the edge of ROW for erosion control.

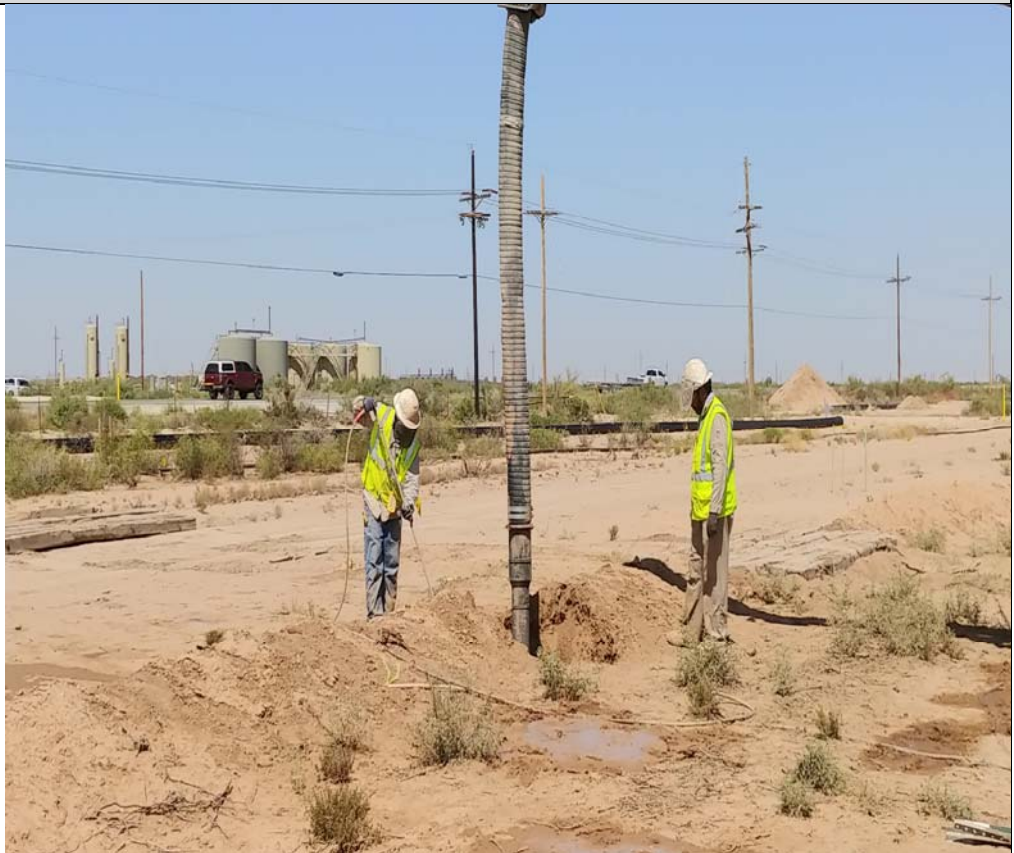
**Location:** Station Number 476+90  
**Direction of Photo:** Northwest  
**Description:** Hydro-vac crew exposing hot line.  
**Date:** 9/25/2020

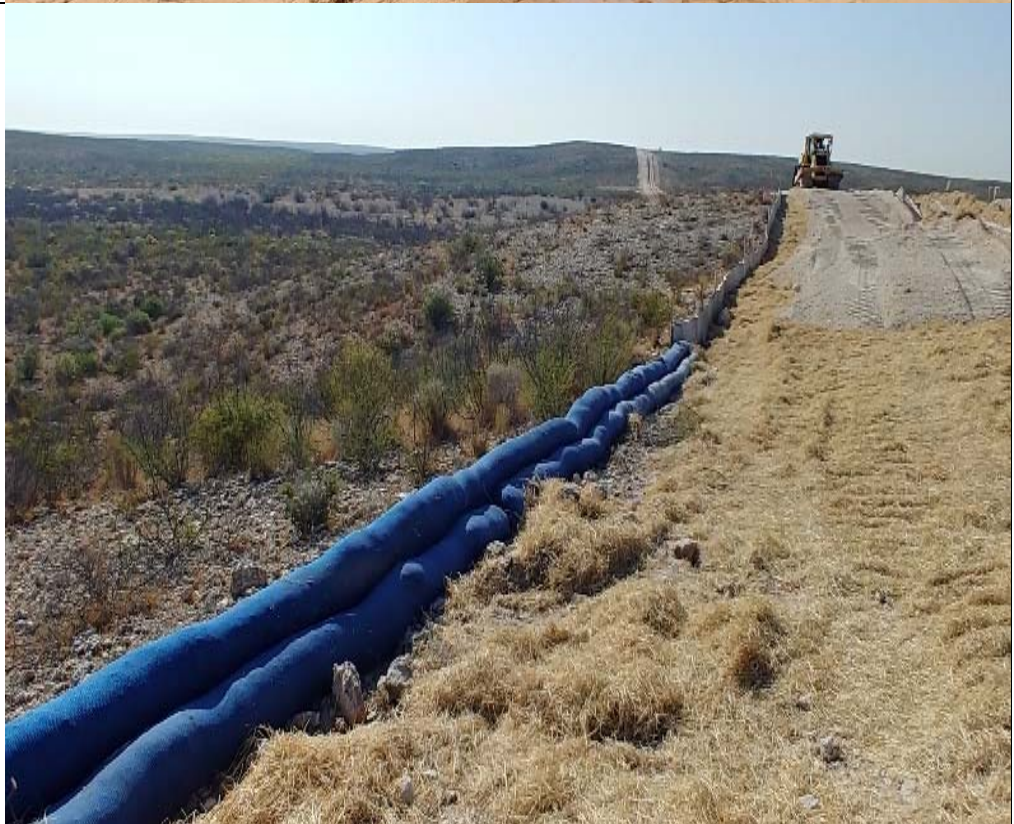
**Location:** Station Number 622+00  
**Direction of Photo:** South  
**Description:** Erosion controls installed along ROW.  
**Date:** 9/25/2020

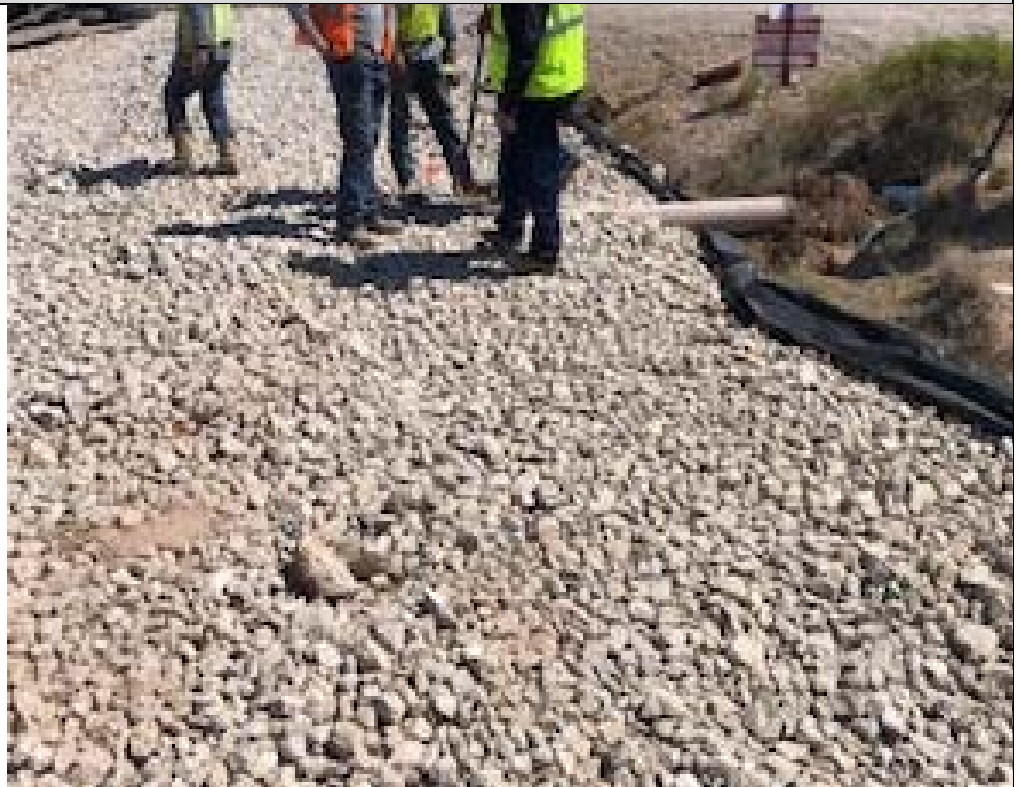
**Location:** Station Number 888+75  
**Direction of Photo:** South  
**Description:** Inadvertent return surfacing under rock construction entrance at Longhorn Road.  
**Date:** 9/25/2020

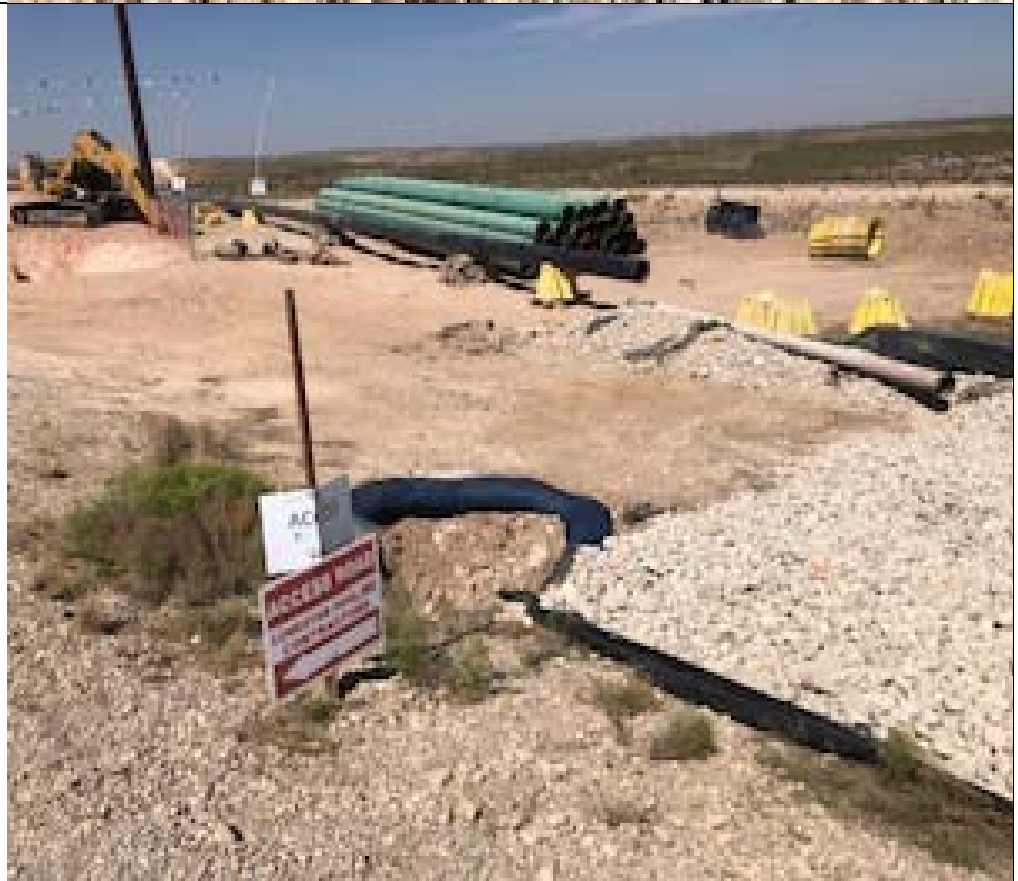
**Location:** Station Number 888+75  
**Direction of Photo:** Northeast  
**Description:** Area of inadvertent return after clean up. No additional returns observed.  
**Date:** 9/27/2020

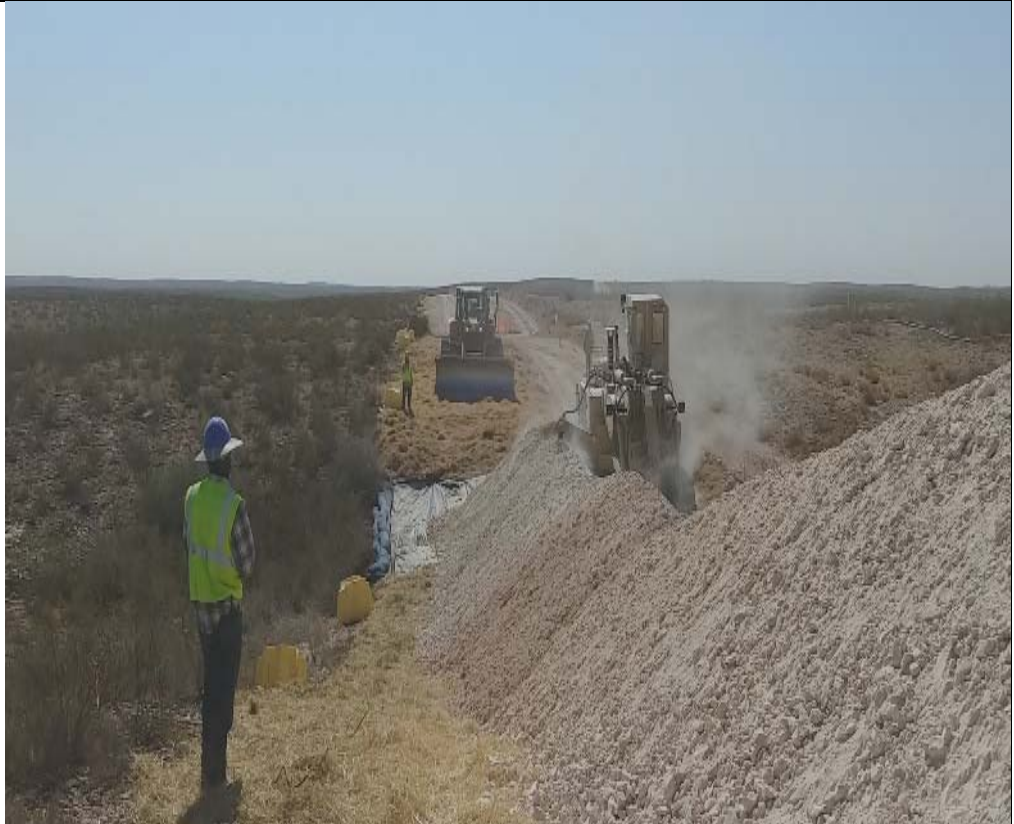
**Location:** Station Number 672+00  
**Direction of Photo:** Southwest  
**Description:** Crew trenching ditch line at dry wash area with ECDs in place.  
**Date:** 9/27/2020

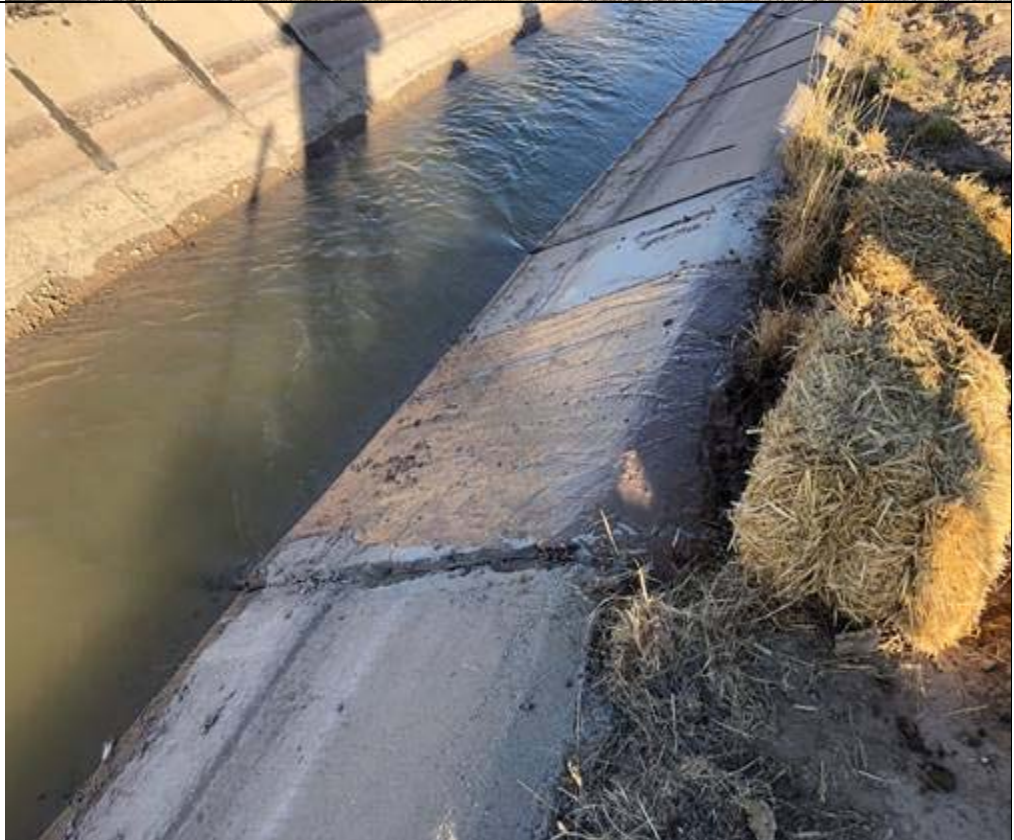
**Location:** Station Number 104+78  
**Direction of Photo:** West  
**Description:** Drilling mud at irrigation canal.  
**Date:** 9/28/2020

After reviewing the incident, EPNG's drilling contractor initiated activities to seal the fracture on September 29, 2020. Drill mud with Magfiber and Super Swell additives was pumped into the drill hole. At this point, EPNG and the drilling contractor are evaluating the current HDD drill location.

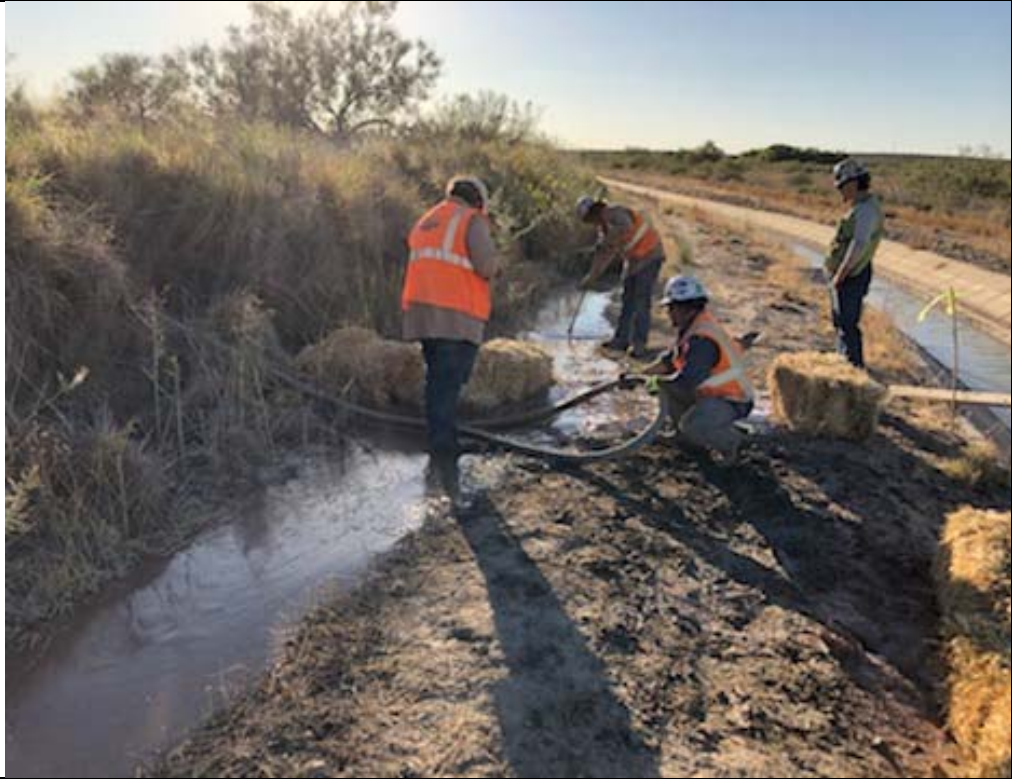
**Location:** Station Number 104+78  
**Direction of Photo:** West  
**Description:** Drilling mud at access road.  
**Date:** 9/28/2020

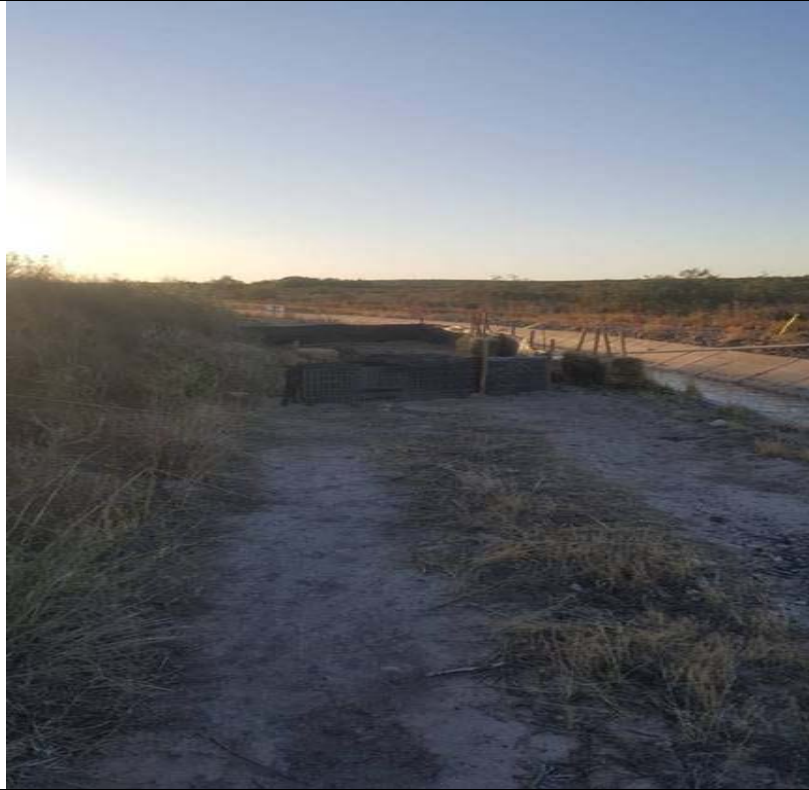
**Location:** Station Number 104+78  
**Direction of Photo:** West  
**Description:** Installed ECD's after cleanup of drilling mud via vacuum truck at the access road.  
**Date:** 9/28/2020

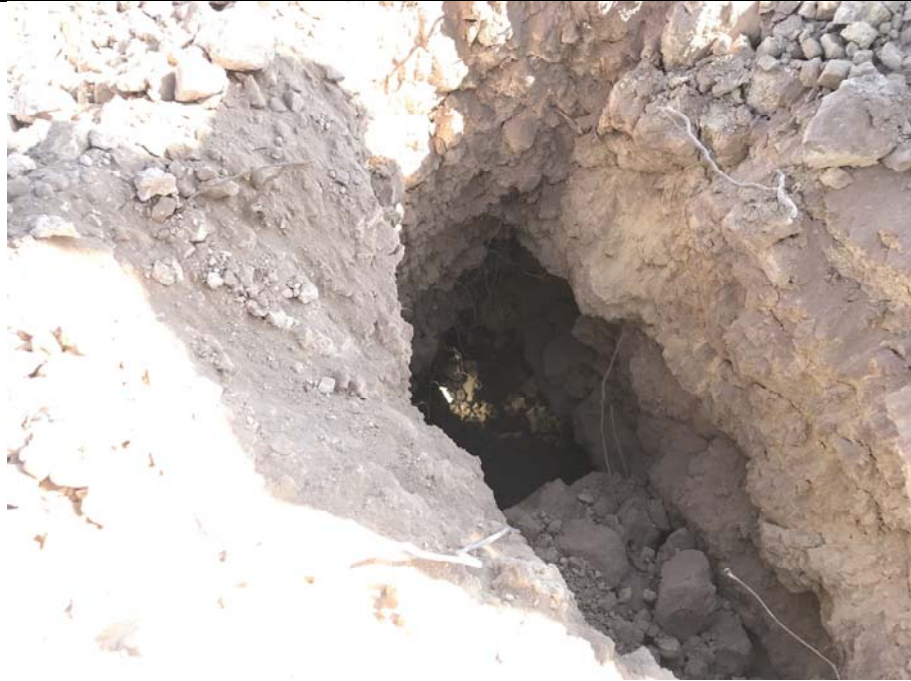
**Location:** Station Number 303+70  
**Direction of Photo:**  
**Description:** Karst feature.  
**Date:** 9/26/2020

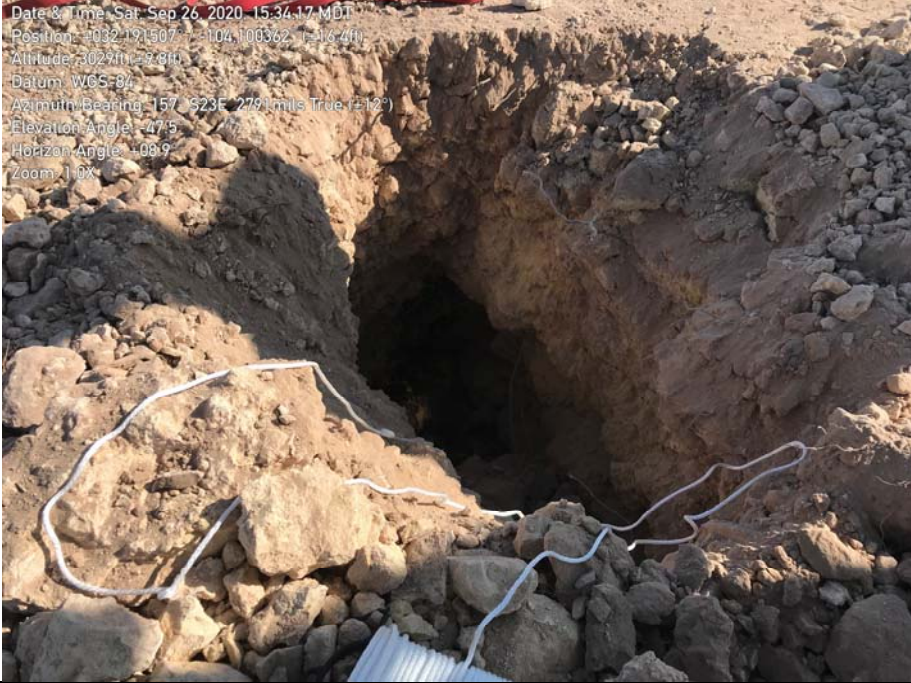
**Location:** Station Number 303+70  
**Direction of Photo:**  
**Description:** Karst feature.  
**Date:** 9/26/2020
