Re: El Paso Natural Gas Company, L.L.C.;
Docket No. CP20-483-000
Carlsbad South Project
Weekly Environmental Inspector Report No. 6

EPNG's Weekly Environmental Inspector Report No. 6		
Docket No. CP20-483-000		
Project Name:	Carlsbad South Project	
County/State:	Eddy and Lea Counties, New Mexico	Date: 10/09/2020
Reporting Period:	09/28/2020 – 10/04/2020	
Environmental Inspectors:	Raymond Patton, Mark Cosby, Danny Day, Adam Eddy, Mike Connors

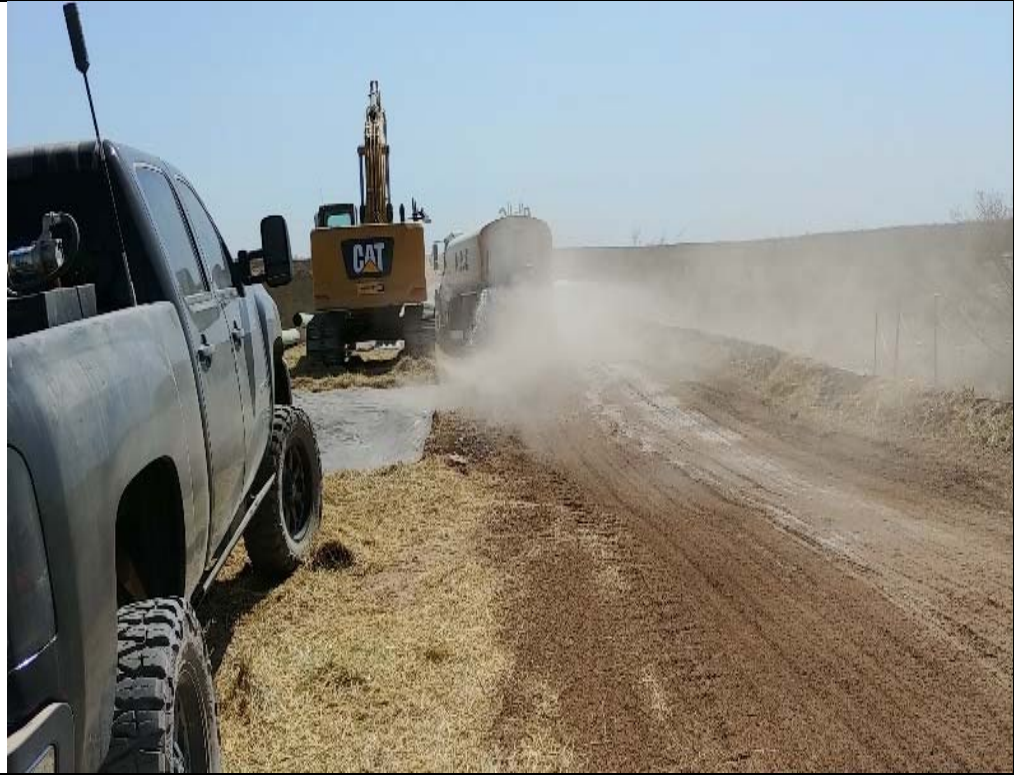
Location: Station Number 580+00
Direction of Photo: Northeast
Description: Water truck maintaining ROW.
Date: 10/02/2020

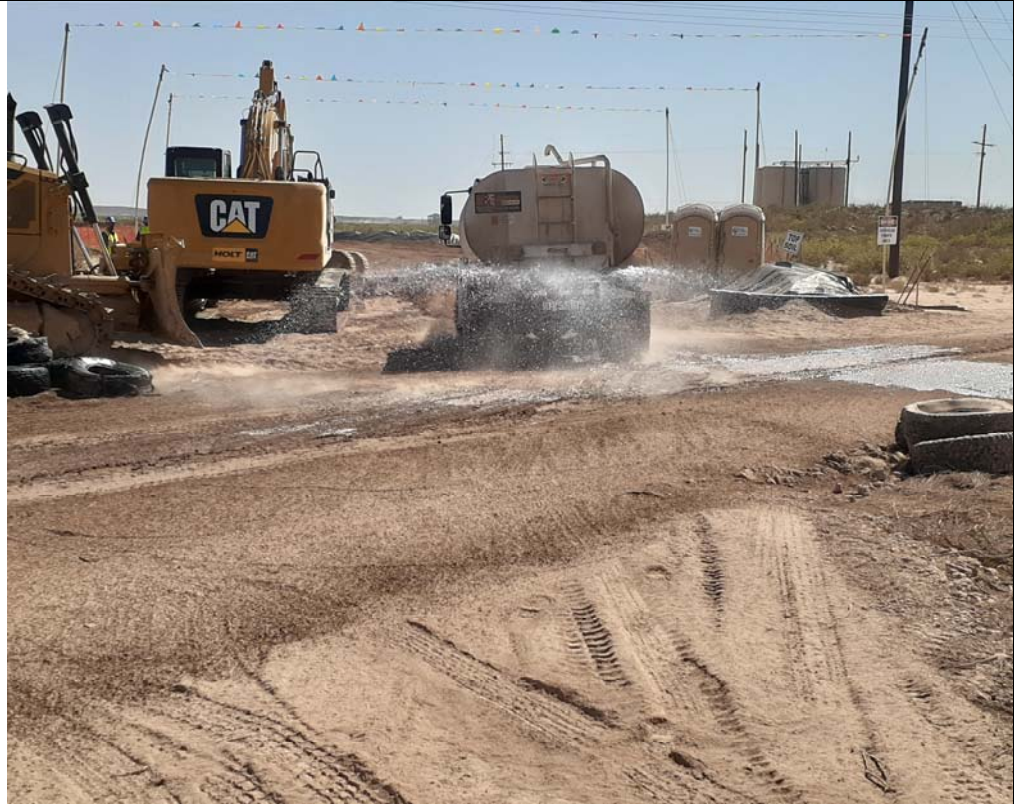
Location: Station Number 26+00
Direction of Photo: South
Description: Fugitive dust control measures at excavation near permanent access road (PAR) 1b.
Date: 10/02/2020

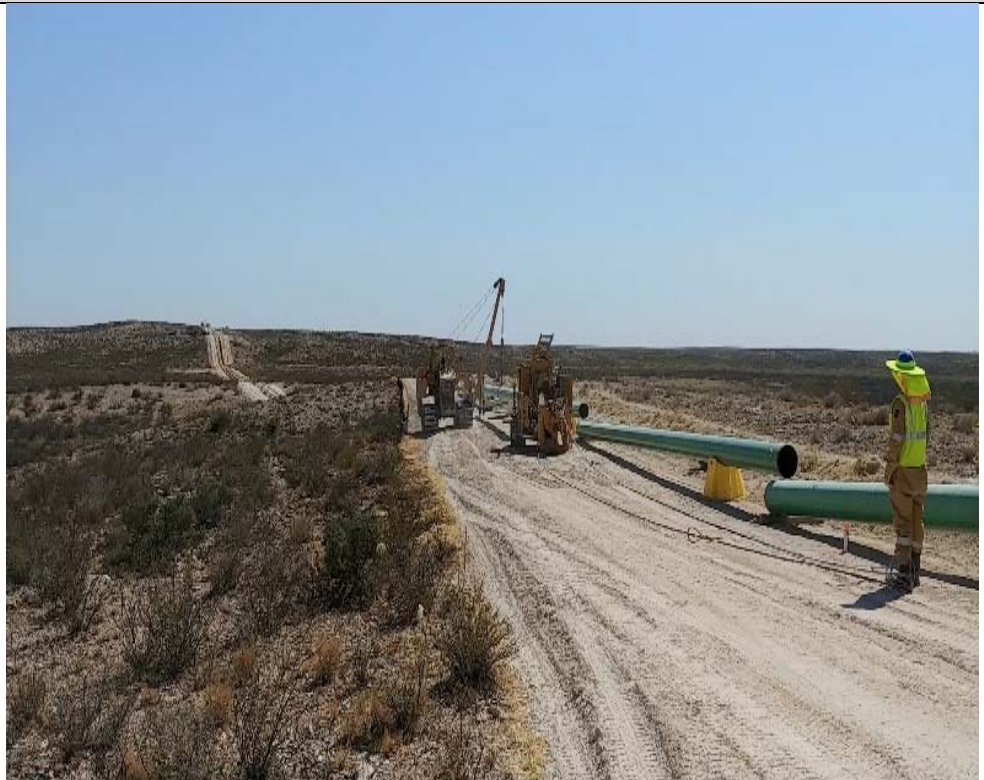
Location: Station Number 630+00
Direction of Photo: Southeast
Description: Pipe bending.
Date: 10/02/2020

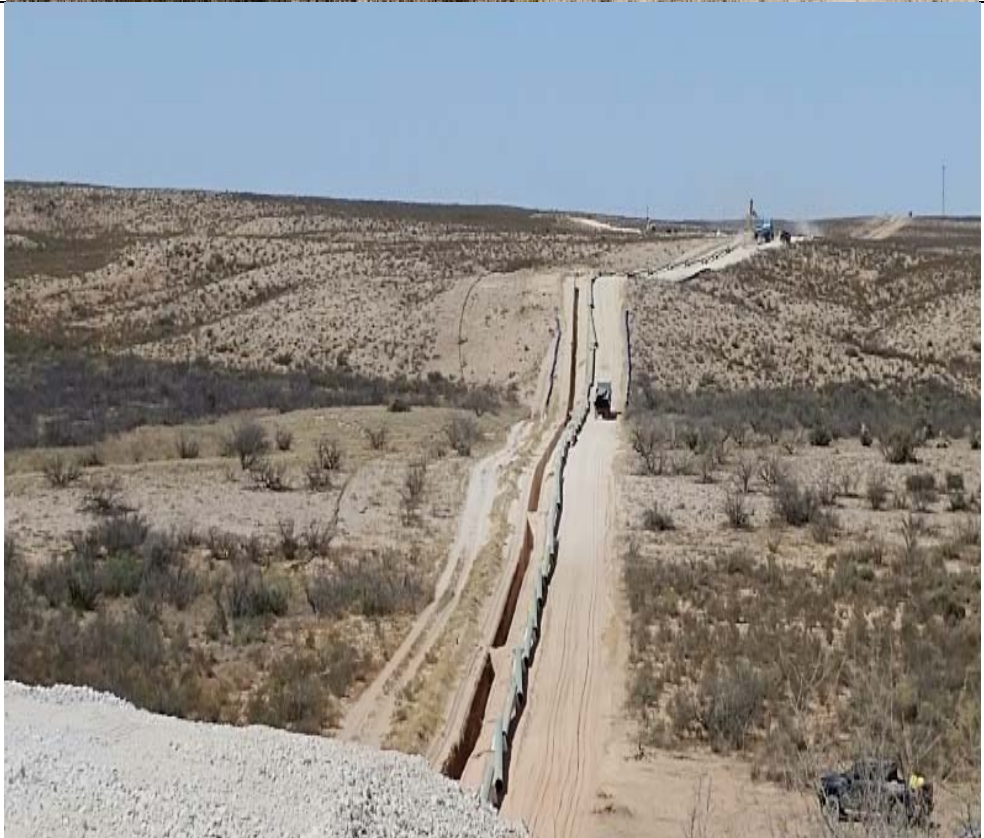
Location: Station Number 650+00
Direction of Photo: Southwest
Description: Pipe stringing and trenching.
Date: 9/28/2020

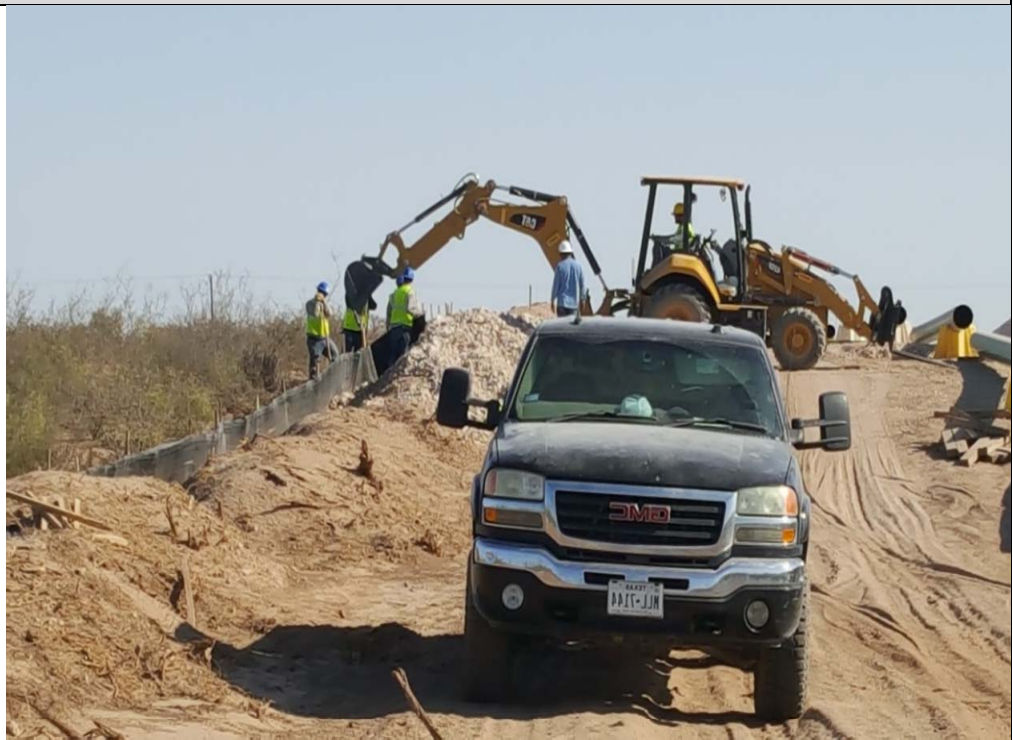
Location: Station Number 252+00
Direction of Photo: Northwest
Description. Hoe driving stakes for silt fence.
Date: 10/01/2020

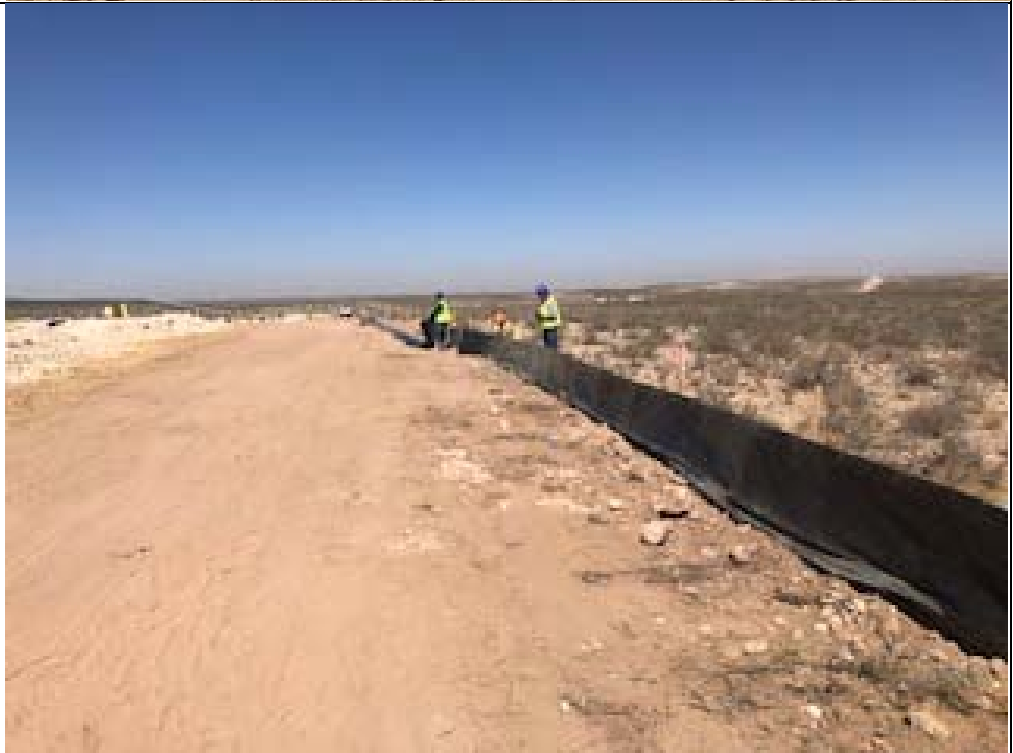
Location: Station Number 791+00 – 794+00
Direction of Photo: North
Description: Silt fence installation.
Date: 9/30/2020

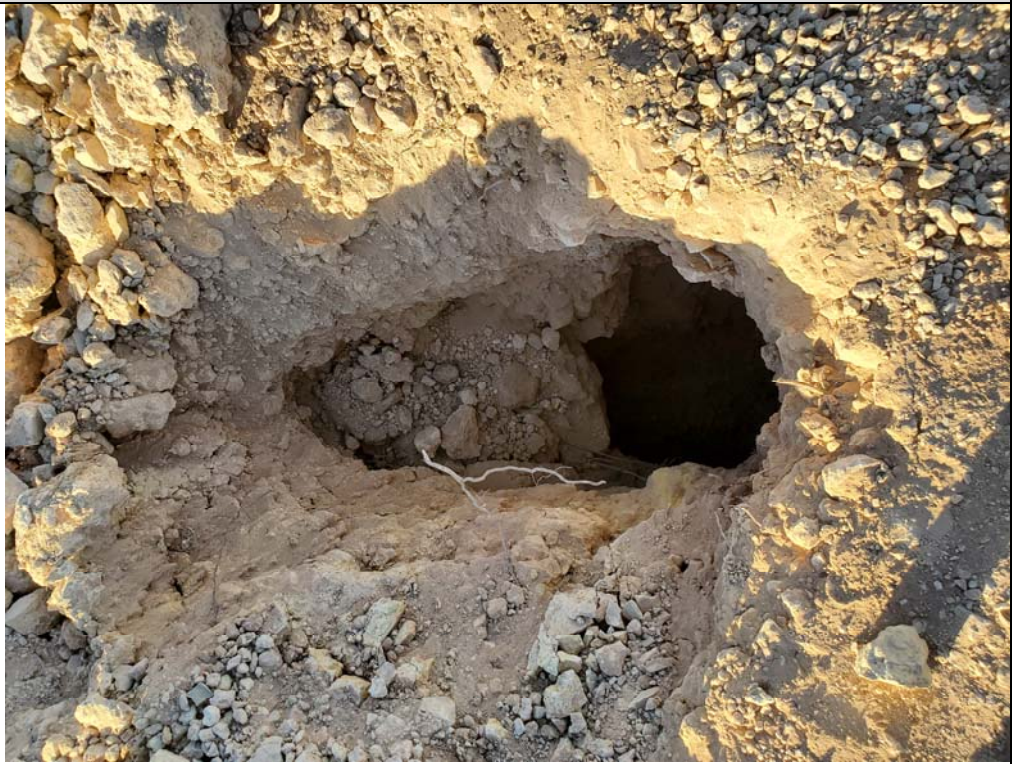
Location: Station Number 304+00
Direction of Photo: N/A
Description: Karst (K13) feature identified on ROW.
Date: 10/02/2020

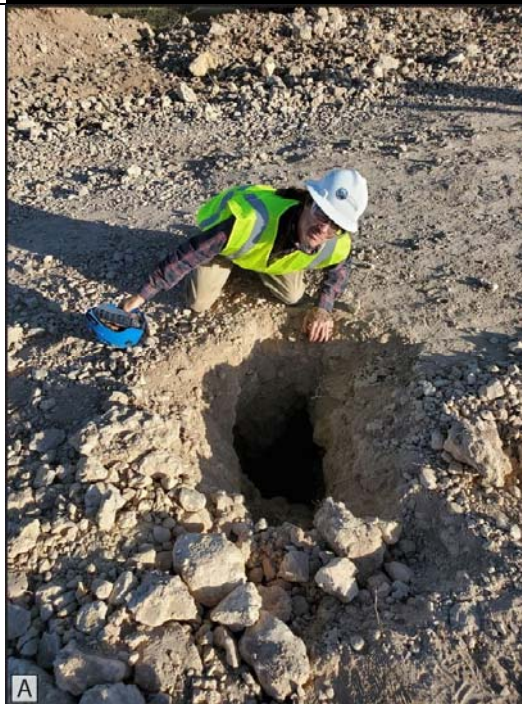
A

Location: Station Number 888+75
Direction of Photo: N/A
Description: Karst (K13) feature and associated bed rock crack.
Date: 10/02/2020

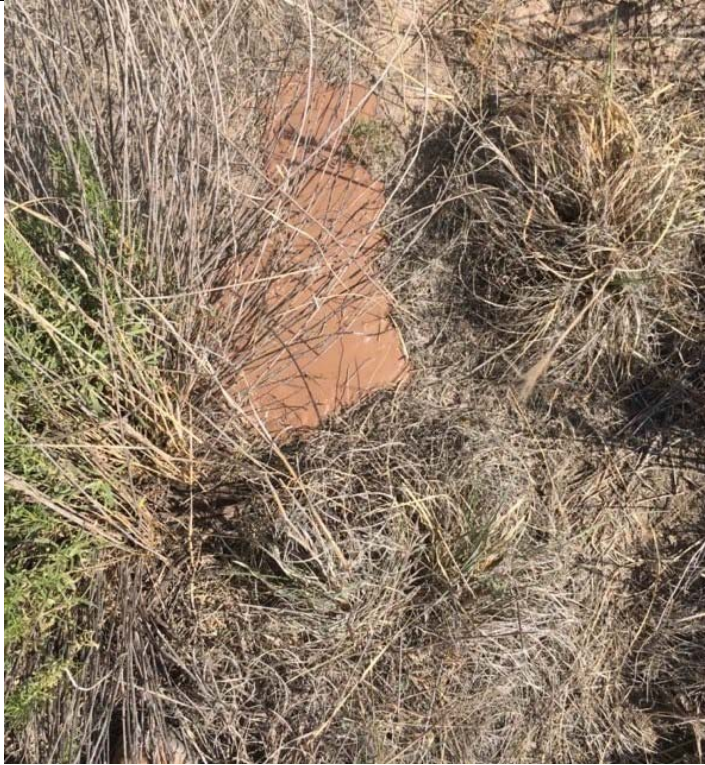
At approximately 2:20 pm Central Time on October 6, 2020, an inadvertent return that reached the land surface occurred approximately 65 feet west of the permanent ROW at Station No. 103+70 in Section 7, Township 24 South, Range 28 East in Eddy County, NM.

- Approximately 3 gallons of drilling fluid spilled into an area of desert grassland located approximately 50 feet south of the irrigation canal and south of the Black River.
- Drilling activities were immediately stopped. The drilling fluid was manually contained and removed.
- The spill did not impact any sensitive resources or enter any waterbodies.
- The affected landowner was contacted and notified of the inadvertent release.
- Agency notifications (i.e., FERC, USFWS and NMGFD) were made on October 7, 2020.
- EPNG's drilling contractor initiated activities to seal the fracture. Drill mud containing Magfiber and Super Swell additives was pumped into the drill hole.

Location: Station
Number 103+70
Direction of Photo:
N/A
Description:
Inadvertent return.
Date: 10/06/2020

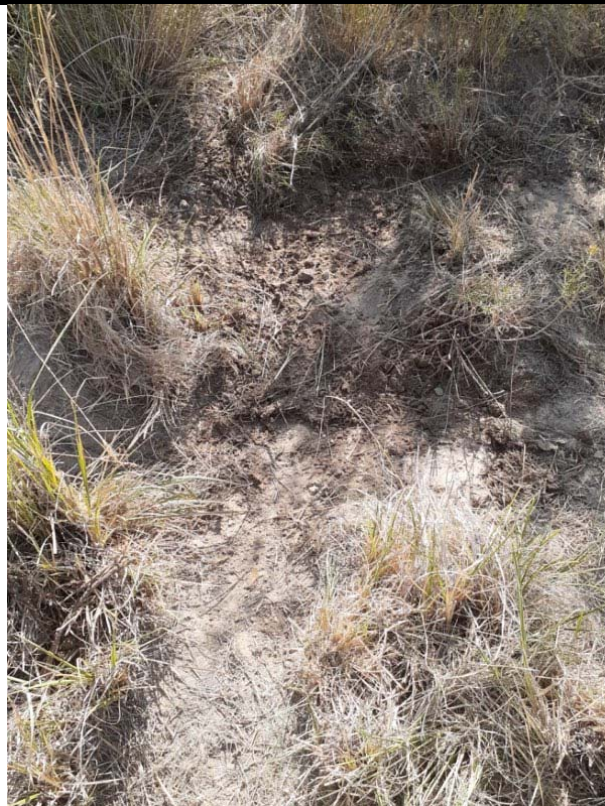
Location: Station
Number 103+70
Direction of Photo:
N/A
Description:
Inadvertent return
after clean-up.
Date: 10/06/2020

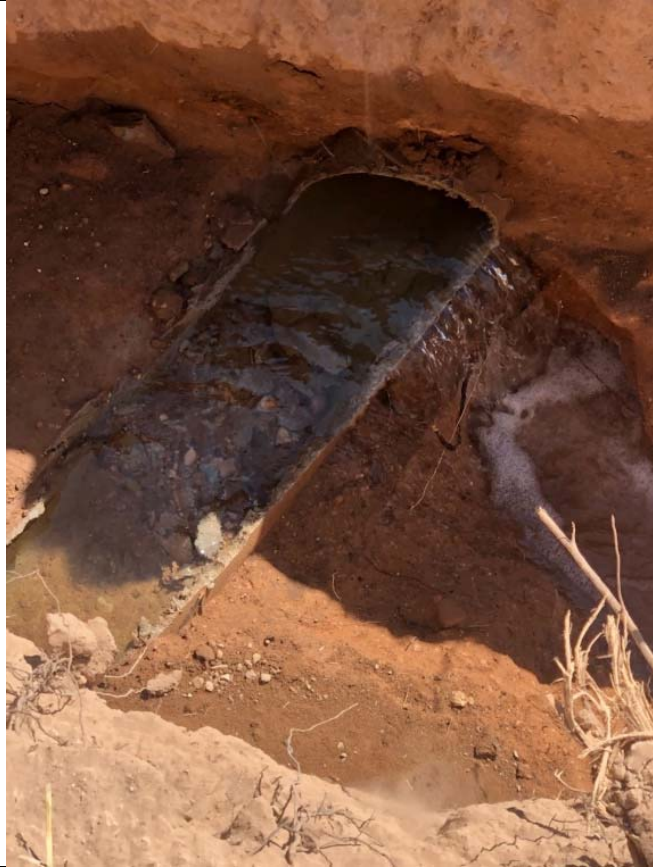
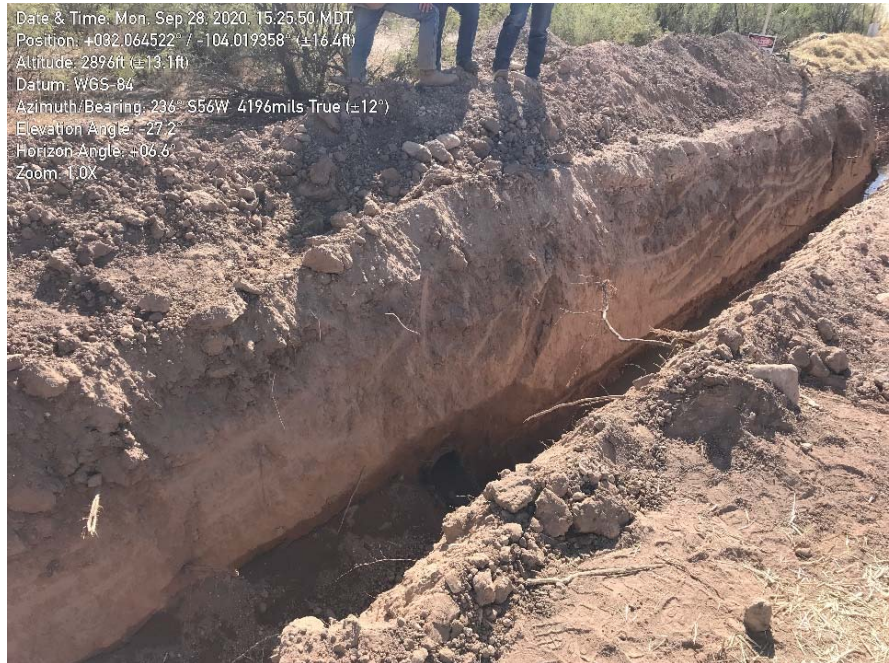
3. ENVIRONMENTAL PROBLEMS/ISSUES AND CORRECTIVE ACTIONS TAKEN:		
<p>Due to dry conditions, dust was becoming a problem in the areas where ditching and heavy vehicle traffic is occurring. The water truck schedule has increased on the Project.</p> <p>On September 28, 2020 an abandoned water line was struck at Station No. 897+45. Approximately 1,000 gallons of water were released but contained in the trench. Samples were taken and evaluated for BTEX (benzene, toluene, ethylbenzene and xylene). All contaminant parameters were below lab detection limits. The concrete water line was unmarked and had not been identified as part of the 811 related surveys or pre-construction sweeps. The affected landowner stated that the line had been inactive since the late 1970's or early 1980's and was in disrepair. The owner asked that the line be completely severed, capped and a riser placed on each side of the intersection.</p> <p><u>Inadvertent Releases</u> In the weekly environmental inspector report no. 5, EPNG reported a September 28th inadvertent release which occurred in the ROW at Station Number 104+78. After reviewing the incident, EPNG determined that the inadvertent release was caused by the HDD bore coming in close proximity to an existing test bore hole</p>

Location: Station Number 897+45
Direction of Photo: N/A
Description: Water line strike.
Date: 9/28/2020

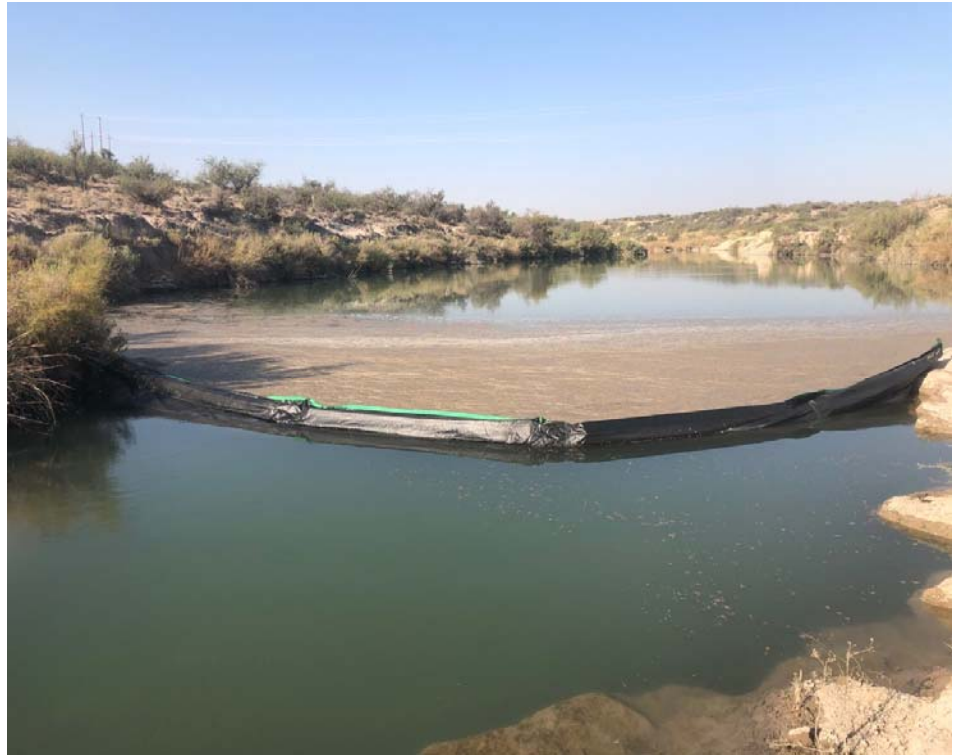
Location: Higby Hole
Road Crossing
Direction of Photo:
West
Description: Turbidity
curtain with material
contained upstream.
Date: 10/9/2020
