Re: El Paso Natural Gas Company, L.L.C.;
Docket No. CP20-483-000
Carlsbad South Project
Weekly Environmental Inspector Report No. 7

EPNG's Weekly Environmental Inspector Report No. 7		
Docket No. CP20-483-000		
Project Name:	Carlsbad South Project	
County/State:	Eddy and Lea Counties, New Mexico	Date: 10/16/2020
Reporting Period:	10/05/2020 – 10/11/2020	
Environmental Inspectors:	Raymond Patton, Mark Cosby, Danny Day, Adam Eddy, Mike Connors	
<p>1. SUMMARY OF CONSTRUCTION ACTIVITY FOR INSPECTION PERIOD:</p> <p><u>Line No. 31113:</u></p> <ul style="list-style-type: none"> • Grading and trenching activities continued. • Pipe string and trenching has been completed. • Erosion control devices (ECDs) continue to be installed, inspected and maintained along ROW. • Backfilling has started. • HDD operations at the Black River and Black River Village Road are continuing. EPNG notes that the initial pilot hole was completed on October 10, 2020 and bore hole reaming commenced. <p><u>Eunice Compressor Station Modifications:</u></p> <ul style="list-style-type: none"> • Concrete foundations were completed for control valve piping. • The tie-ins into the existing system were completed. <p><u>Anc

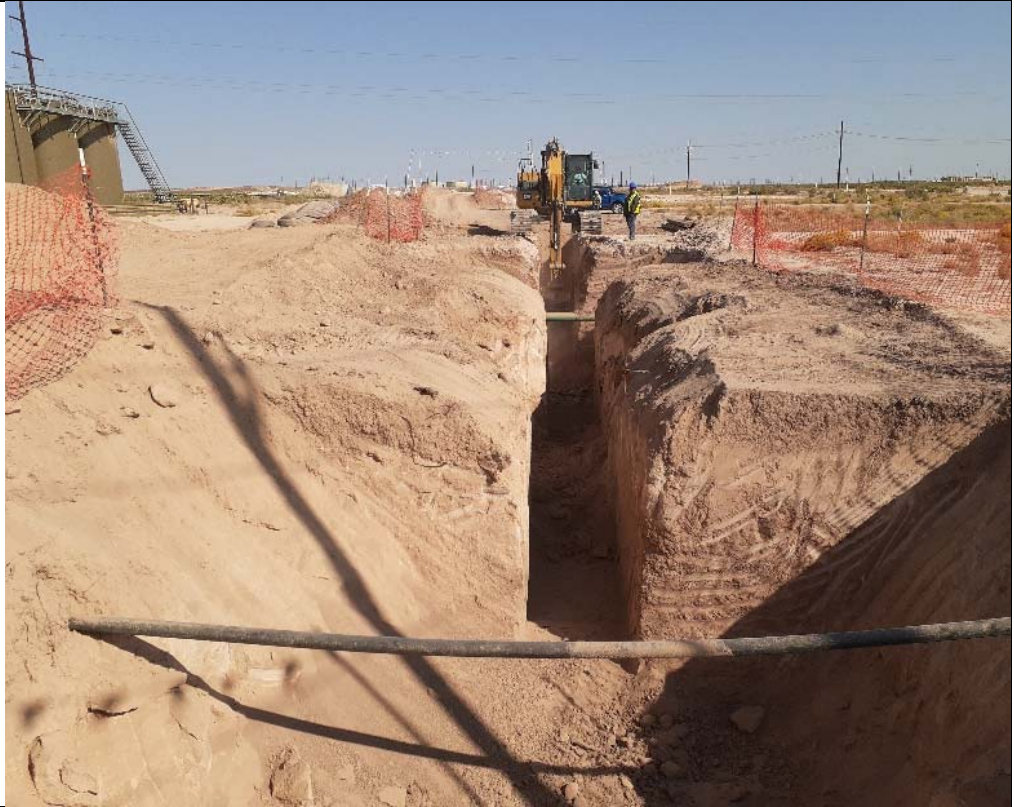
Location: Station Number 39+00
Direction of Photo: North
Description: Trenching under foreign lines.
Date: 10/05/2020

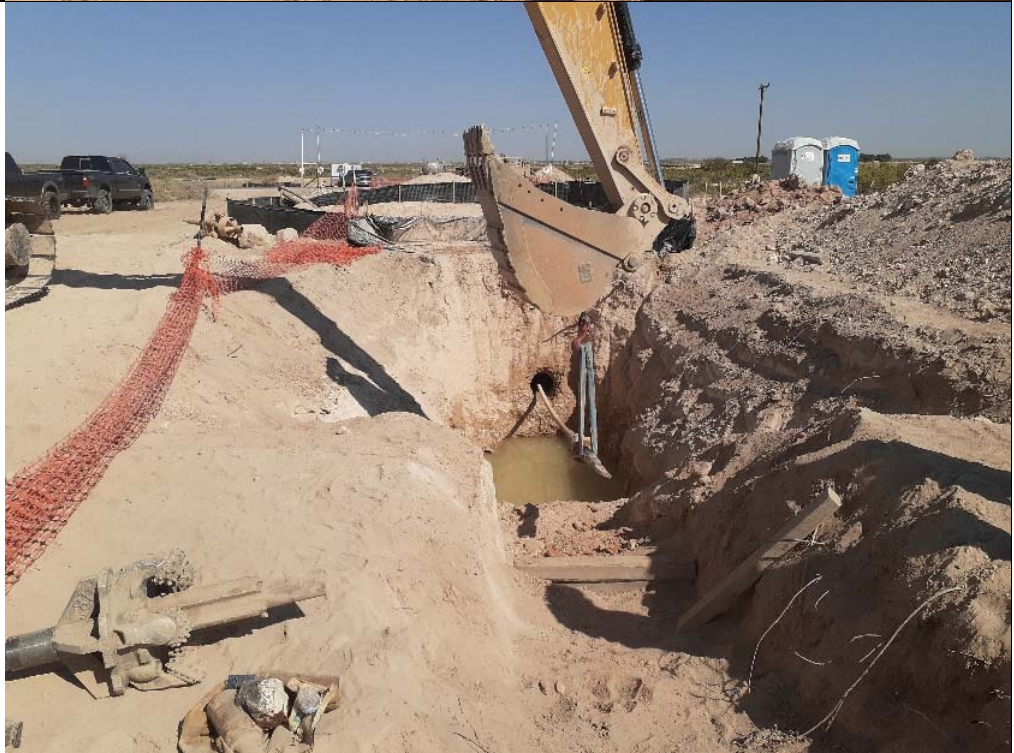
Location: Station Number 146+00
Direction of Photo: South
Description: Black River Village Road pilot hole.
Date: 10/05/2020

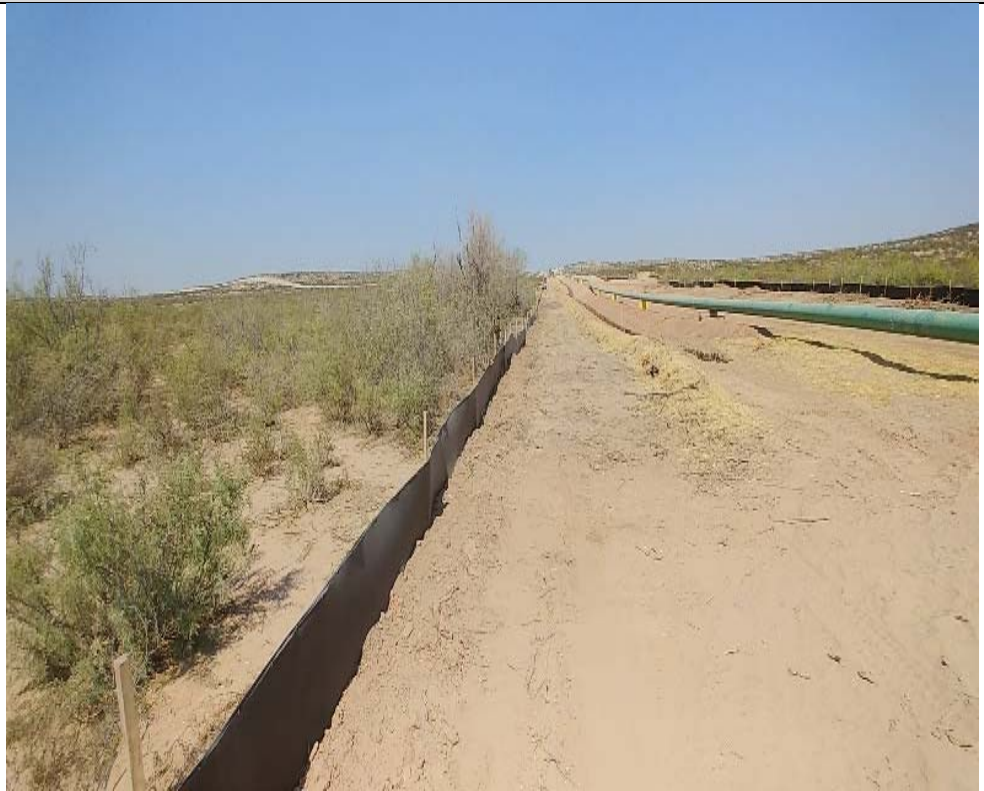
Location: Station Number 742+00
Direction of Photo: Northwest
Description: Silt fence and strung pipe on ROW.
Date: 10/07/2020

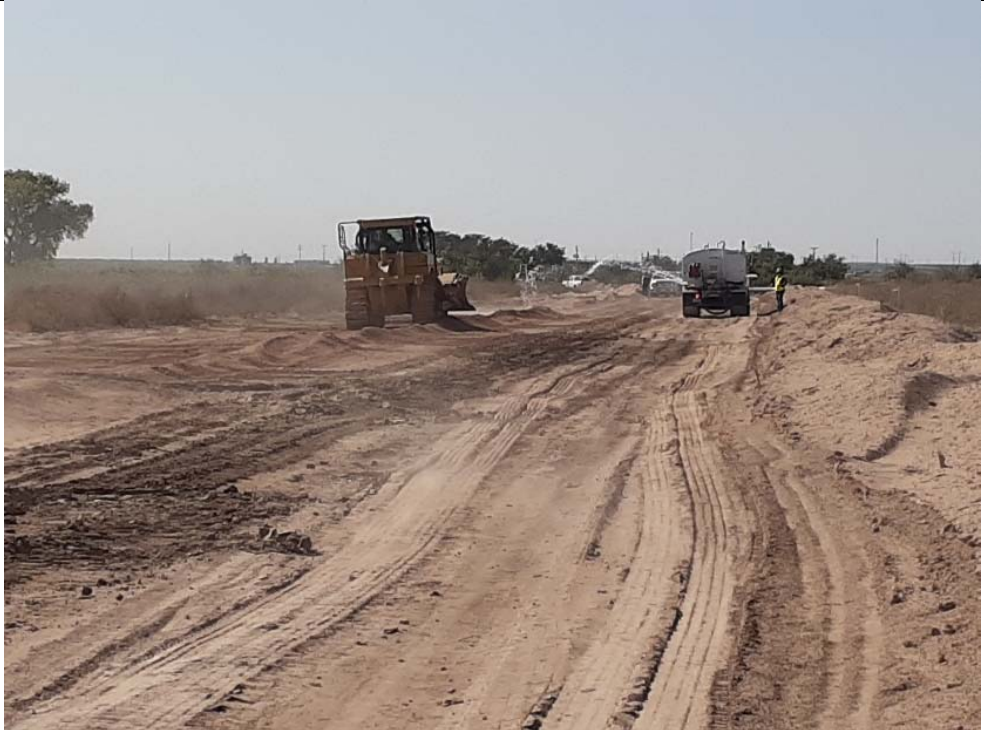
Water trucks continuing to operate at an increased rate due to dust from dry conditions.

Location: Station Number 90+00
Direction of Photo: North
Description: Water truck spraying backfill material ahead of dozer.
Date: 10/07/2020

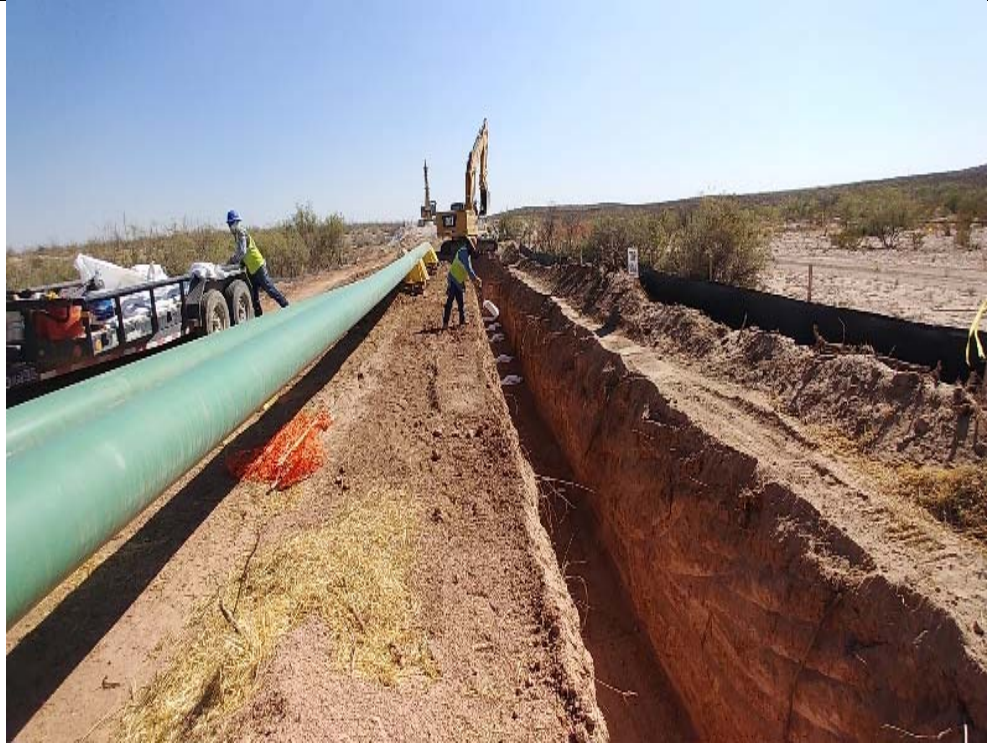
Location: Station Number 693+00
Direction of Photo: Southwest
Description. Pipe padding with sandbags.
Date: 10/10/2020

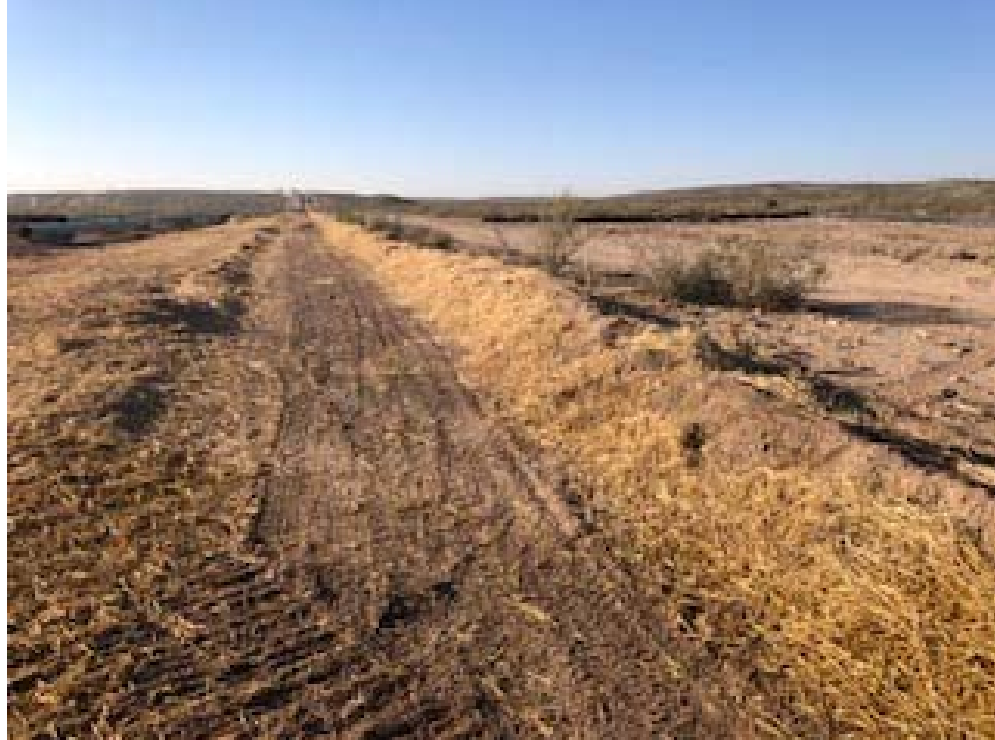
Location: Station Number 852+00
Direction of Photo: South
Description: Topsoil stabilized with hay.
Date: 10/10/2020

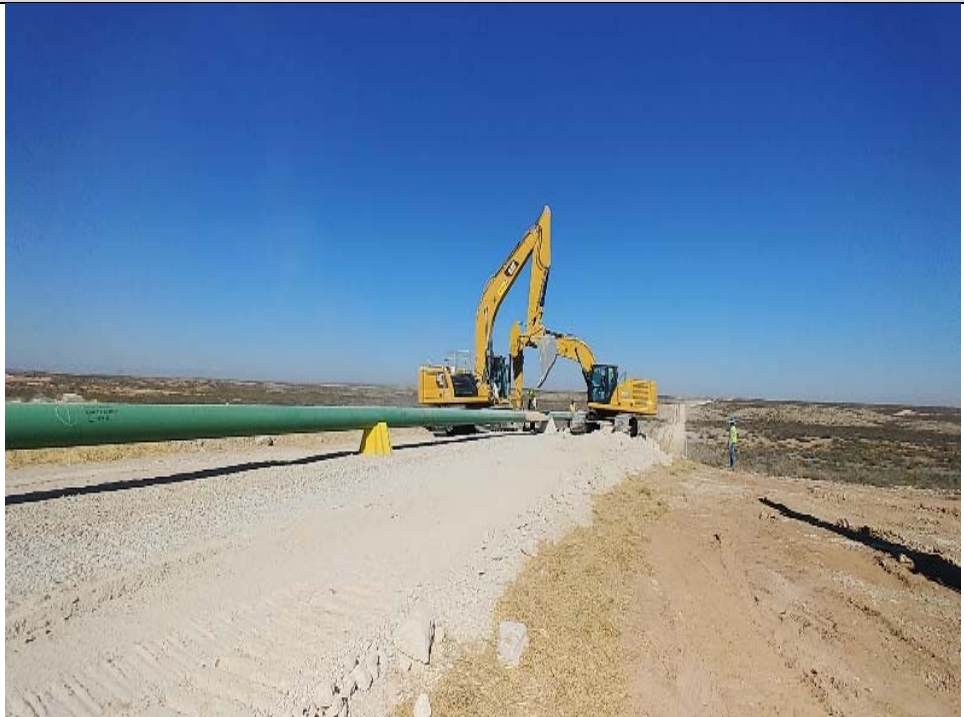
Location: Station Number 662+00
Direction of Photo: 622+00
Description: Pipe ready for lowering-in.
Date: 10/10/2020

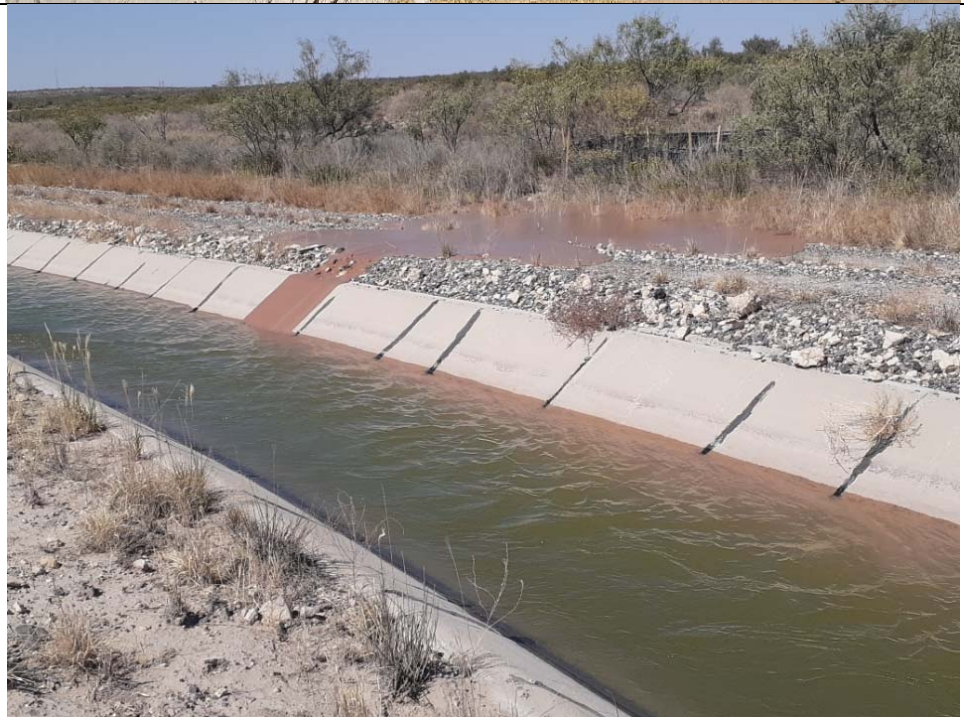
On October 13, 2020, an inadvertent return was identified at Station 103+85 approximately 65 feet west of the permanent ROW. Up to 400 gallons of fluid was observed in an area located between the Carlsbad Irrigation District (CID) South Canal and the south bank of the Black River. The return was contained and no fluids reached the Black River. However, EPNG estimates that up to 10 gallons reached the CID irrigation canal. Affected landowner notifications were made and environmental personnel accessed the area for clean-up of drilling fluids. The area was promptly cleaned up. Agency notifications were made regarding this inadvertent return.

Location: Station Number 103+85
Direction of Photo: South
Description: Inadvertent return at the Carlsbad Irrigation District south canal.
Date: 10/13/2020

Once HDD reaming operations were restarted later that day, a small amount (1-2 gallons) of drilling fluid came to the surface. As HDD reaming operations passed the location of the inadvertent return, no additional inadvertent returns were observed. EPNG has staged additional crews in this area and along the Black River to monitor for fluids as the HDD operations continue.

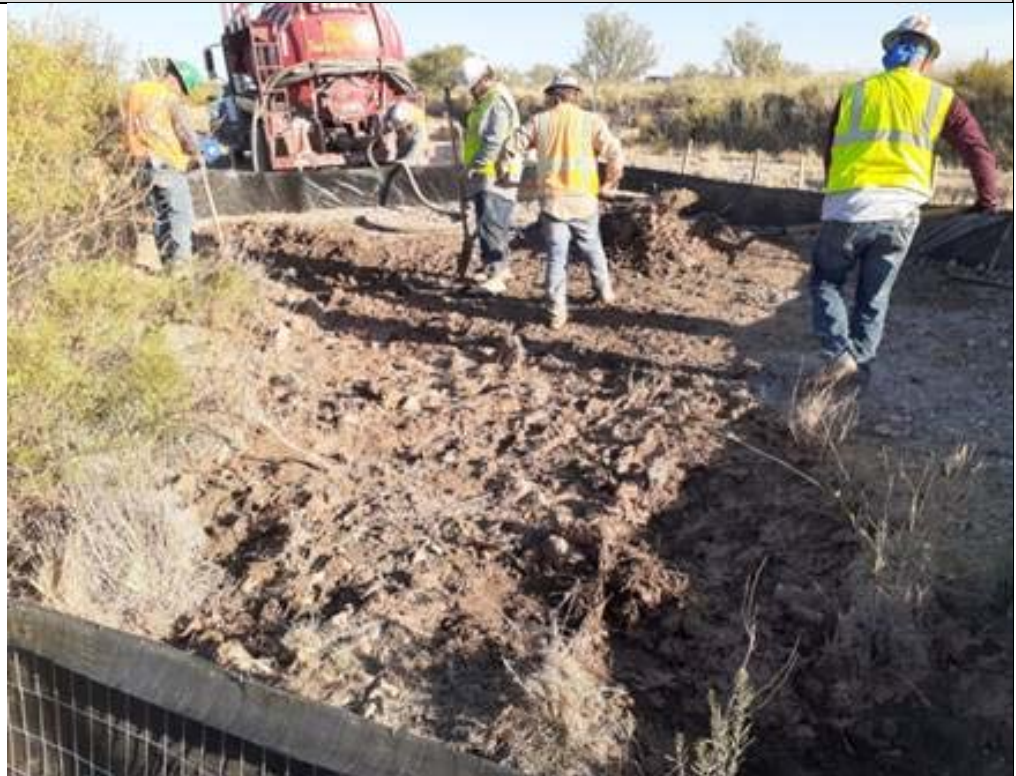
Location: Station Number 103+85
Direction of Photo: West
Description: Inadvertent return with silt fence containment installed being cleaned up.
Date: 10/13/2020

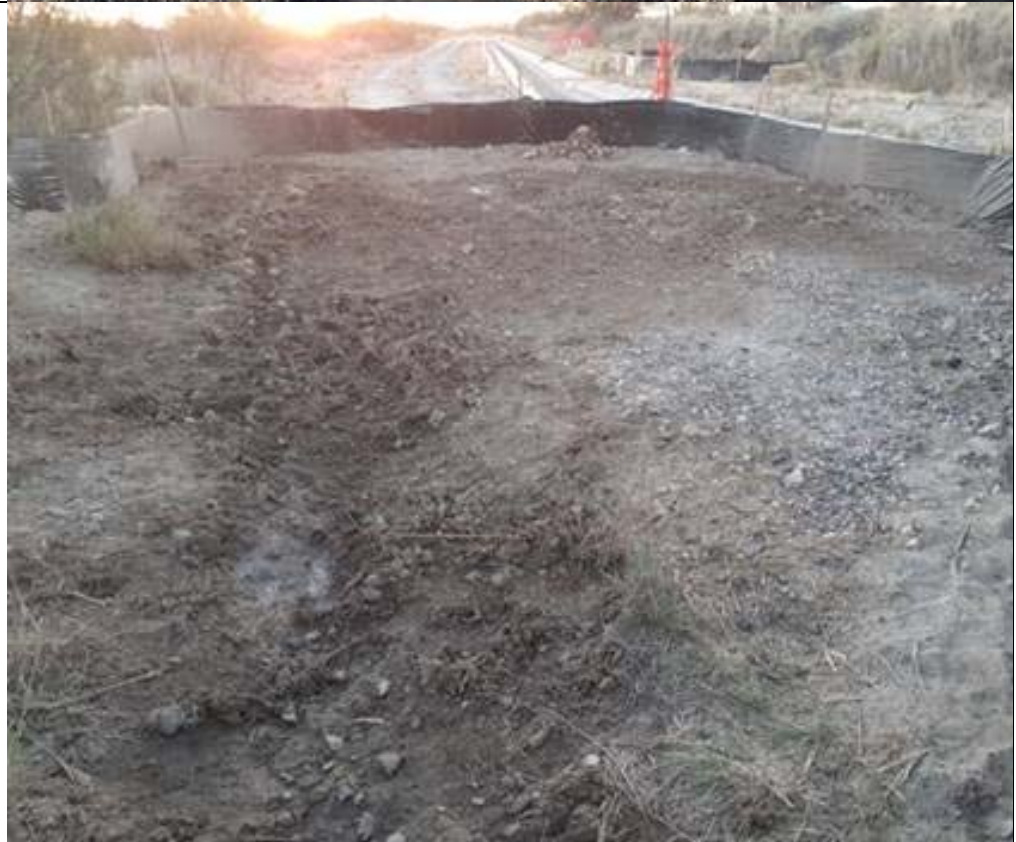
Location: Station Number 103+85
Direction of Photo: West
Description: Inadvertent return cleaned up.
Date: 10/13/2020

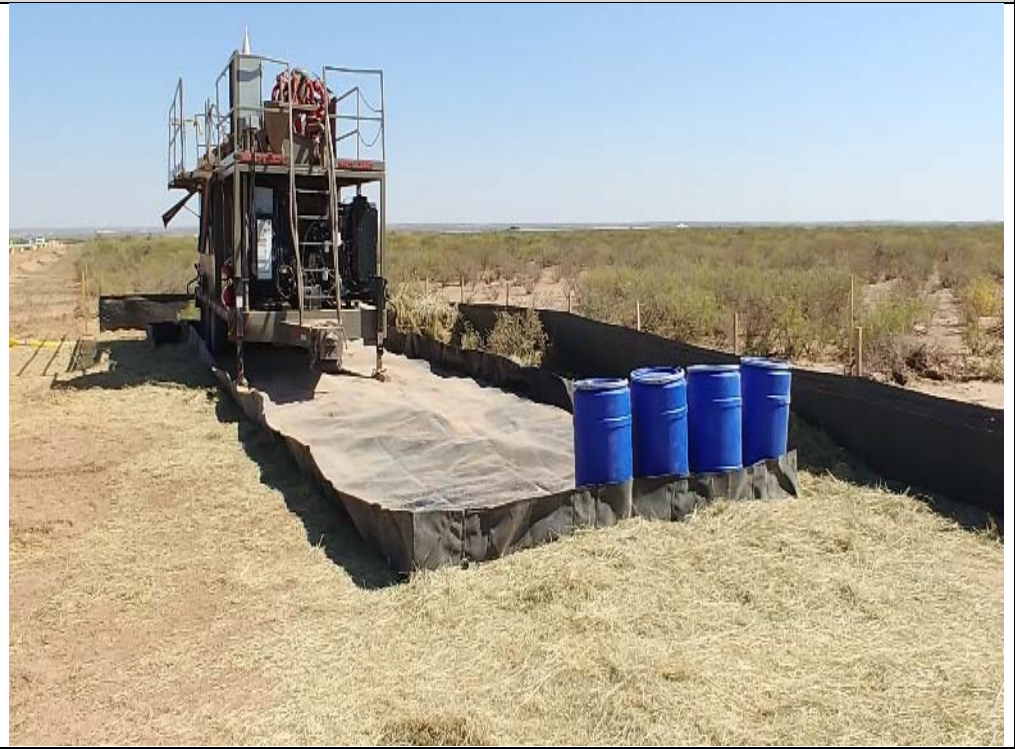
Location: Station
Number 477+00
Direction of Photo:
Southeast
Description: HDD
equipment in
secondary
containment
Date: 10/10/2020
