Re: El Paso Natural Gas Company, L.L.C.;
Docket No. CP20-483-000
Carlsbad South Project
Weekly Environmental Inspector Report No. 9

EPNG's Weekly Environmental Inspector Report No. 9		
Docket No. CP20-483-000		
Project Name:	Carlsbad South Project	
County/State:	Eddy and Lea Counties, New Mexico	Date: 10/30/2020
Reporting Period:	10/19/2020 – 10/25/2020	
Environmental Inspectors:	Raymond Patton, Mark Cosby, Danny Day, Adam Eddy, Mike Connors	
<p>1. SUMMARY OF CONSTRUCTION ACTIVITY FOR INSPECTION PERIOD:</p> <p><u>Line No. 31113:</u></p> <ul style="list-style-type: none"> • Grading and trenching activities continue on both spreads. • Pipe stringing, welding and pipe installation also continue on both spreads. • HDD drilling activities continue at Dry Wash 50 and US Highway 285 crossing. <p><u>Eunice Compressor Station Modifications:</u></p> <p>Eunice Compressor Station Modifications work has been completed including restoration.</p> <p><u>Ancillary Facilities:</u></p> <p>No updates during this reporting period.</p> <p>2. RELEVANT ENVIRONMENTAL ACTIVITIES:</p> <p>During this reporting period, eight (8) people received environmental training. A total of six hundred and eighty-nine (6

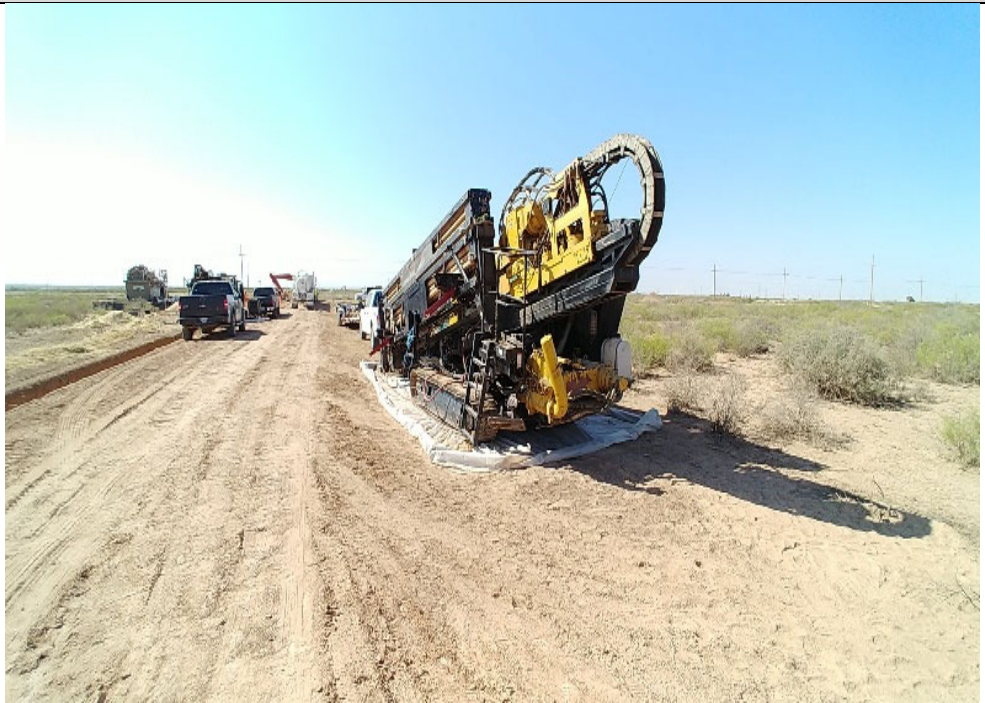
Location: Station Number 478+00
Direction of Photo: Northwest.
Description: HDD drill rig staged on ROW with secondary containment.
Date: 10/19/2020

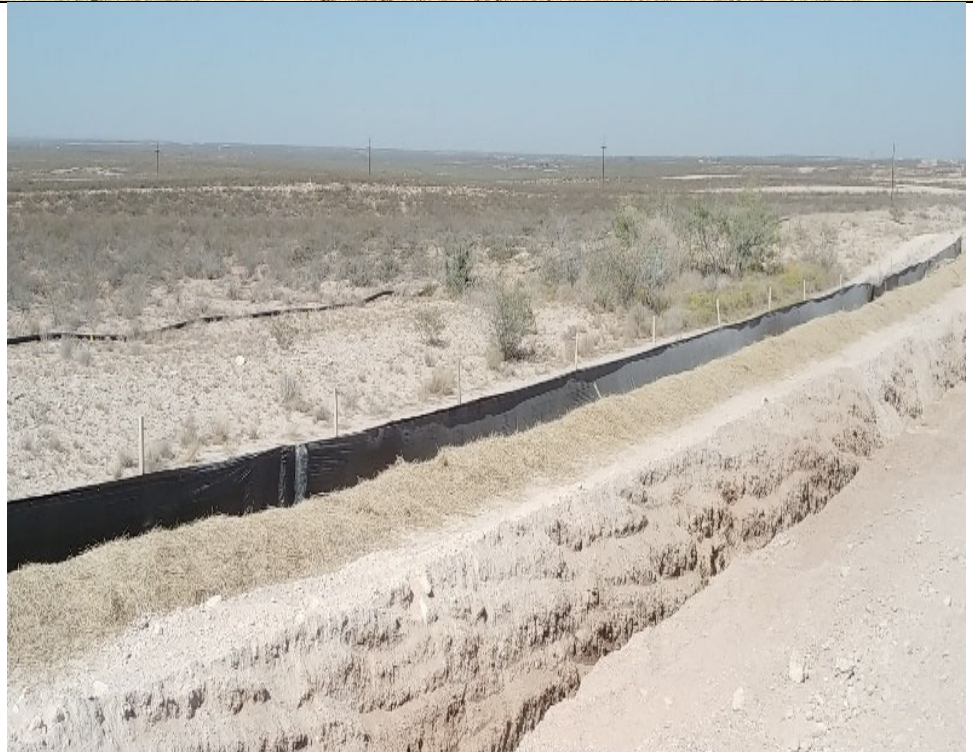
Location: Station Number 580+00
Direction of Photo: Northwest
Description: Silt fence, topsoil pile, and trench installed on ROW.
Date: 10/22/2020

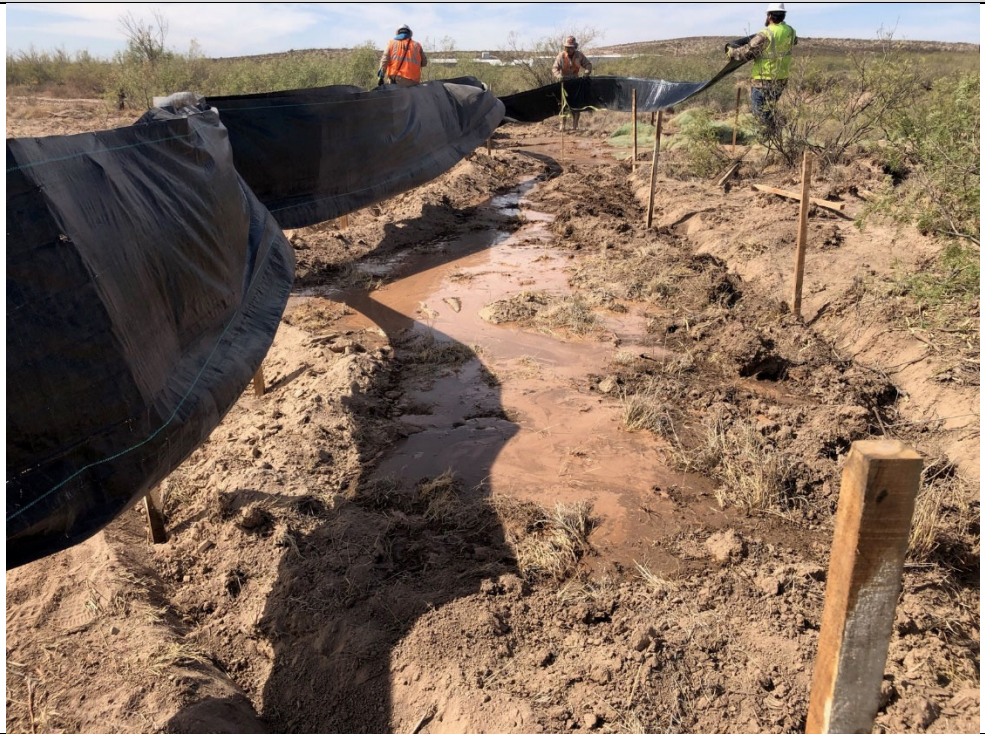
Location: Station Number 748+77
Direction of Photo: Northeast
Description: Crew installing containment around inadvertent return at Dry Wash 50 HDD location.
Date: 10/24/2020

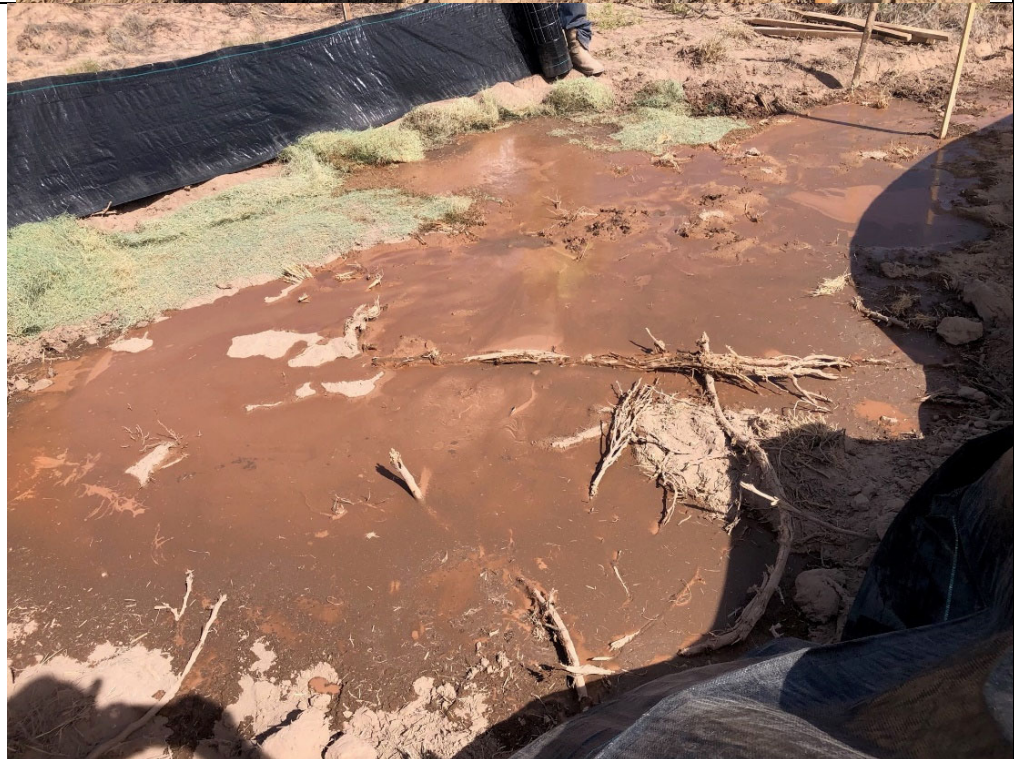
Location: Station Number 748+77
Direction of Photo: Southeast
Description: Inadvertent return containment at Dry Wash 50 HDD location.
Date: 10/24/2020

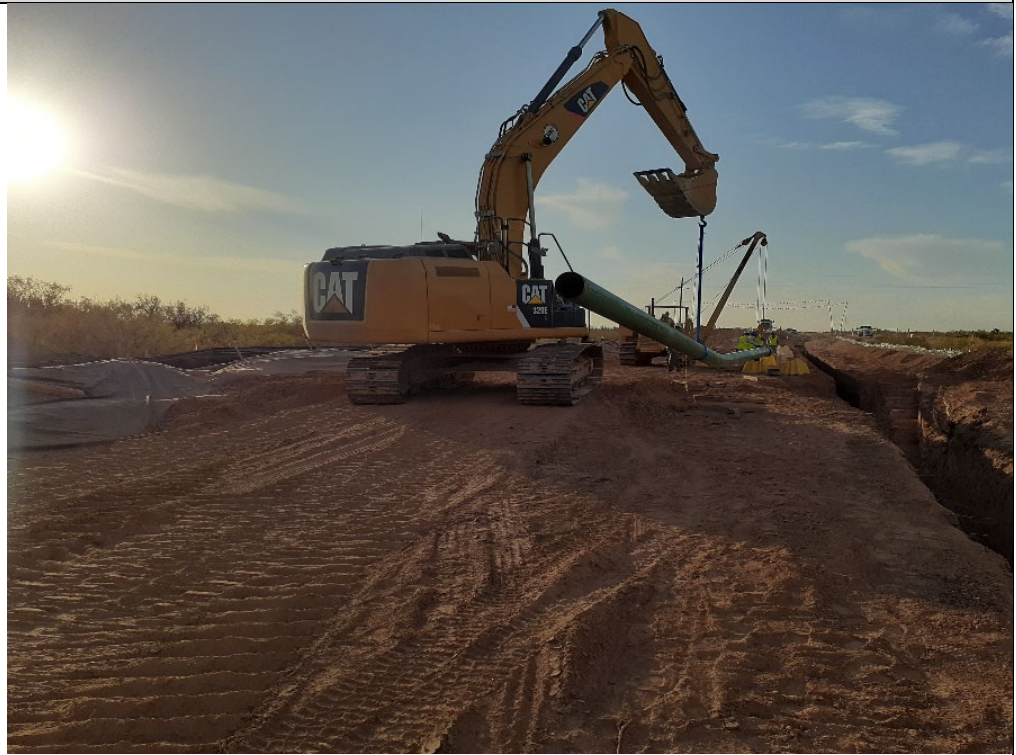
Location: Station Number 191+00
Direction of Photo: South
Description: View of pipe being lowered into trench.
Date: 10/22/2020

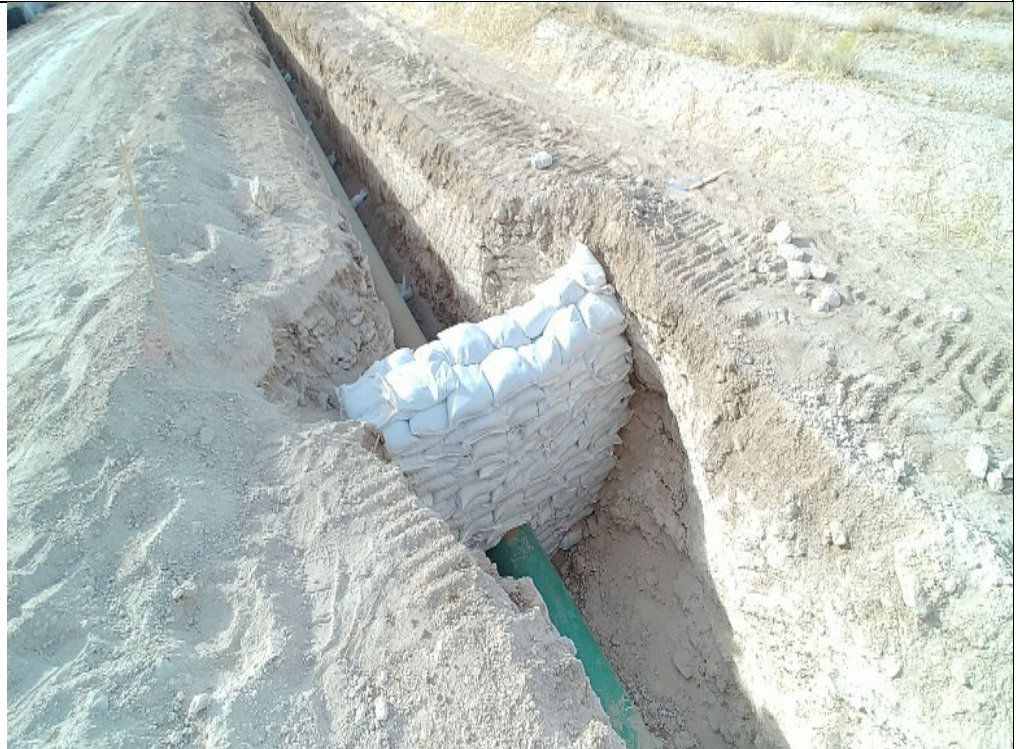
Location: Station Number 568+00
Direction of Photo: Northeast
Description: Trench breaker installed around pipe.
Date: 10/23/2020

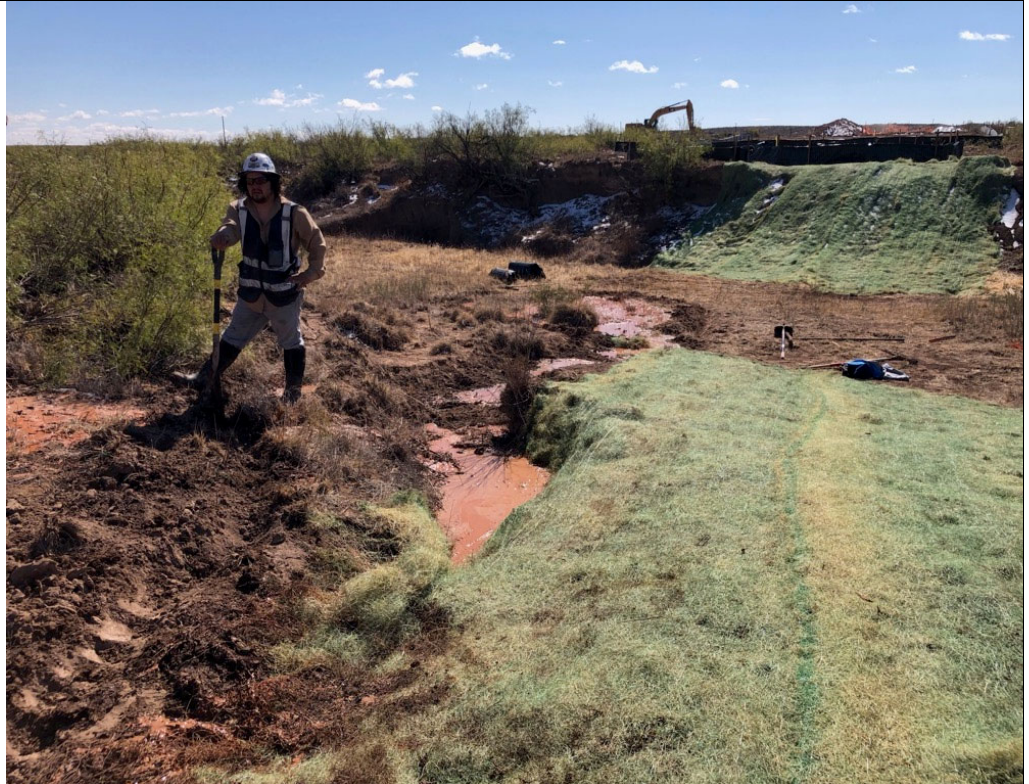
Location: Station Number 748+00
Direction of Photo: Southeast
Description: Inadvertent return in dry wash prior to cleanup at Dry Wash 50 HDD location.
Date: 10/28/2020

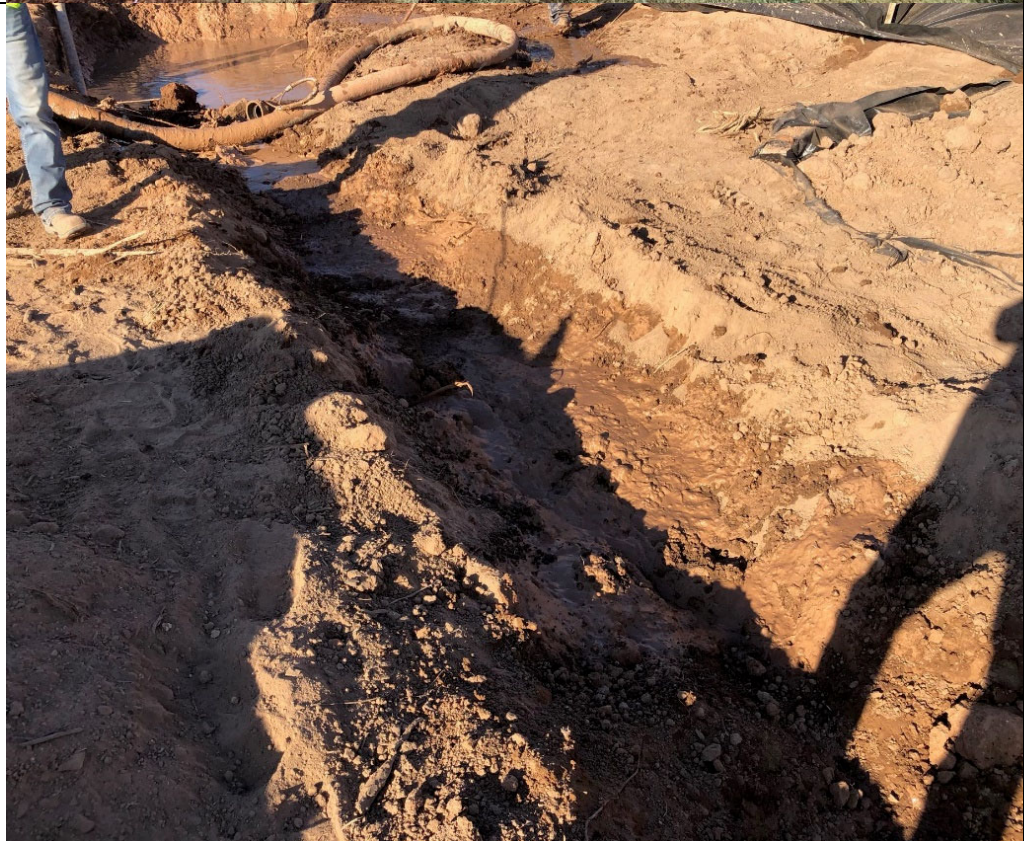
Location: Station Number 745+97
Direction of Photo: East
Description: Inadvertent return with relief trench dug to funnel drilling fluid back to the bore pit at Dry Wash 50 HDD location.
Date: 10/28/2020

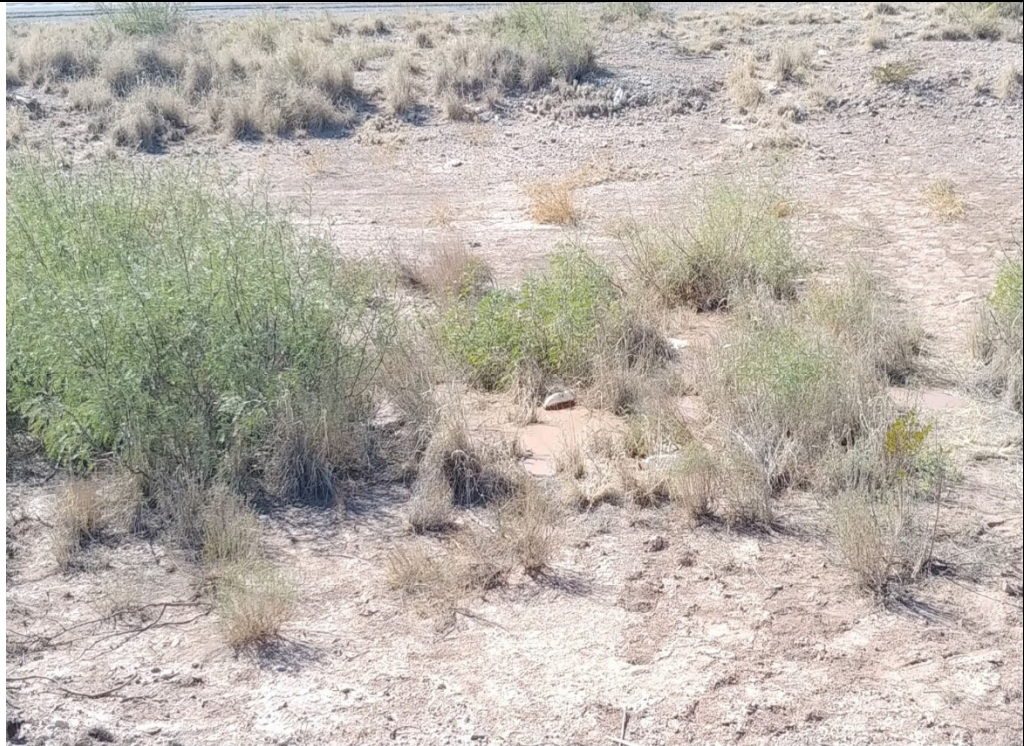
Location: Station Number 475+06
Direction of Photo: Northwest
Description: Inadvertent release (approx. 5 gallons) on the east side of US Highway 285 crossing.
Date: 10/29/2020

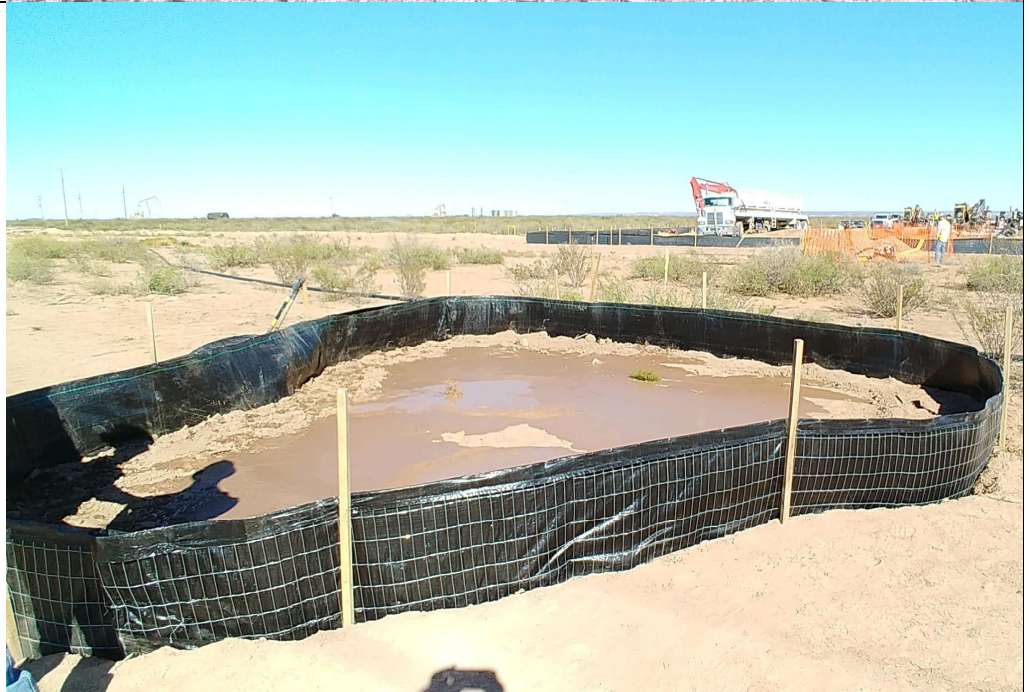
Location: Station Number 475+76
Direction of Photo: Northwest
Description: Inadvertent release (approx. 20 gallons) on the east side of US Highway 285 crossing.
Date: 10/29/2020
