Re: El Paso Natural Gas Company, L.L.C.;  
Docket No. CP24-520-000  
Maricopa Lateral Expansion Project  
Weekly Environmental Inspector Report No. 29

| <b>Weekly Status Report No. 29</b> | | |
| <b>Project Name:</b> | <b>Maricopa Lateral Expansion Project</b> | |
| <b>Reporting Period:</b> | June 14, 2026 to June 20, 2026 | |

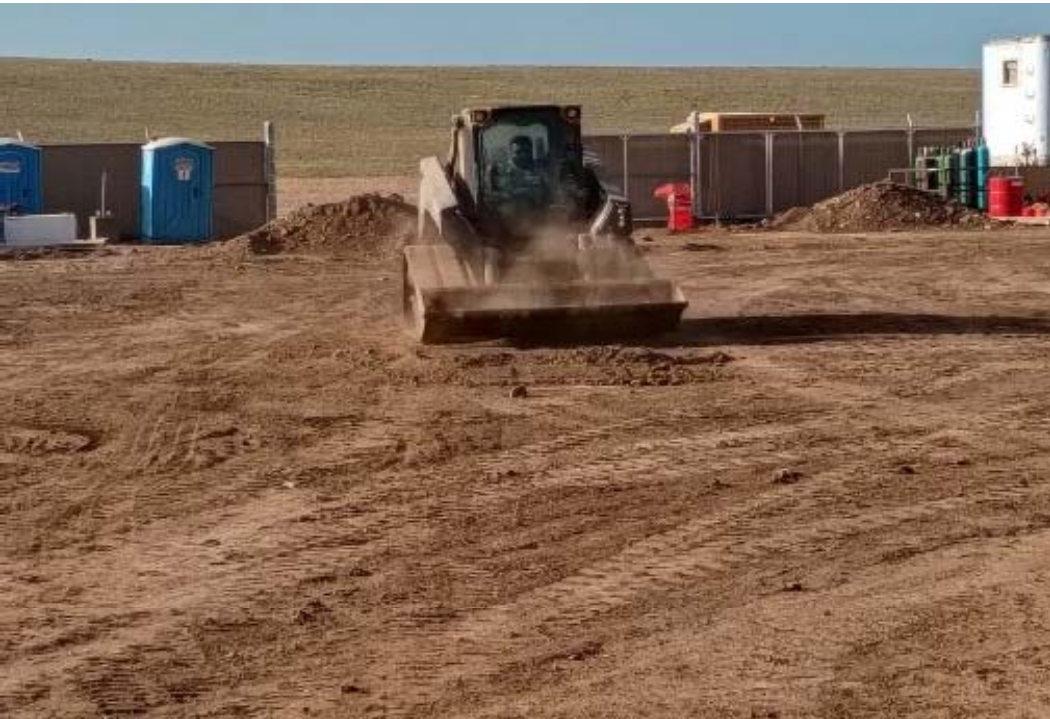
| Maricopa Lateral Expansion Project Photo Documentation | |
|--|---|
| <p><b>Location:</b><br/>Haystack<br/>Compressor<br/>Station site.<br/><b>Direction of<br/>Photo:</b><br/>South<br/><b>Date;</b><br/>6/18/26<br/><b>Description:</b><br/>Trench<br/>backfilling.</p> | A skid steer loader is shown in the process of backfilling a trench. The machine is positioned in the center of the frame, moving dirt from a pile on the right towards the trench. The ground is dry and dusty. In the background, there are several blue portable toilets, a chain-link fence, and a white storage tank. The sky is clear and blue. |

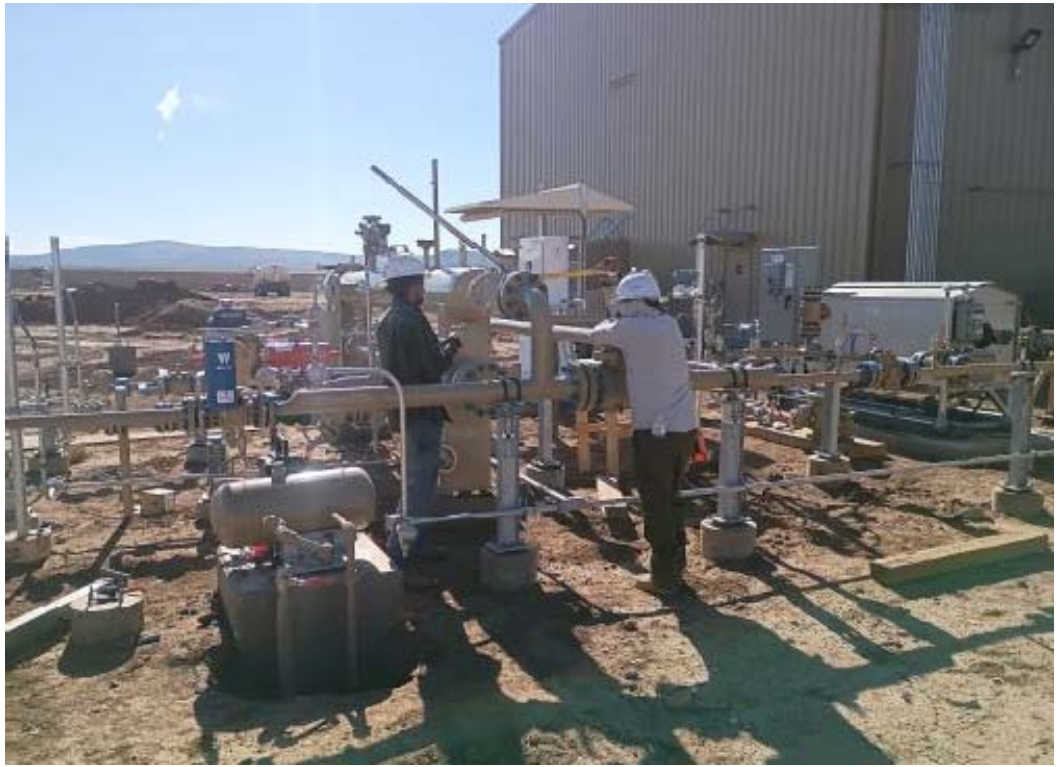
**Location:**  
Haystack  
Compressor  
Station site.  
**Direction of  
Photo:**  
North  
**Date:**  
6/17/26  
**Description:**  
Bolting and  
torquing up  
flanges.

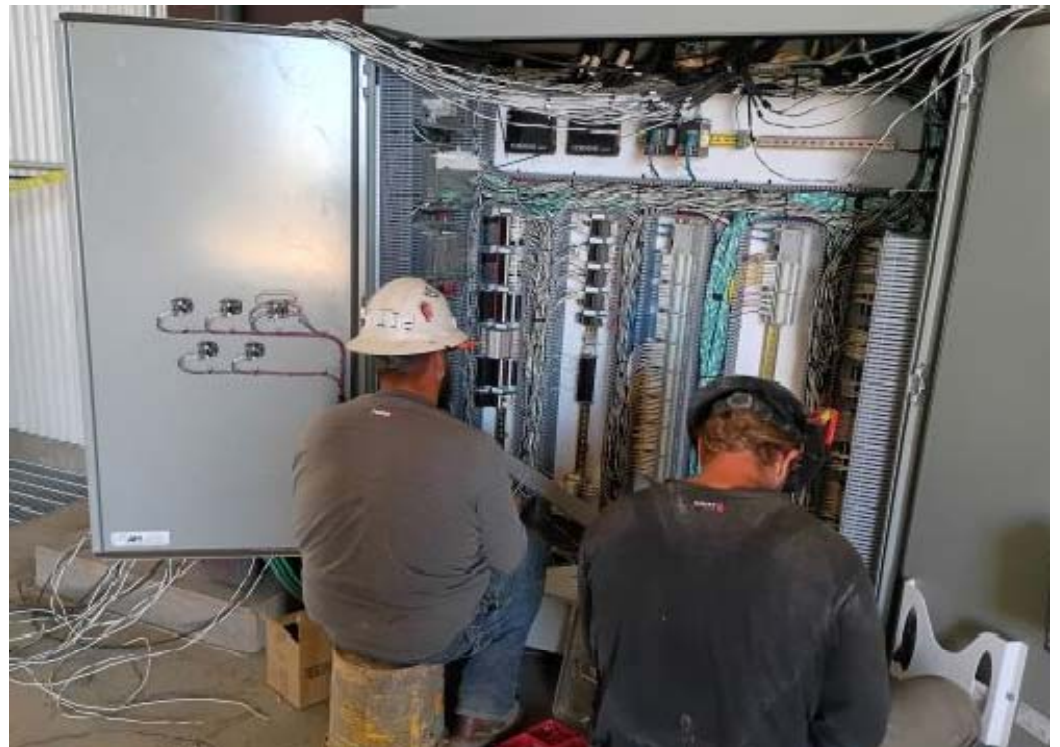
**Location:**  
Haystack  
Compressor  
Station site.  
**Direction of  
Photo:**  
East  
**Date:** 6/17/26  
**Description:**  
Wiring  
Installation in  
the new  
compressor  
building.

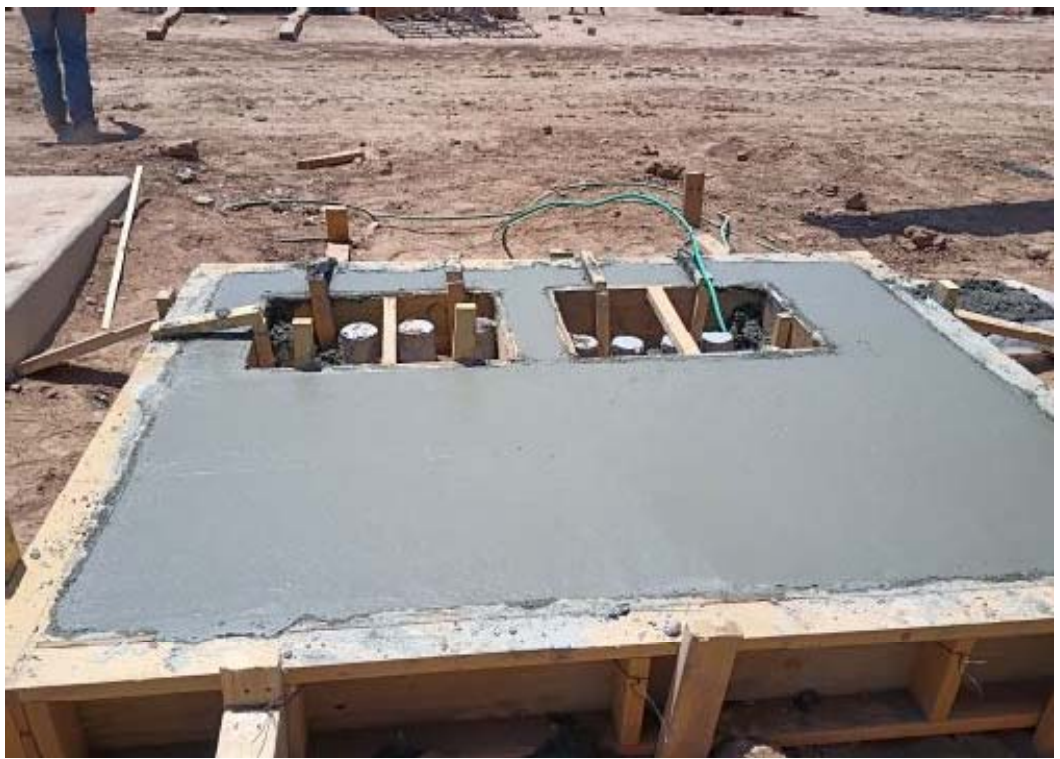
**Location:**  
Haystack  
Compressor  
Station site.  
**Direction of  
Photo:**  
North  
**Date:**  
6/18/26  
**Description:**  
Foundation for  
electrical  
disconnect.

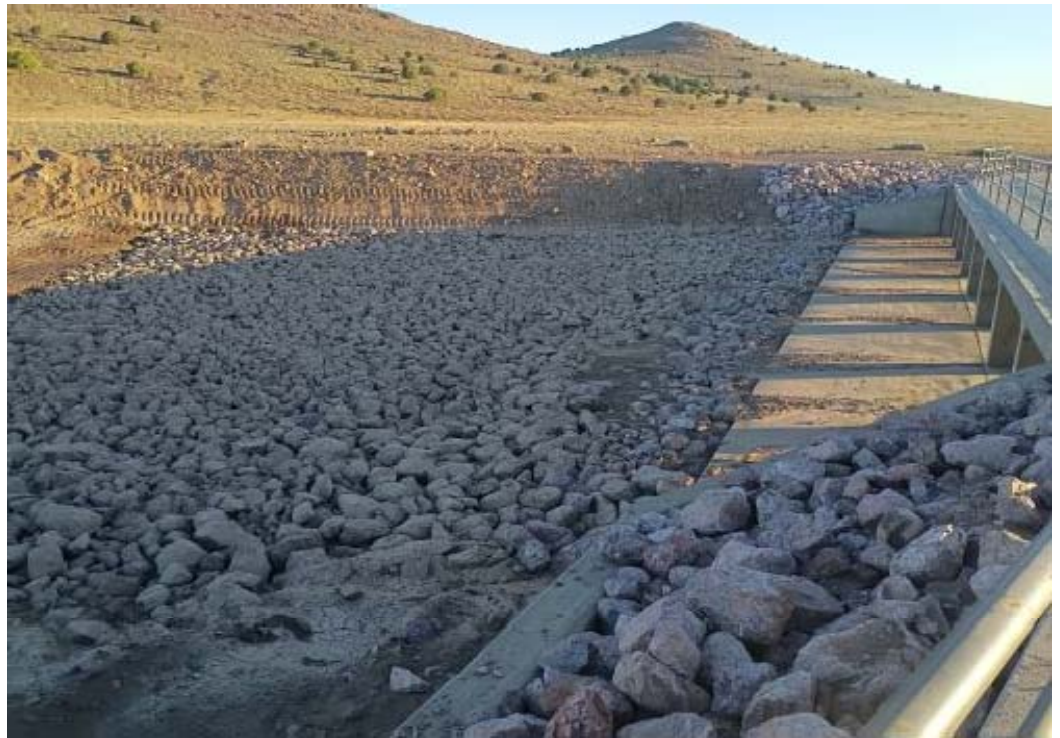
**Location:**  
Haystack  
Compressor  
Station site.  
**Direction of  
Photo:**  
East  
**Date:** 6/20/26  
**Description**  
Completed  
access road  
culvert.
