Re: El Paso Natural Gas Company, L.L.C.;  
Docket No. CP26-156-000  
Permian West Expansion Project  
Weekly Environmental Inspector Report No. 9

| <b>El Paso Natural Gas Company, L.L.C.'s (EPNG) Weekly Environmental Inspection Report No. 9</b> | | |
| <b>Project Name:</b> | <b>Permian West Expansion Project</b> | |
| <b>Reporting Period:</b> | September 20, 2026 to September 26, 2026 | |

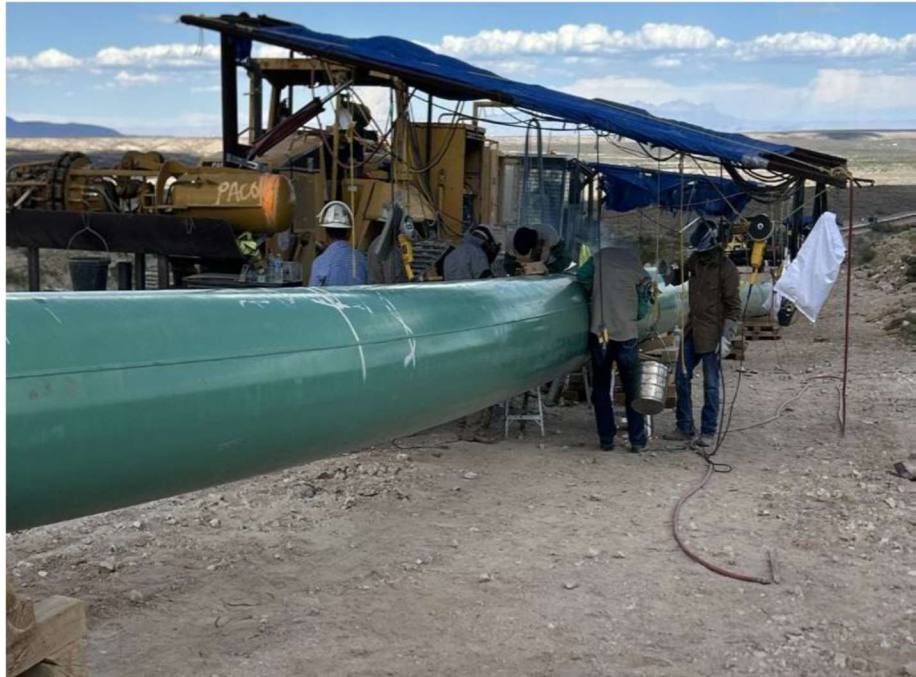
**Location:** Project ROW near MP 4.5.  
**Direction of Photo:** West  
**Date:** 9/21/26  
**Description:** Pipeline welding operations.

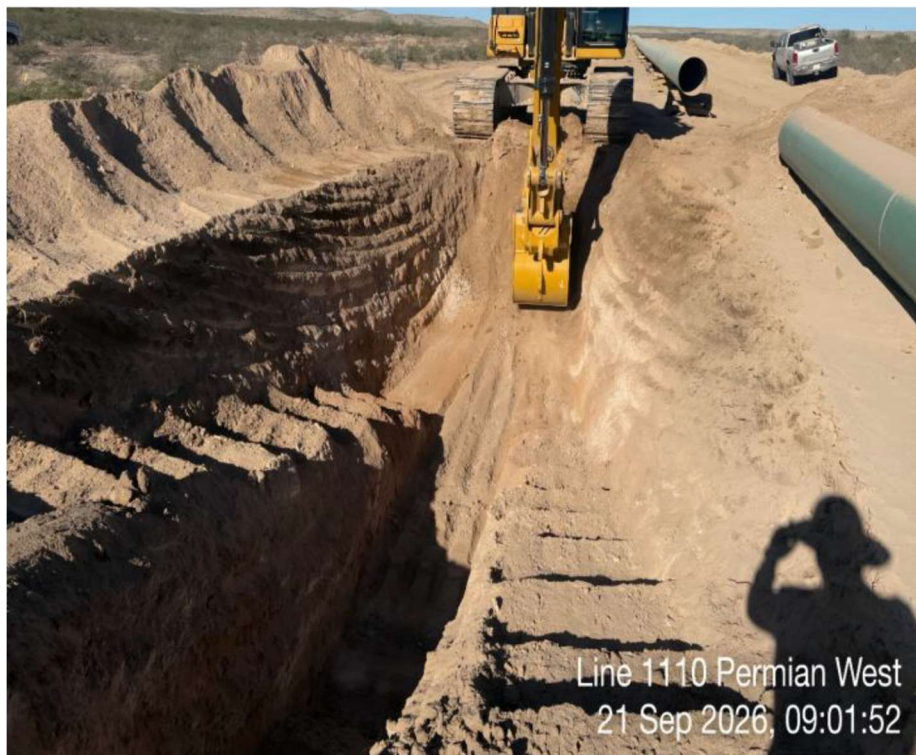
**Location:** Project right-of-way near MP 6.5.  
**Direction of Photo:** West  
**Date:** 9/21/26  
**Description:** Pipeline trenching operations.

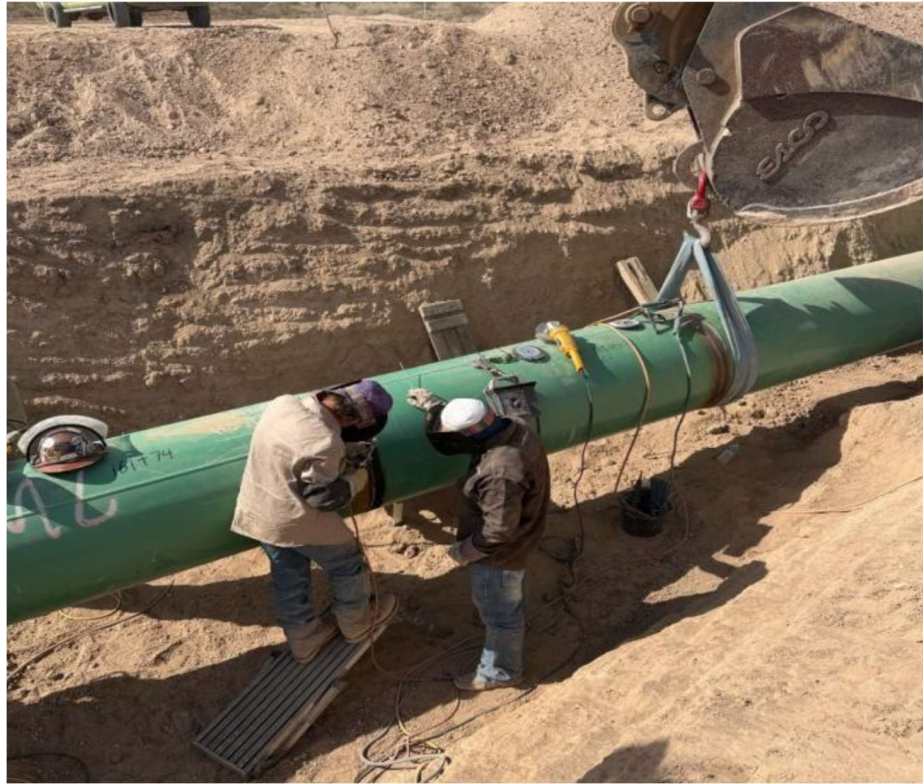
**Location:** Project right-of-way near MP 6.  
**Direction of Photo:** Southwest  
**Date:** 9/22/2026  
**Description:** Pipeline tie-in welding operations.

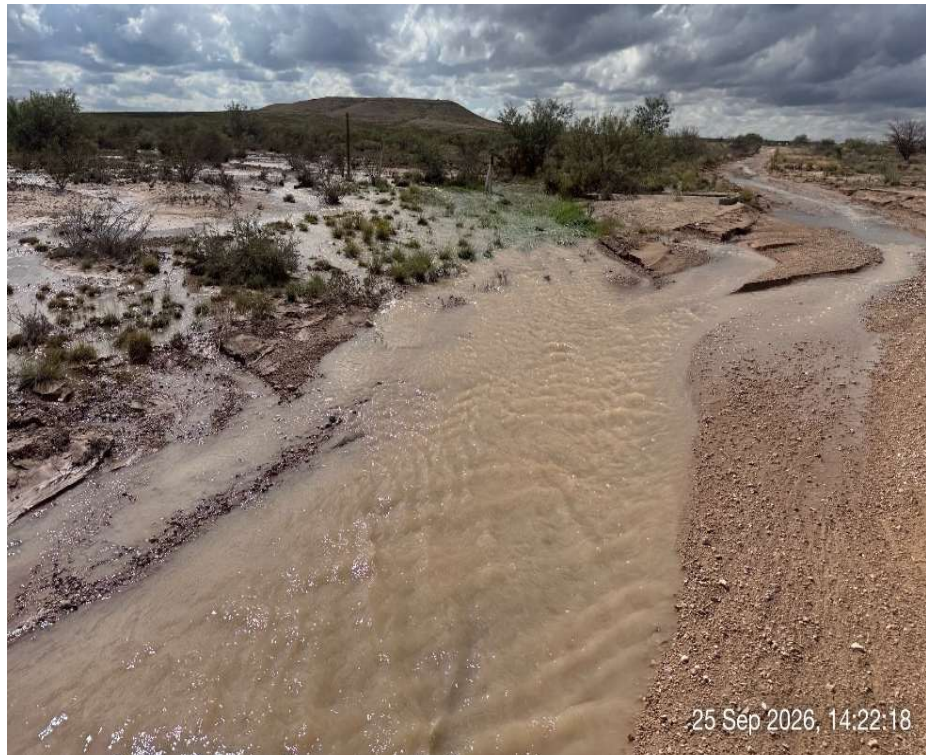
**Location:** Access road near MP 8.5.  
**Direction of Photo:** West  
**Date:** 9/25/26  
**Description:** Stormwater runoff flowing onto the access road off of Highway 2317 following the rain storm event.

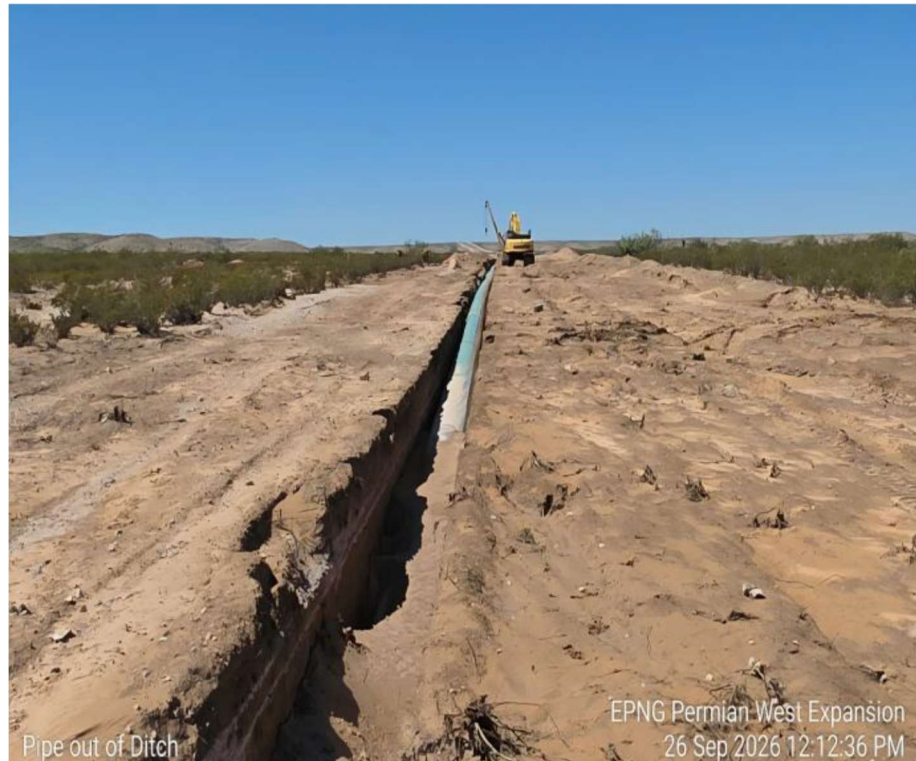
**Location:** Project right-of-way near MP 5.5.

Stormwater runoff in pipeline trench following the storm event.

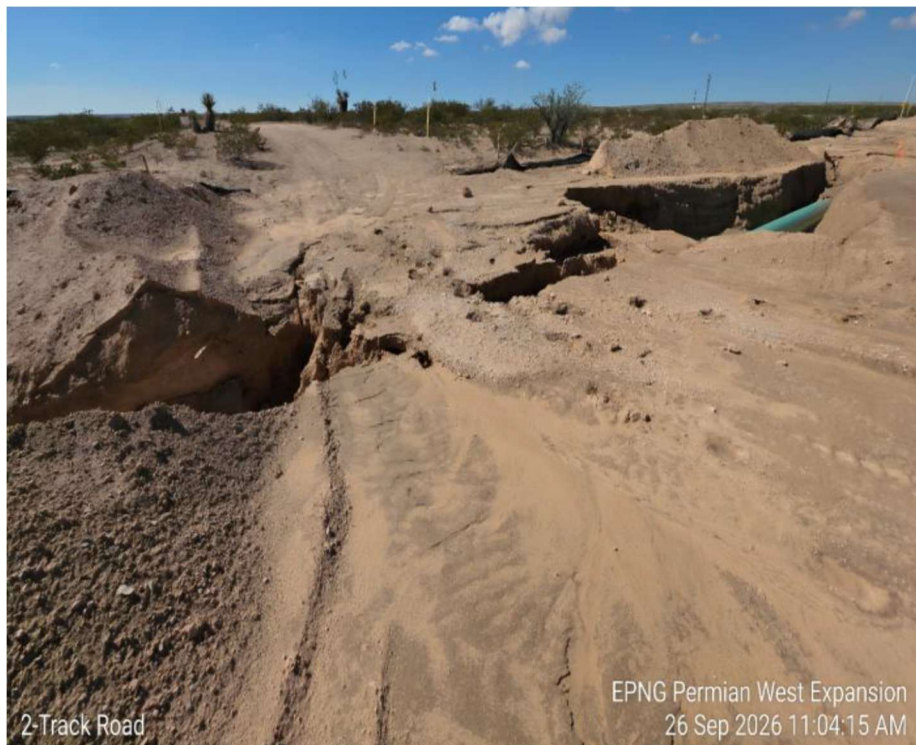
**Location:** Access road near MP 7.

**Description:** Damage to access road from storm event.

During the next reporting period, the contractor will continue storm-related repair and restoration activities, including erosion control device repairs and ROW stabilization efforts. Construction activities will also continue as conditions allow, including pipe bending, welding, sandblasting, coating, trenching, pipe lowering, and backfilling operations.

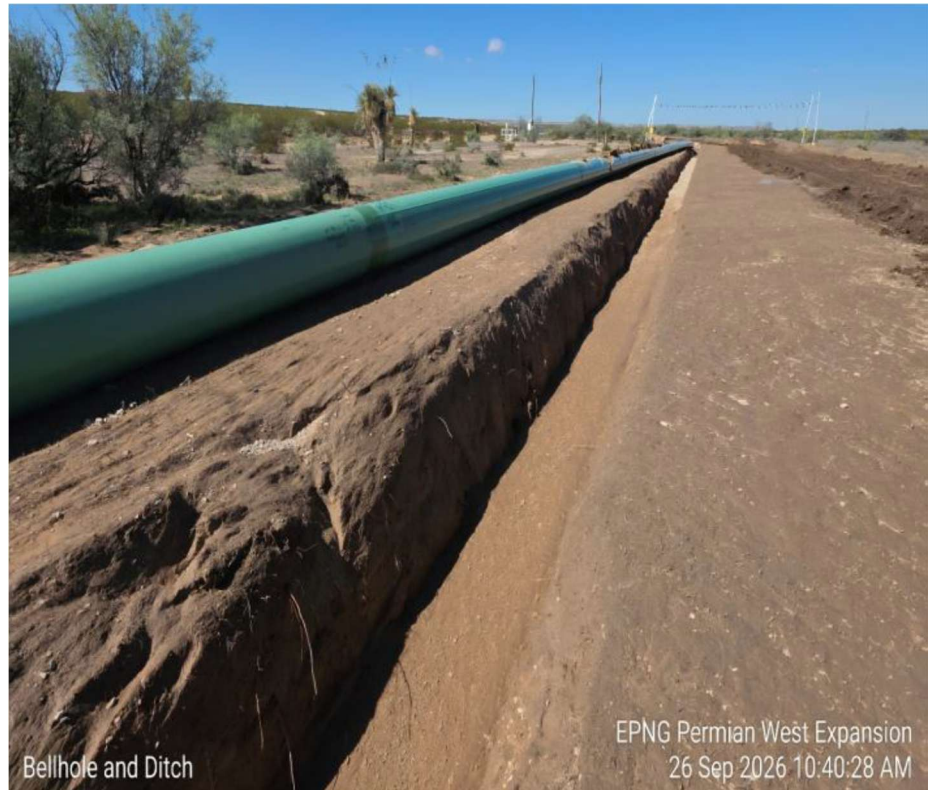
**Location:** Project right-of-way near MP 8.

**Description:**  
Stormwater runoff in pipeline trench following the storm event.

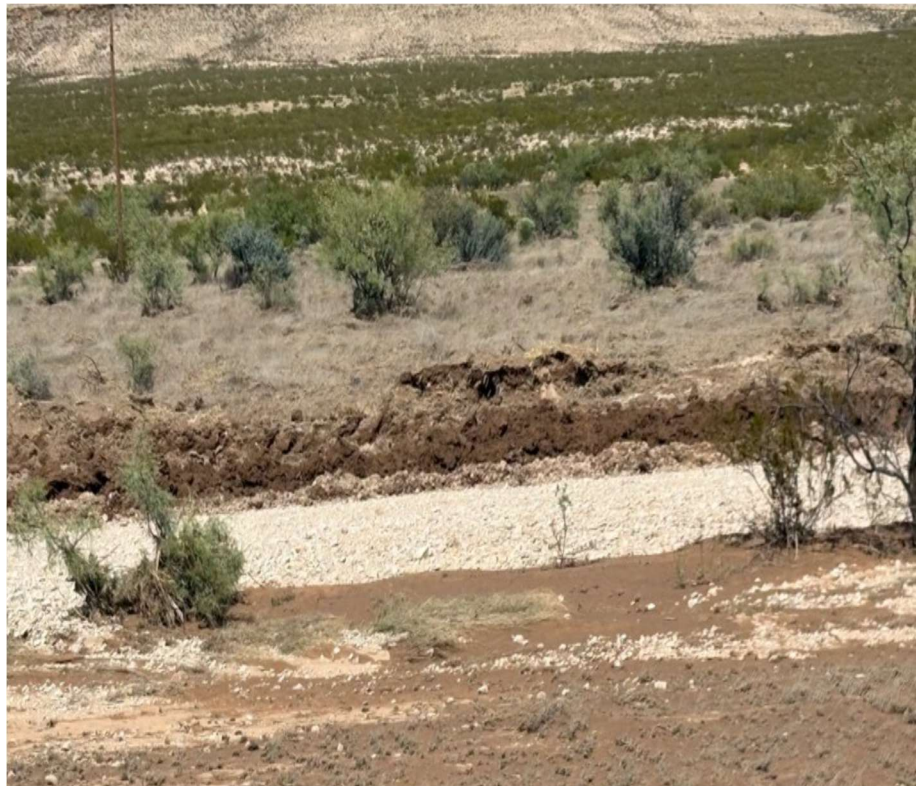
**Location:** Project right-of-way near MP 8.

**Description:** Side view of the east access road showing the depth of cut caused by running rainwater following the storm event.

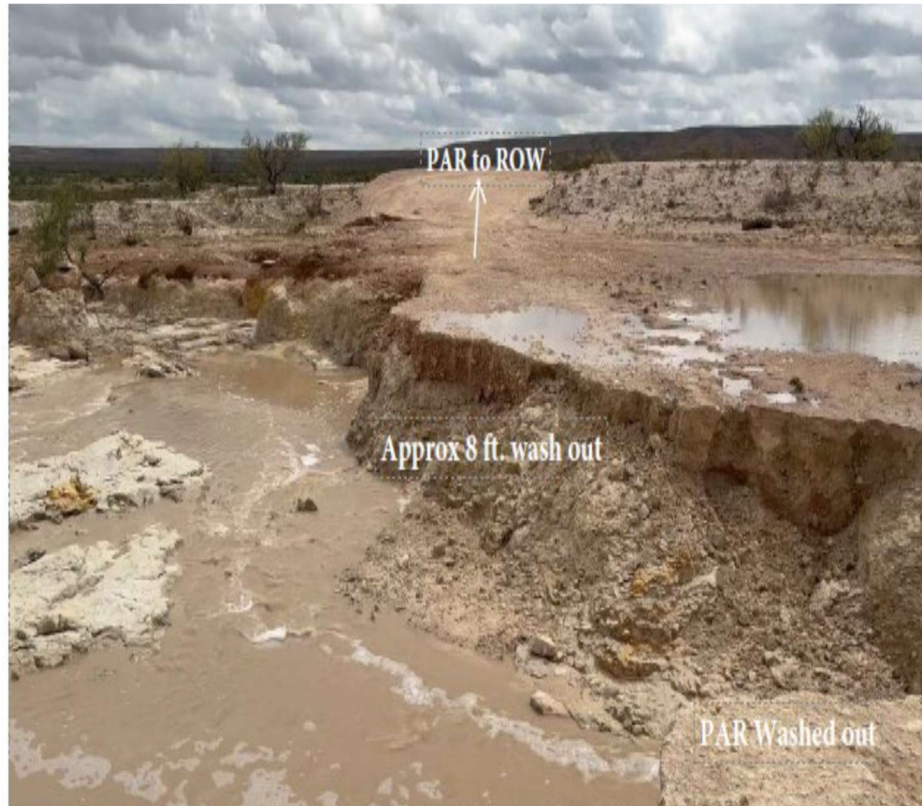
**Location:** Access road off of Highway 62, approximately 3,800 feet north of the pipeline ROW  
**Direction of Photo:** South  
**Date:** 9/26/26  
**Description:** View of west access road heading south from Hwy 62 towards the ROW.

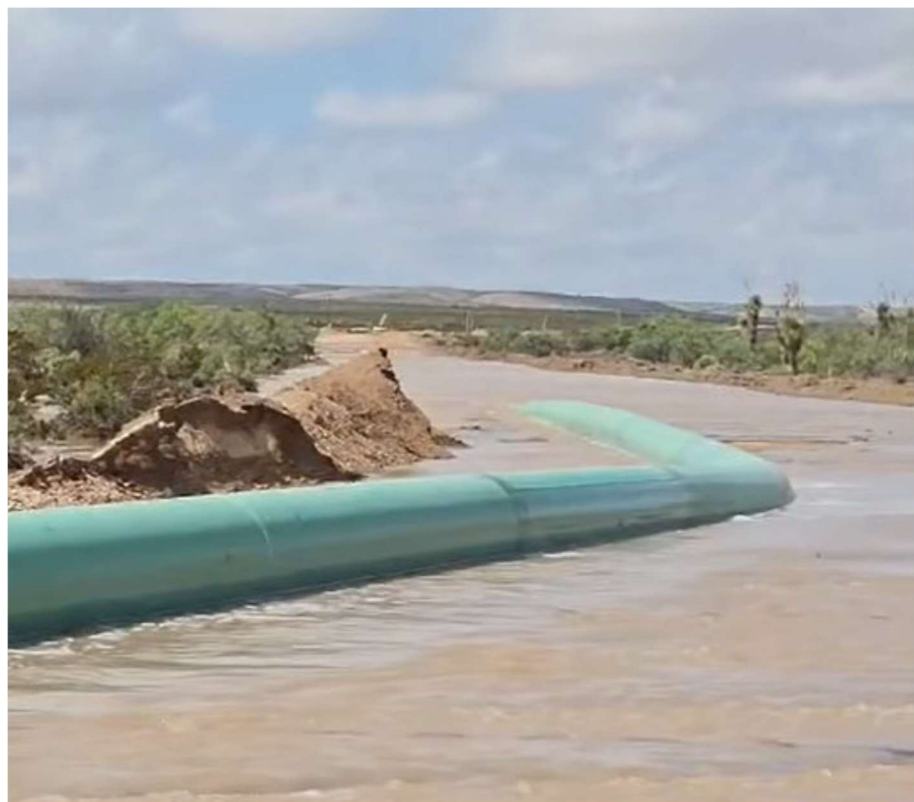
**Location:** Project right-of-way near MP 8.  
**Direction of Photo:** West  
**Date:** 9/26/26  
**Description:** View of section of pipe floating out of the trench.

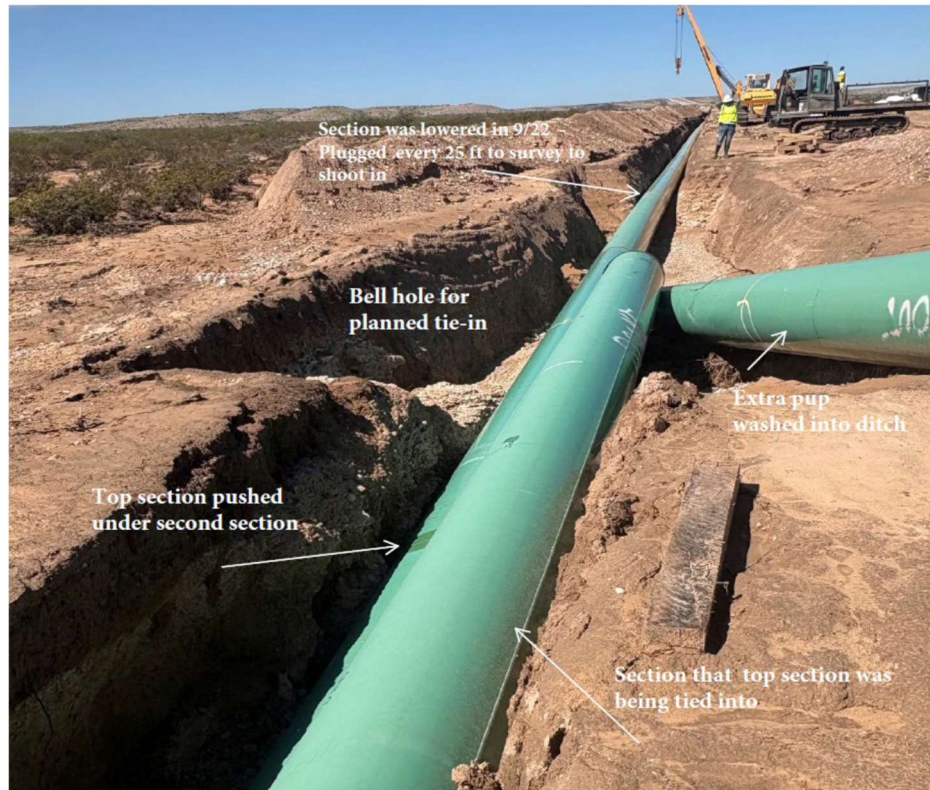
**Location:** Project right-of-way near MP 6.

**Description:** Sections of pipe washed into the trench.

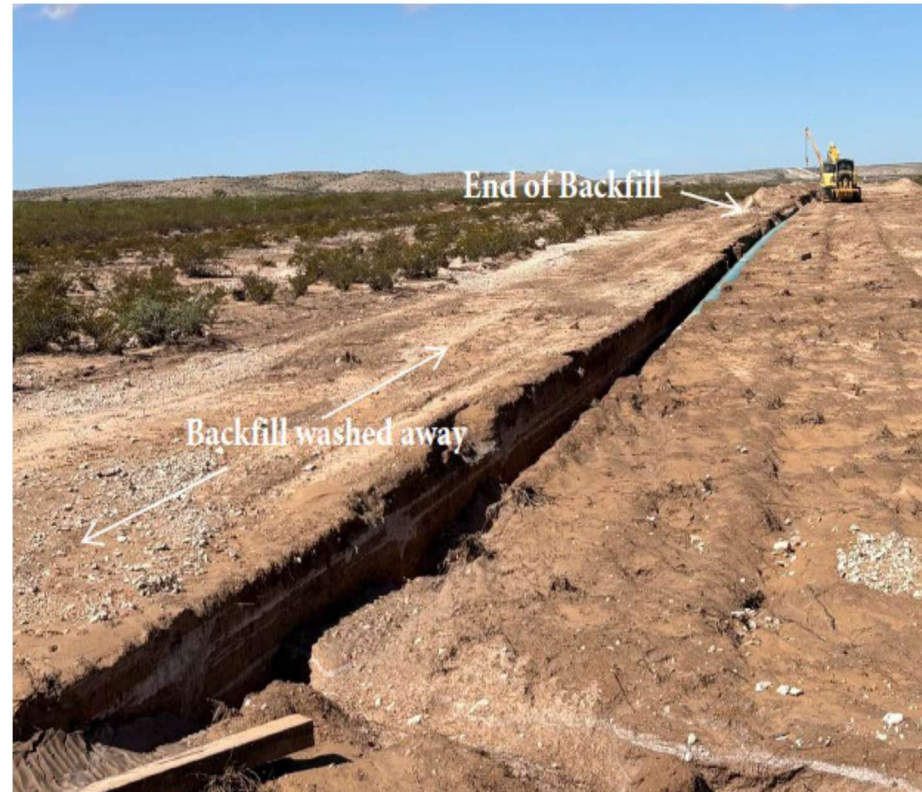
**Location:** Project right-of-way near MP 6.

**Description:** Stormwater runoff in pipeline trench following the storm event.

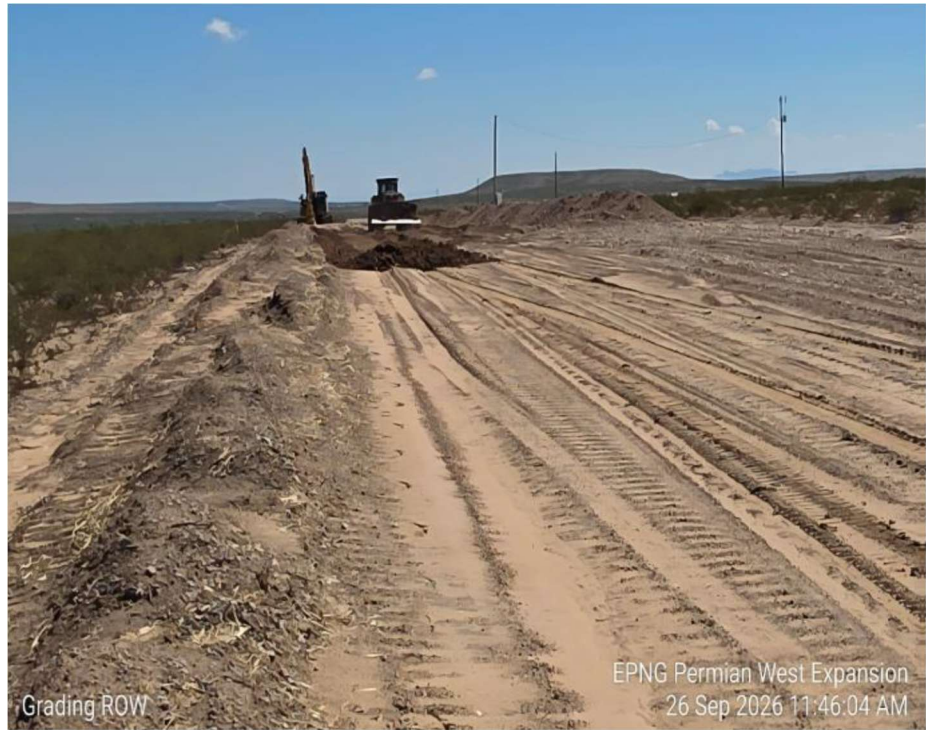
**Location:** Project right-of-way near MP 6.

**Description:** Regrading a portion of the ROW after the storm event.
