Re: Sierrita Gas Pipeline LLC;
Docket No. CP18-37-000;
Sierrita Compressor Expansion Project;
Project Status Report No. 2

Sierrita Project Status Report No. 2		
Docket No. CP18-37-000		
Project Name:	Sierrita Compressor Expansion Project	
County/State:	Pima County, Arizona	Date: 5/08/19
Reporting Period:	April 21, 2019 to May 4, 2019	
Environmental Inspector:	Russell Waldron	
<p>1. Summary of Construction Activity for Inspection Period: During this reporting period, the contractor completed welding, hydrostatic testing, and moving the pipe segments into ditch. On April 30th, the pipeline between MLV 1 and 3 was blown down. The contractor then cut the mainline and tied in new segments. On May 3rd, the contractor began the backfill of the ditch.</p> <p>2. Relevant Environmental Activities: During this reporting period, seven (7) people received environmental training. A total of twenty-five (25) people have received environmental training on the Sierrita Compressor Expansion Station Project.</p> <p>3. Environmental Problems/Issues and Corrective Actions Taken: There were no environmental problems or issues identified during this reporting period.</p> <p>4. Environmental Compliance I

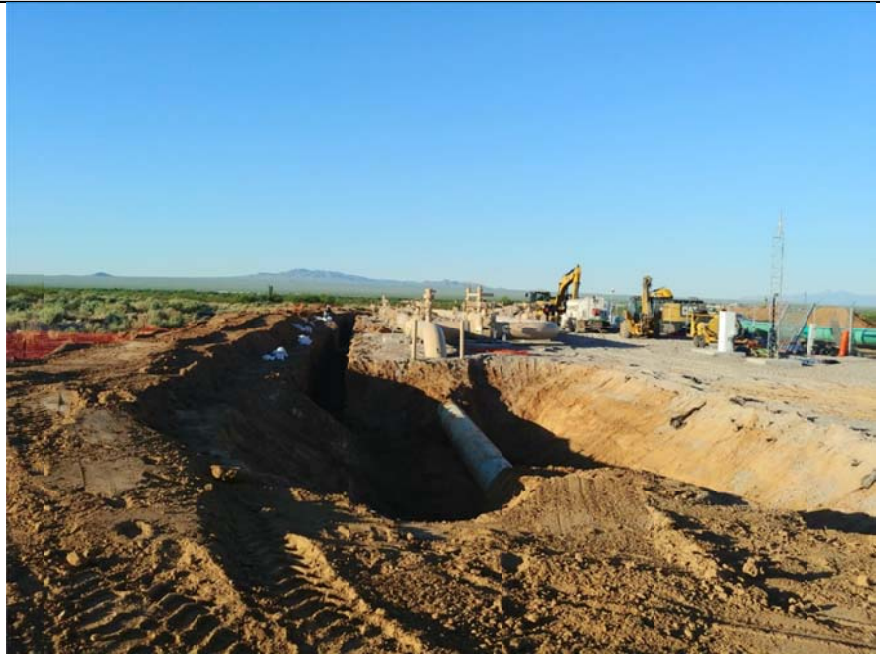
Location: MP 1.2/MLV2
Direction of Photo: South
Description: Looking south from north side of MLV 2 facility, on 04-26-19; prepping the ditch and tie-in point of the bypass.

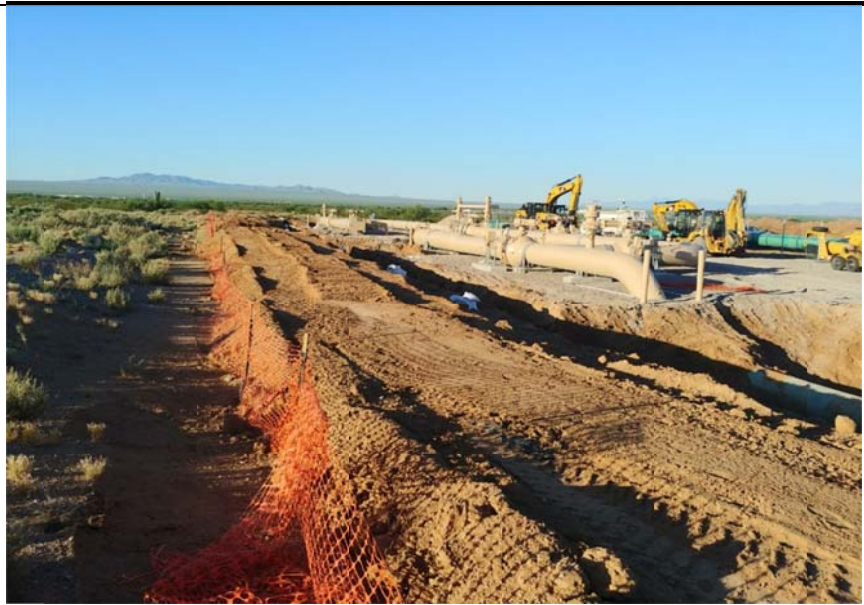
Location: MP 1.2/MLV2
Direction of Photo: South
Description: Looking south along the east boundary of the workspace from north side of site on 04-26-19.

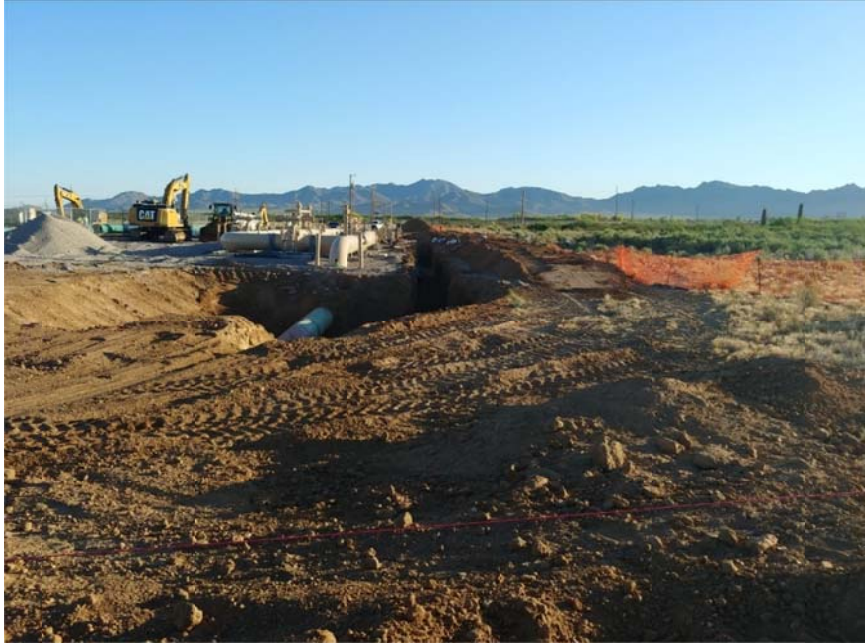
Location: MP 1.2/MLV2

Description: Looking north from south side of site along east boundary on 04-26-19.

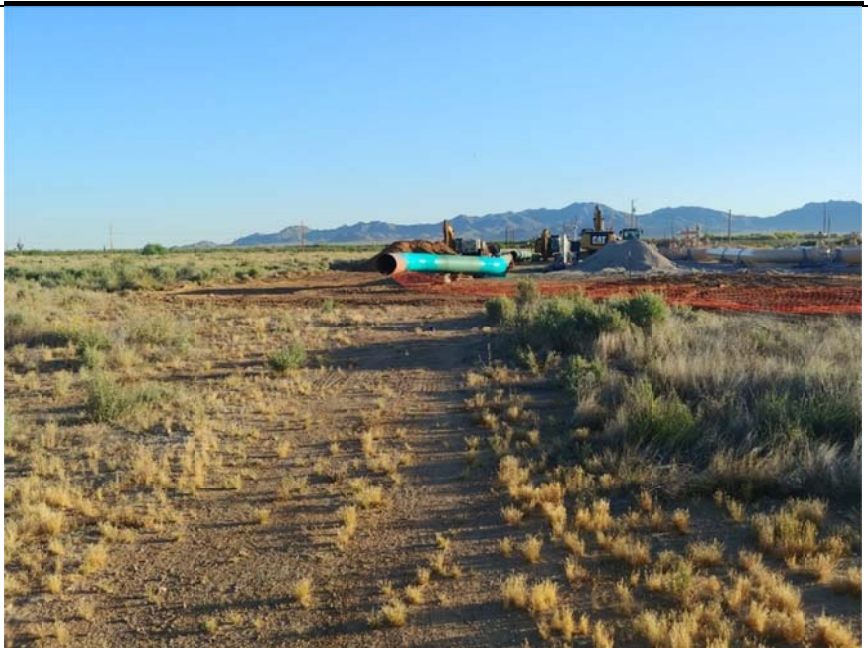
Location: MP 1.2/MLV2

Description: Looking north along edge of workspace requested for a one time use variance to maneuver pipeline segment around southern bell hole on 4-26-19.

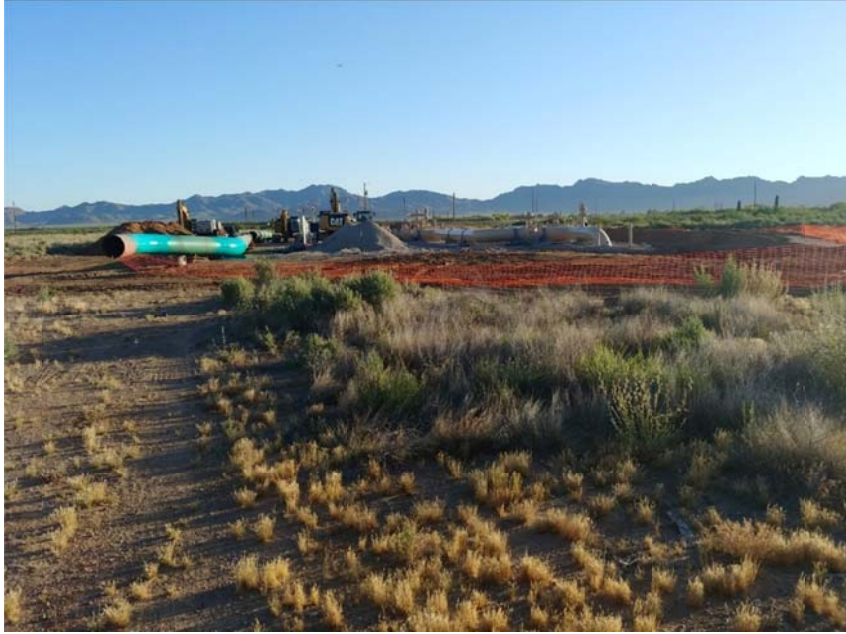
Location: MP 1.2/MLV2
Direction of Photo: North
Description: Looking north/northeast across workspace (from foreground of Photo to near the orange fencing) requested for a one time use variance to maneuver pipeline segment around southern bell hole on 4-26-19.

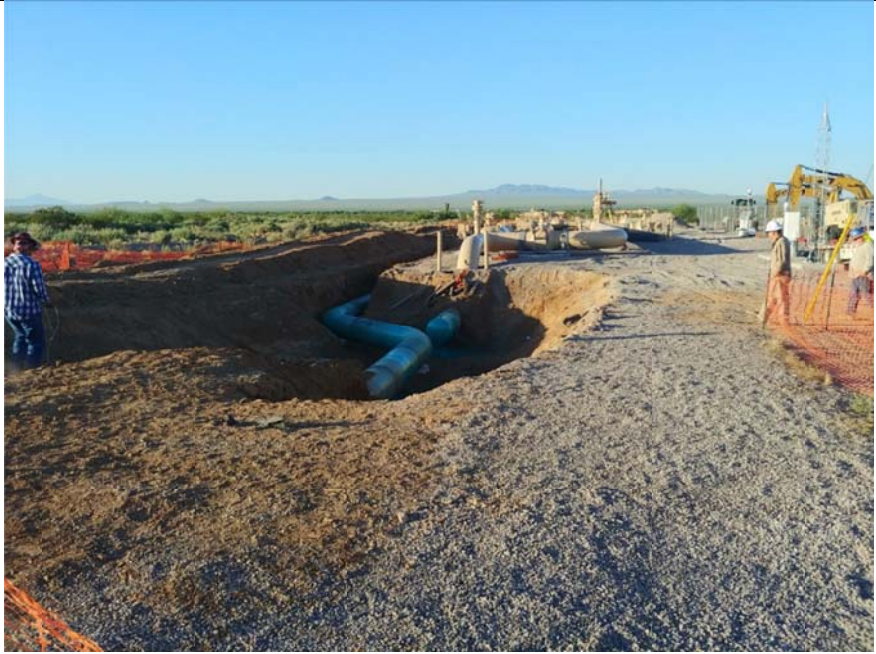
Location: MP 1.2/MLV2
Direction of Photo: South
Description: Looking south from north side of MLV 2 facility, on 05-03-19.

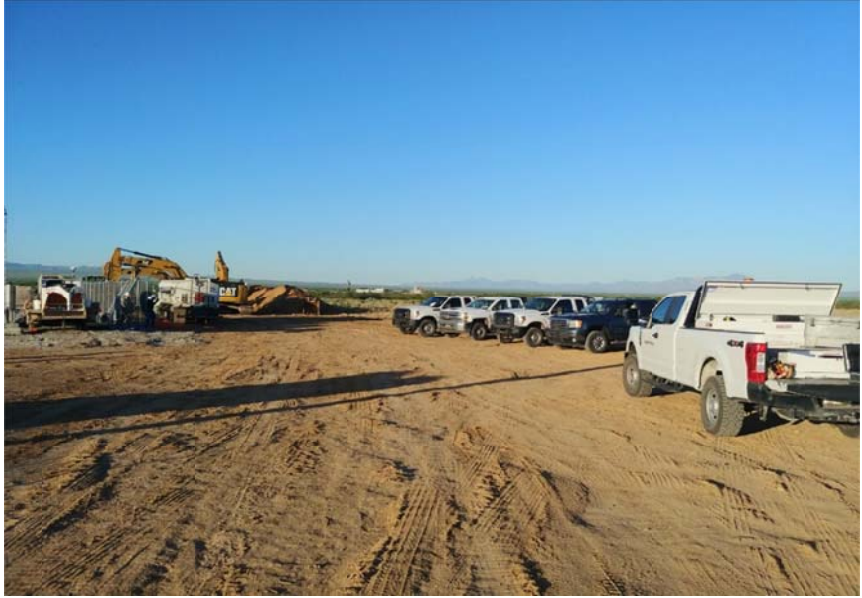
Location: MP 1.2/MLV2

Description: Looking southwest from north side of site on 05-03-19.

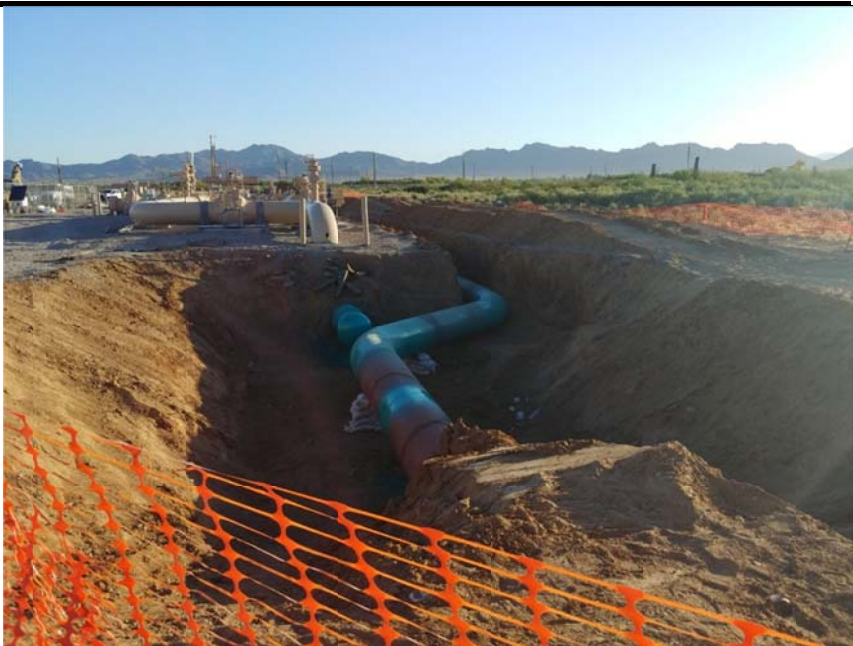
Location: MP 1.2/MLV2

Description: Looking north from the south end of the bypass on 05-03-19.

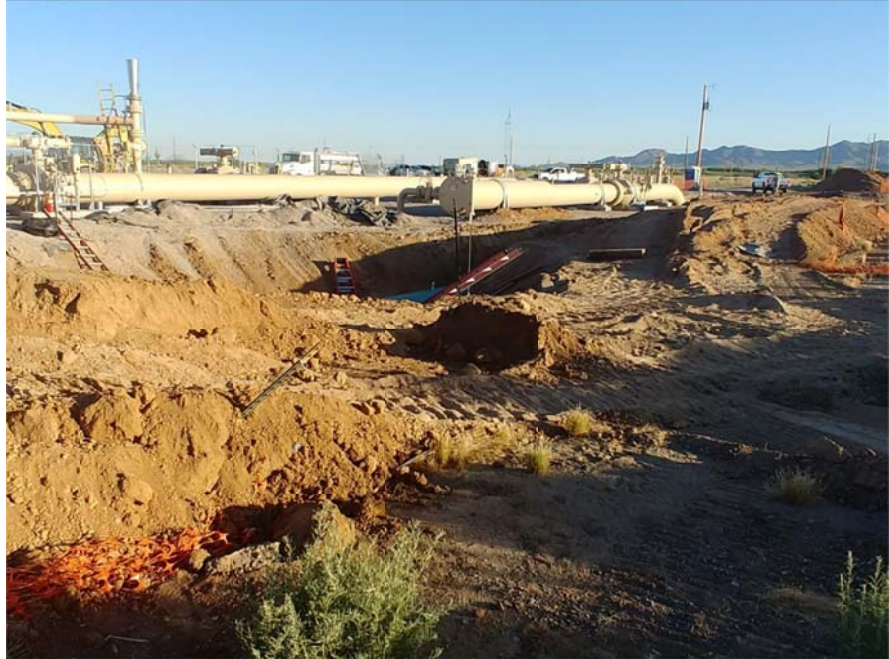
1.2/MLV2

Description: Looking
at the midpoint of the
ditch bell hole on 05-
03-19.
