Re: Sierrita Gas Pipeline LLC;
Docket No. CP18-37-000;
Sierrita Compressor Expansion Project;
Project Status Report No. 1

Sierrita Project Status Report No. 1		
Docket No. CP18-37-000		
Project Name:	Sierrita Compressor Expansion Project	
County/State:	Pima County, Arizona	Date: 4/25/19
Reporting Period:	April 7, 2019 to April 20, 2019	
Environmental Inspector:	Russell Waldron

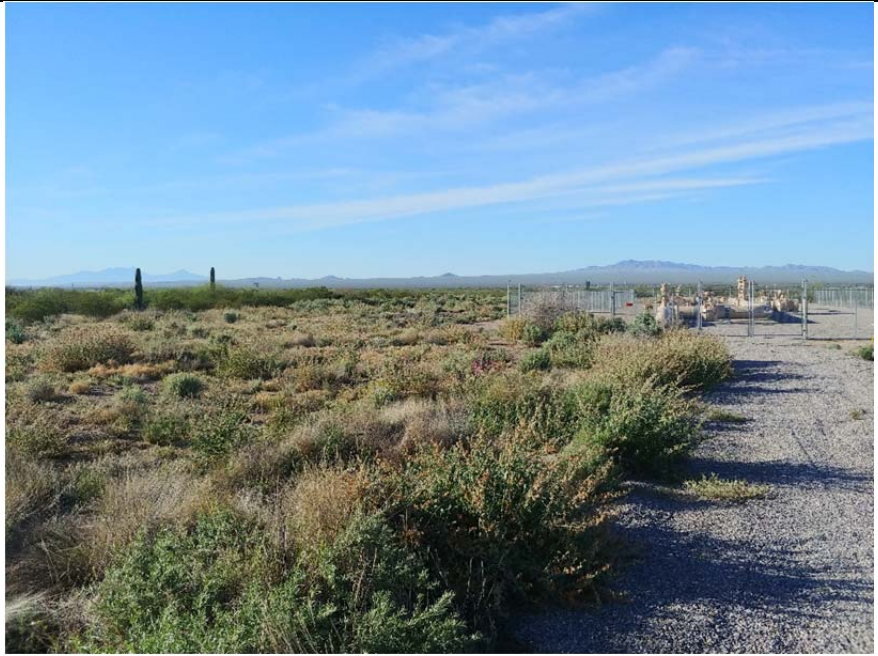
Location: MP 1.2/MLV2
Direction of Photo: South
Description: Looking south from north side of MLV2 facility, pre-construction on 4-08-19.

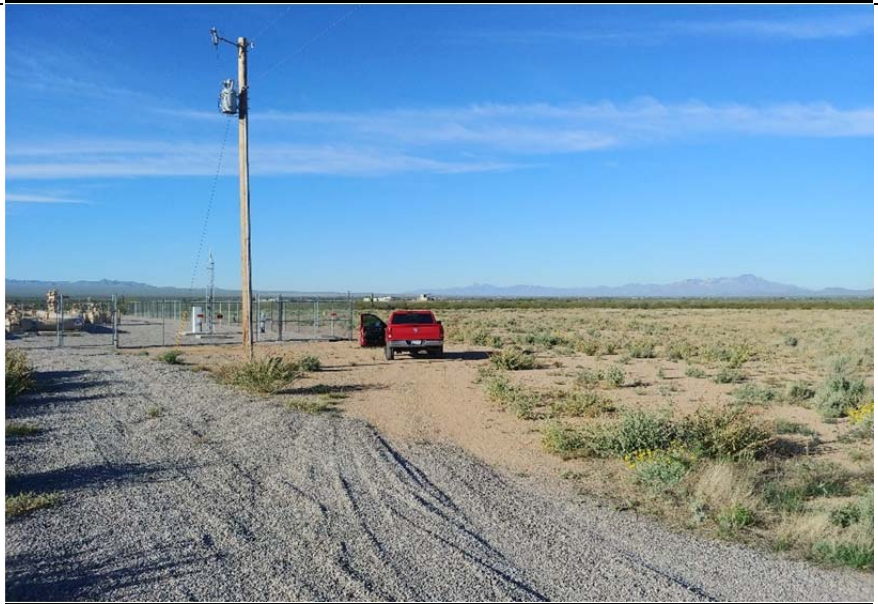
Location: MP 1.2/MLV2
Direction of Photo: Southwest
Description: Looking southwest from north of site pre-construction on 04-08-19.

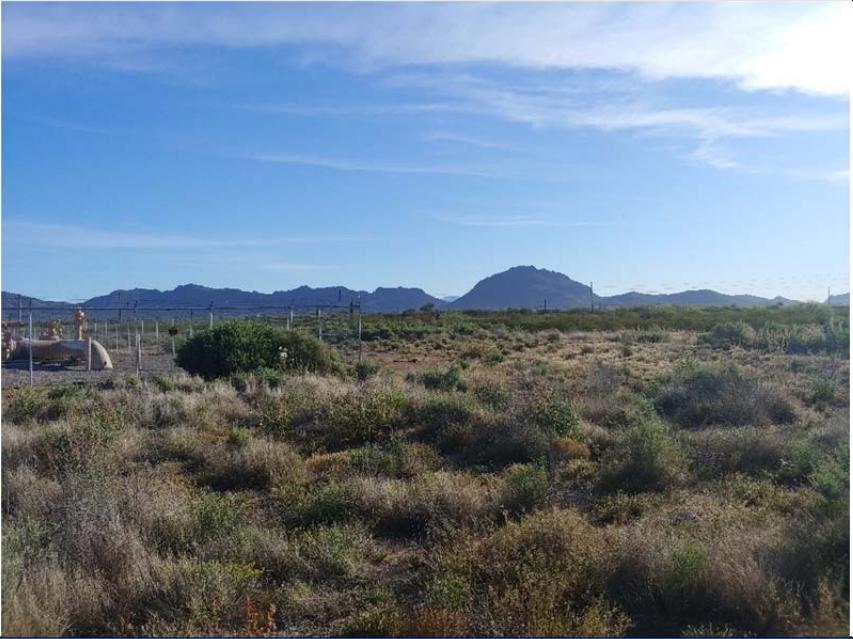
<p>Location: MP 1.2/MLV2</p> <p>Direction of Photo: East</p> <p>Description: Looking east from the southwest corner of the site; pre-construction on 04-08-19.</p>

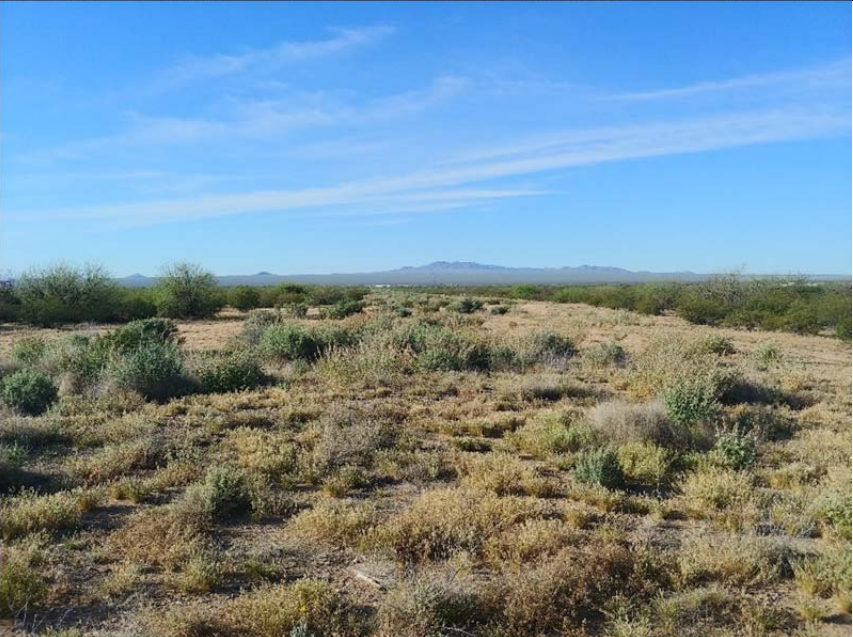
<p>Location: MP 1.2/MLV2</p> <p>Direction of Photo: South</p> <p>Description: Looking south from the south end of the site on 04-08-19 (pre-construction).</p>

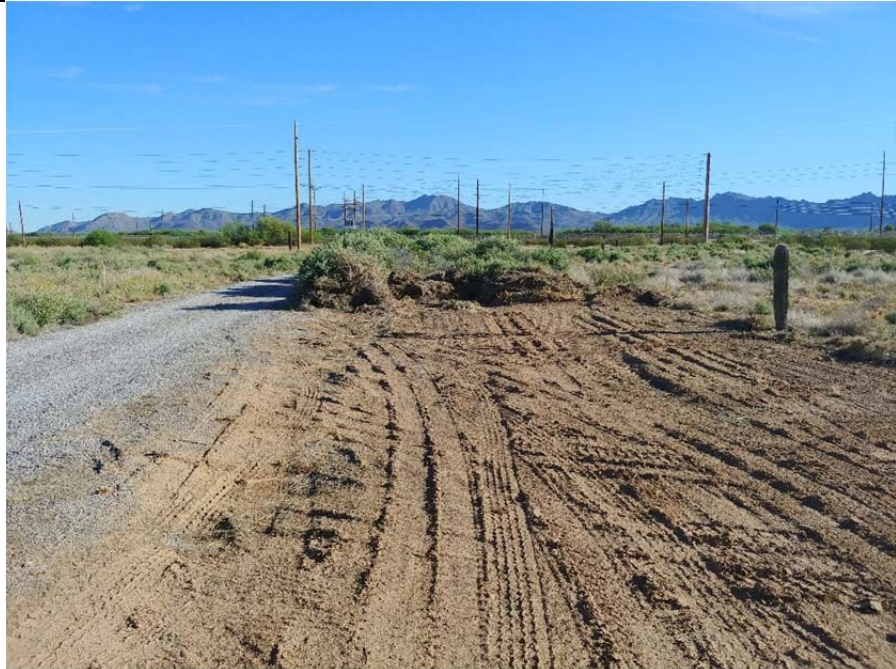
Description: Looking north at cleared ROW and access road from north side of MLV2 on 04-19-19.

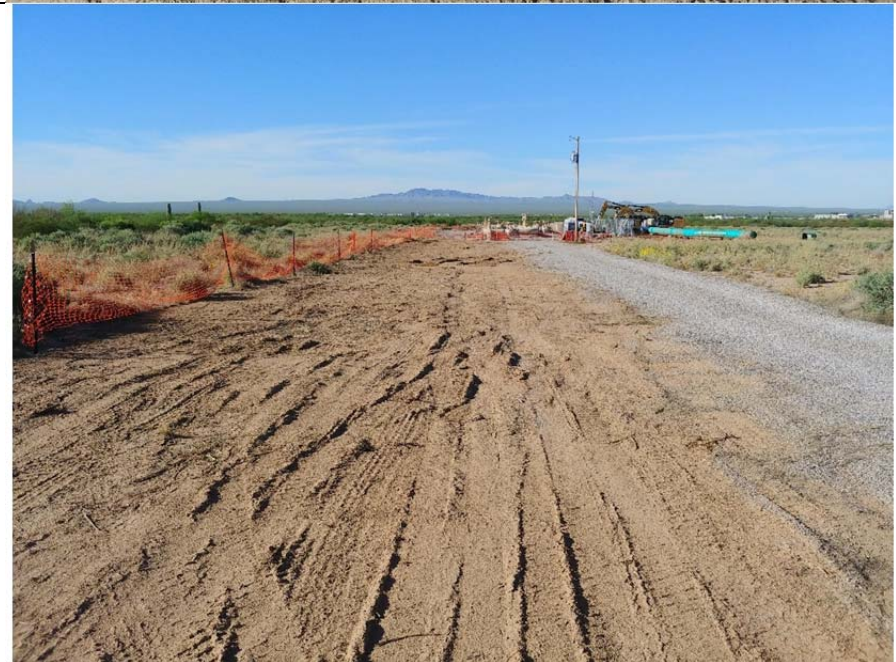
Description: Looking south at the north side of the MLV2 site on 04-19-19. ROW and access road with orange safety fencing.

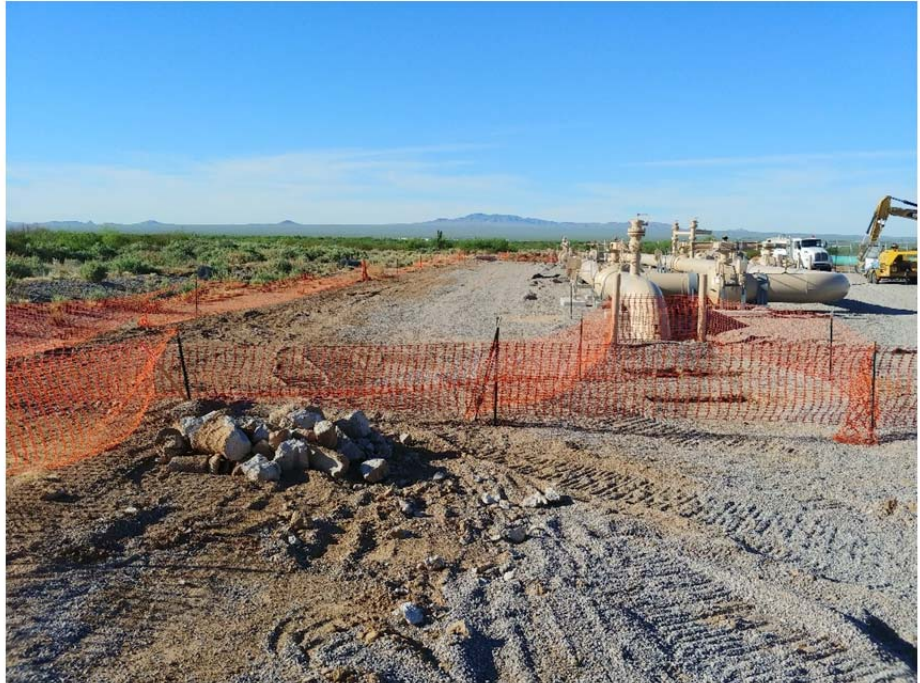
Description: Looking south from north side of MLV2 site on 4-19-19. Concrete blocks in foreground are security fencing post anchors.

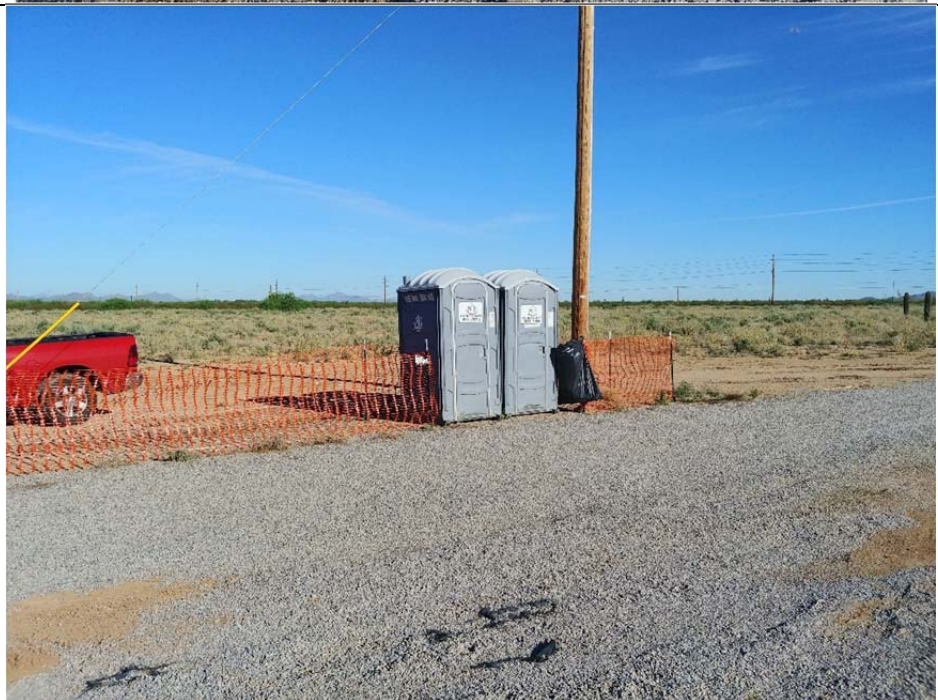
Description: Portable restrooms on 4-19-19.

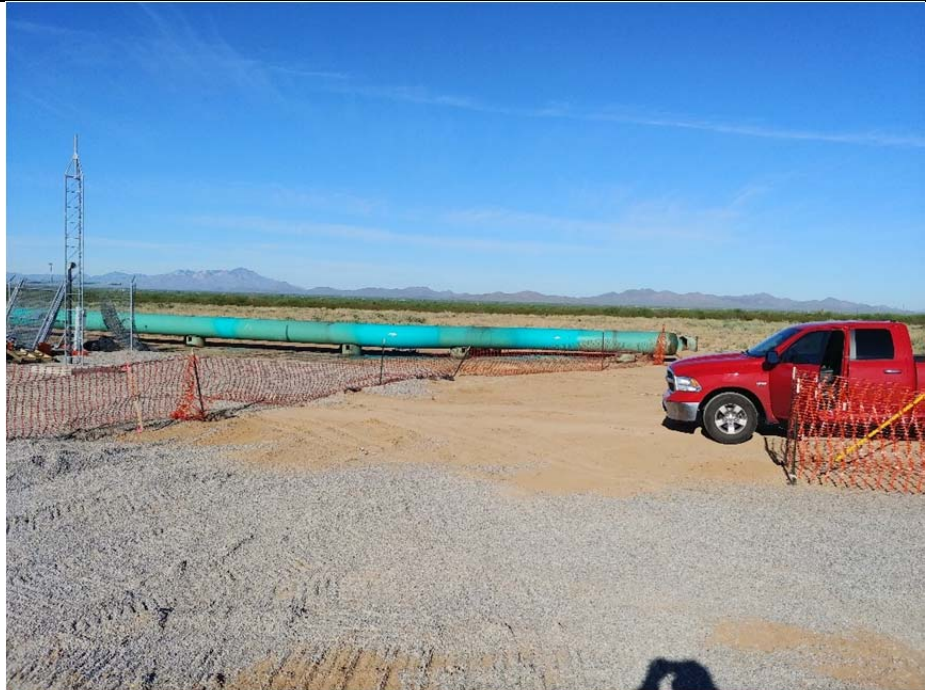
Description: Looking west from north end at pipeline segment on 4-19-19.

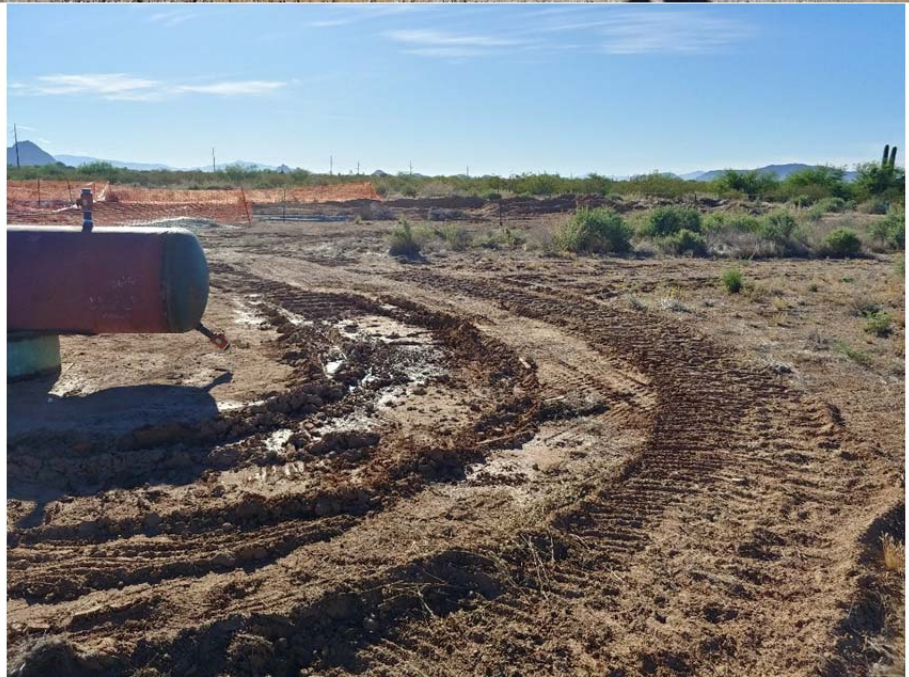
Description: Looking east from southwest corner of MLV2 site on 4-19-19.

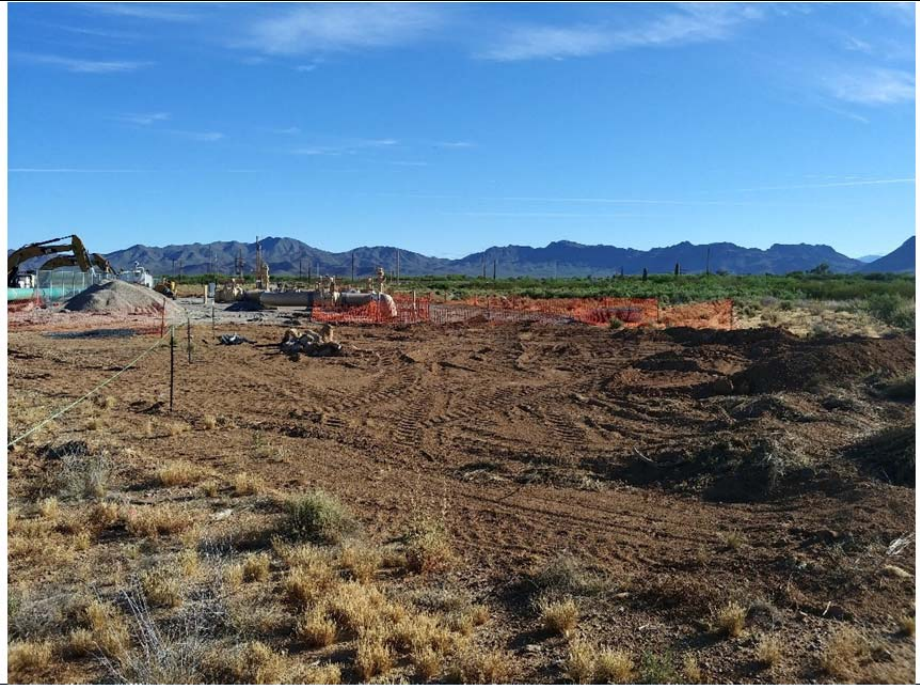
Description: Looking northeast from south side of MLV2 site on 4-19-19.

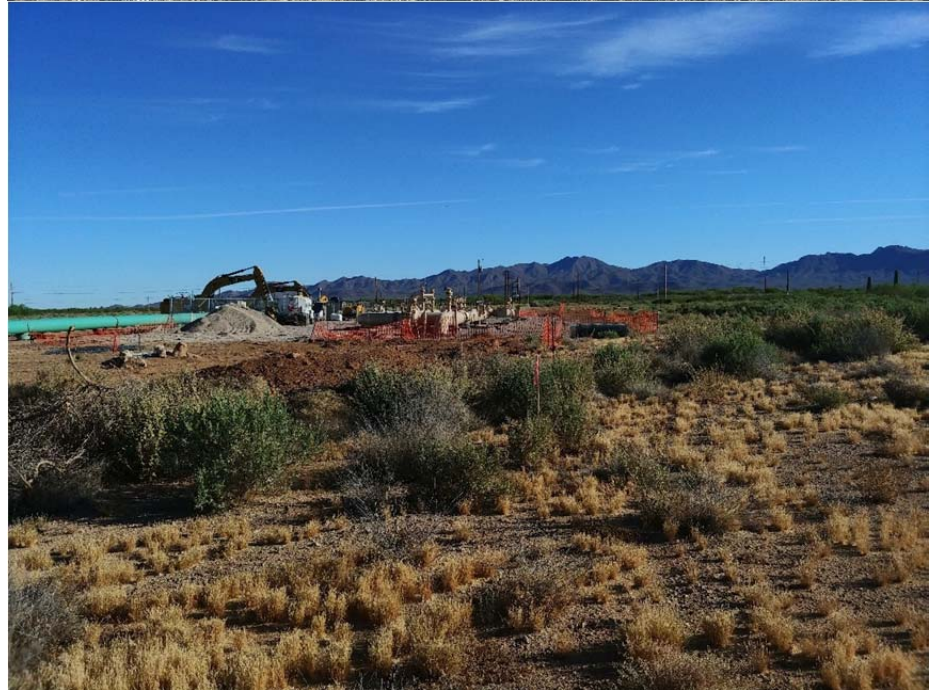
Description: Looking north from southeast corner of MLV2 site on 4-19-19.
