Re: Sierrita Gas Pipeline LLC;
Docket No. CP18-37-000;
Sierrita Compressor Expansion Project;
Project Status Report No. 23

Report No. 23

Sierrita Expansion: Bi-Weekly Environmental Inspector Report		
Docket No. CP18-37-000		
Project Name:	Sierrita Compressor Expansion Project	
County/State:	Pima County, Arizona	Date: 02/27/2020
Reporting Period:	February 9, 2020 to February 22, 2020	
Environmental Inspector:	John Durham	
<p>1. Summary of Construction Activity for Inspection Period: Contractor worked on hydrostatic testing of lead lines and other components. Prepping and painting of components occurred in the paint spraying station. Electrical connection work continued. Component welding, excavation and backfill activities continued. Lube oil flushing and filtration for the Solar Turbine was completed.</p> <p>2. Relevant Environmental Activities: Twelve (12) people received the environmental training during this reporting period. A project total of one hundred eighty-six (186) people have received environmental training.</p> <p>The Environmental Inspector ("EI") monitored the hydrostatic testing water discharge.</p> <p>3. Environmental Problems/Issues and Corrective Actions Taken:

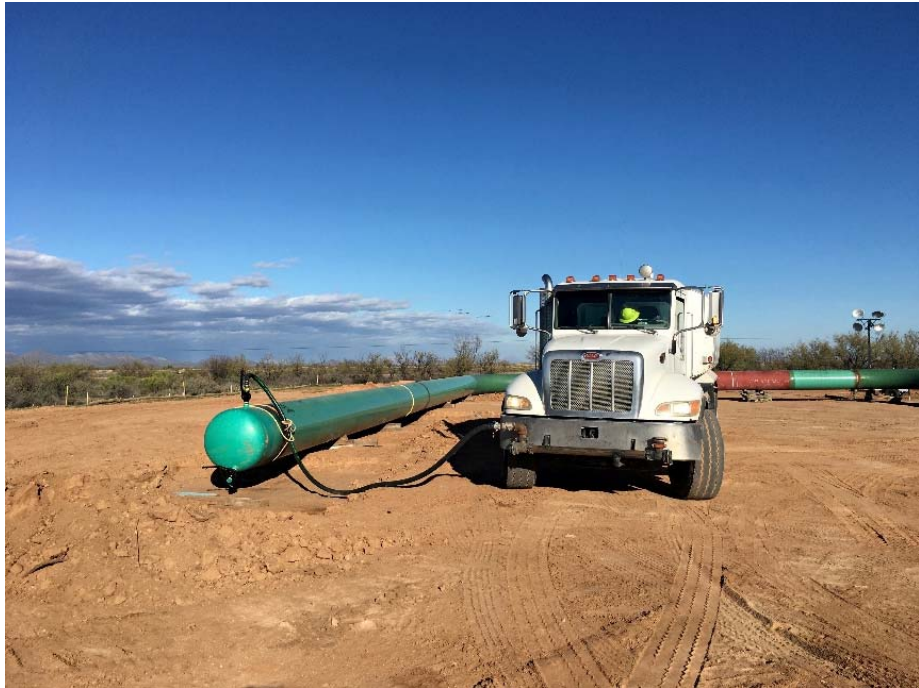
Location: Line
No. 2177 ROW
**Direction/Date of
Photo:** East
02-10-2020
Description:
Preparation for
hydrostatic
testing.

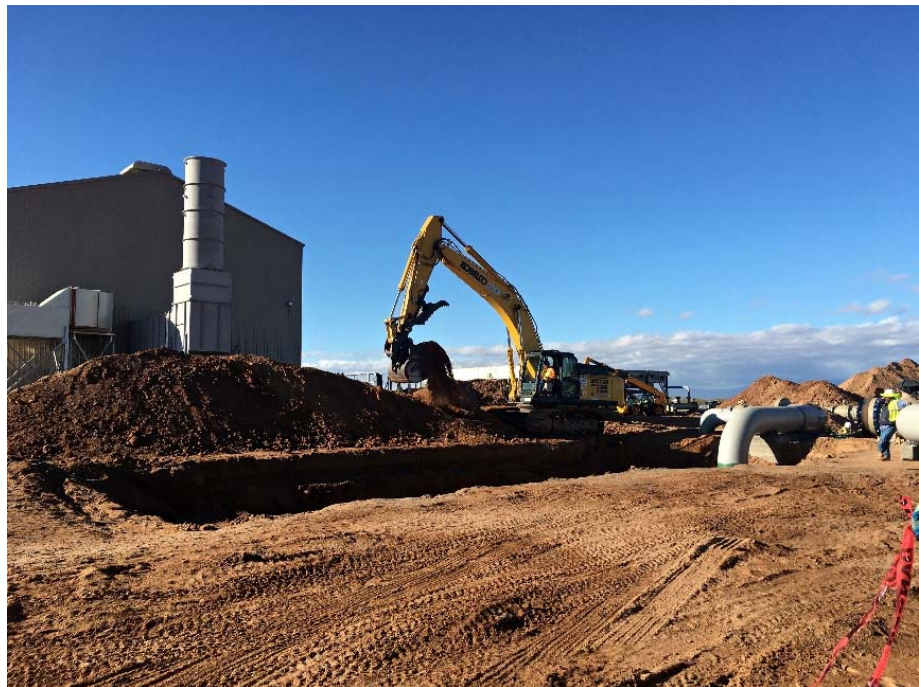
Location:
Compressor
Station Site
**Direction/Date of
Photo:** North
02-10-2020
Description:
Trench
excavation.

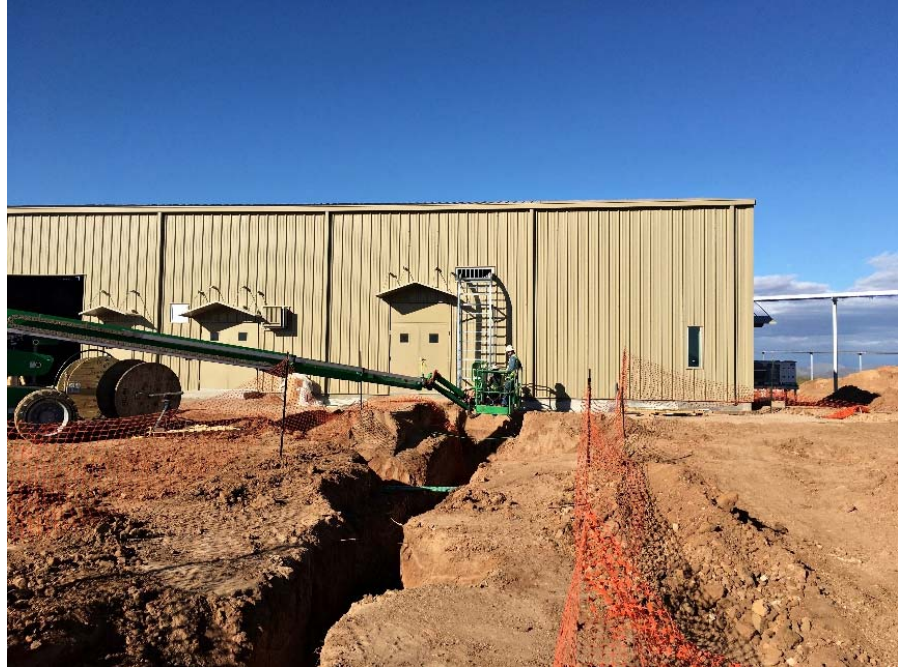
Compressor
Station Site

Description:
Electrical line
installation.

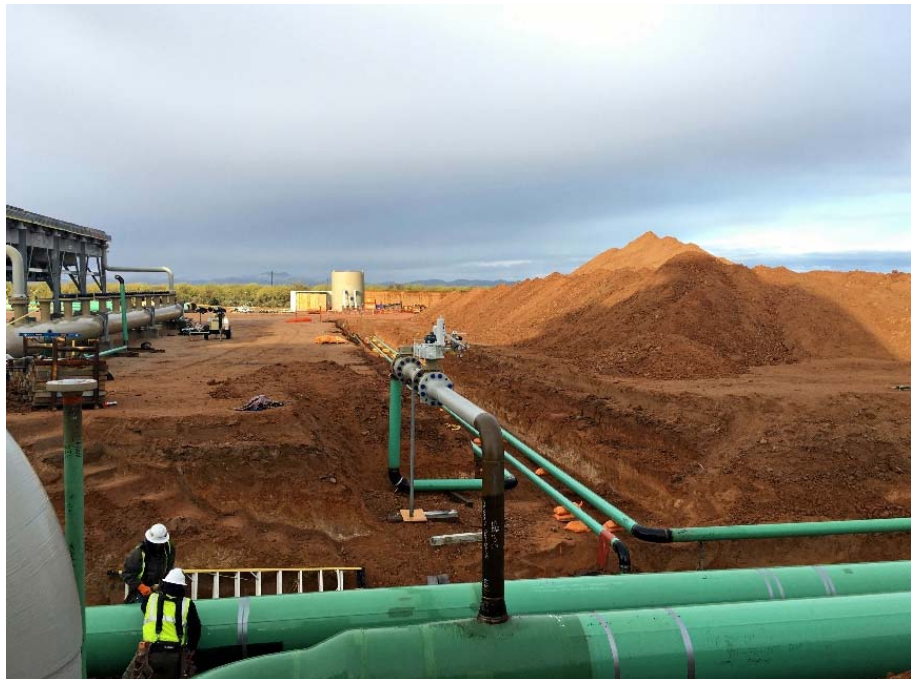
Compressor
Station Site

Description:
Waste oil
separator
connection.

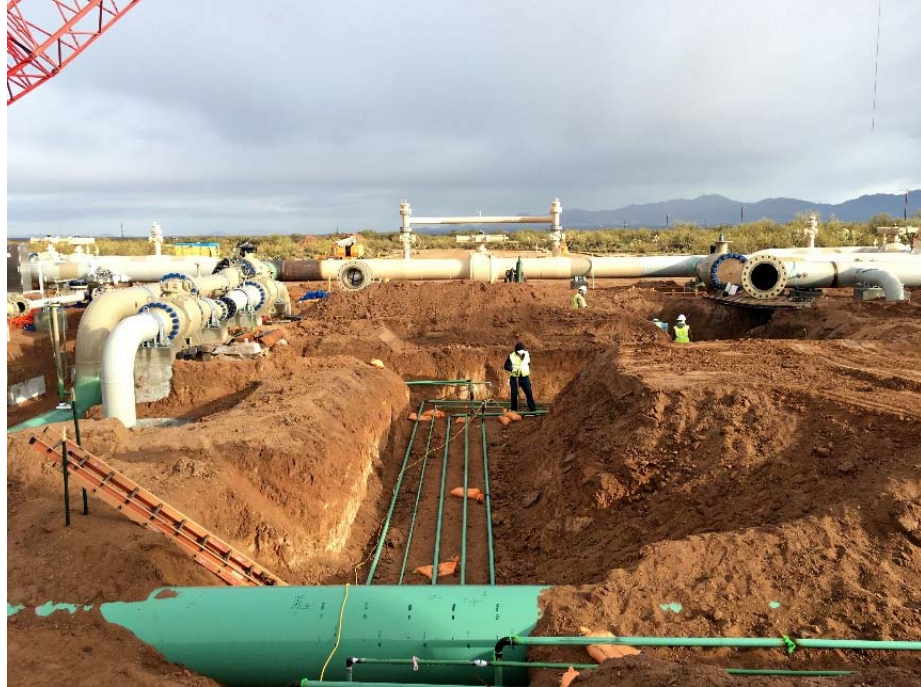
Compressor
Station Site

Utility piping
layout.

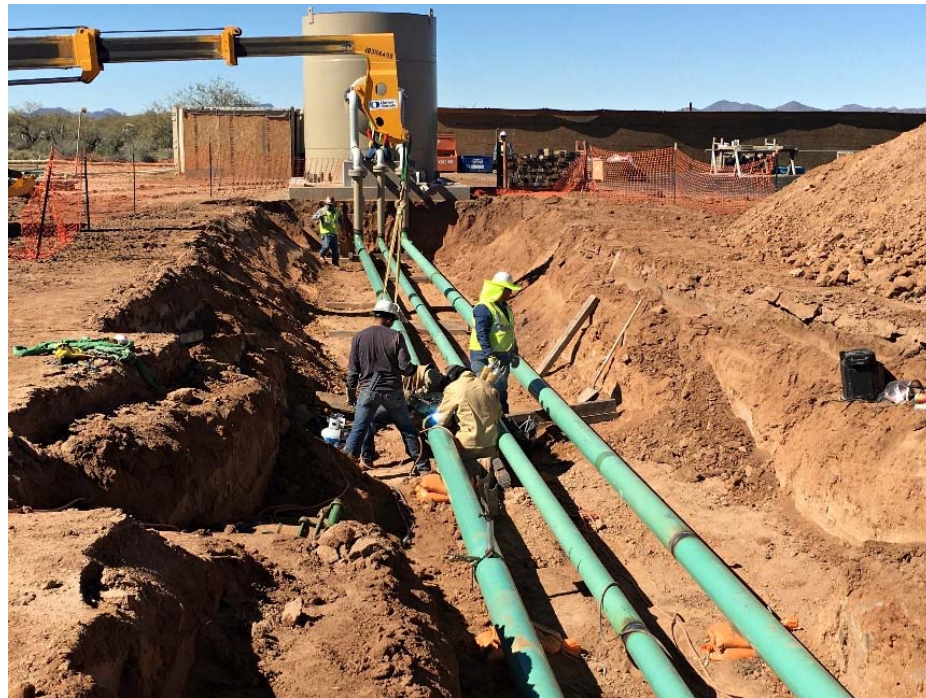
Compressor
Station Site

Welding work.

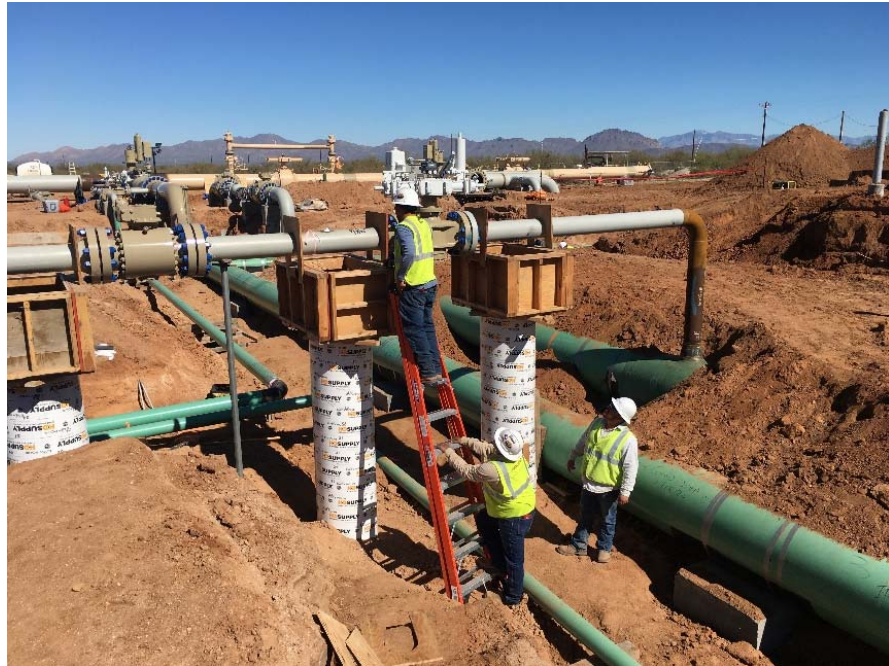
Mainline ROW

Support forms set up.

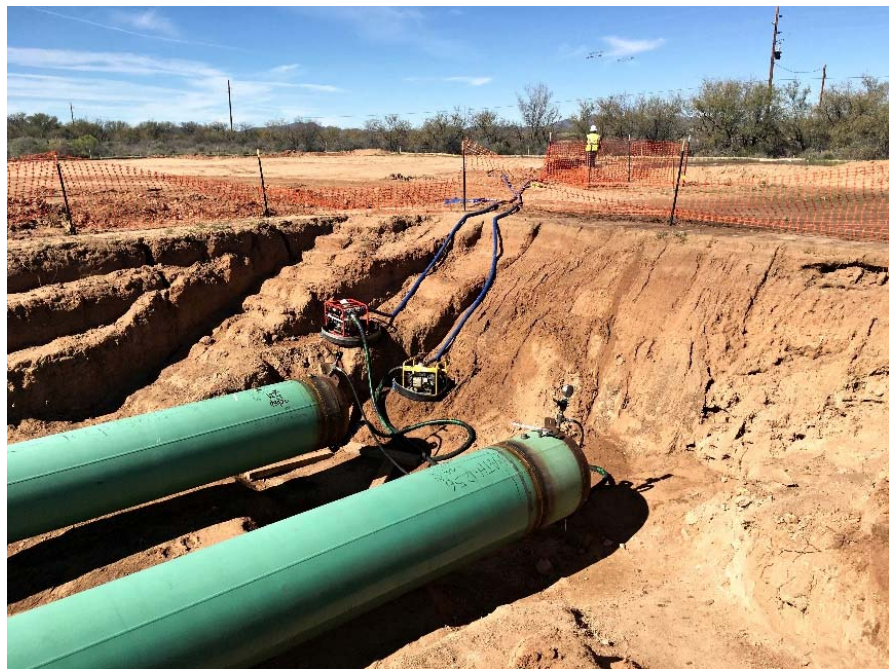
Prepping for
hydro test water
discharge.

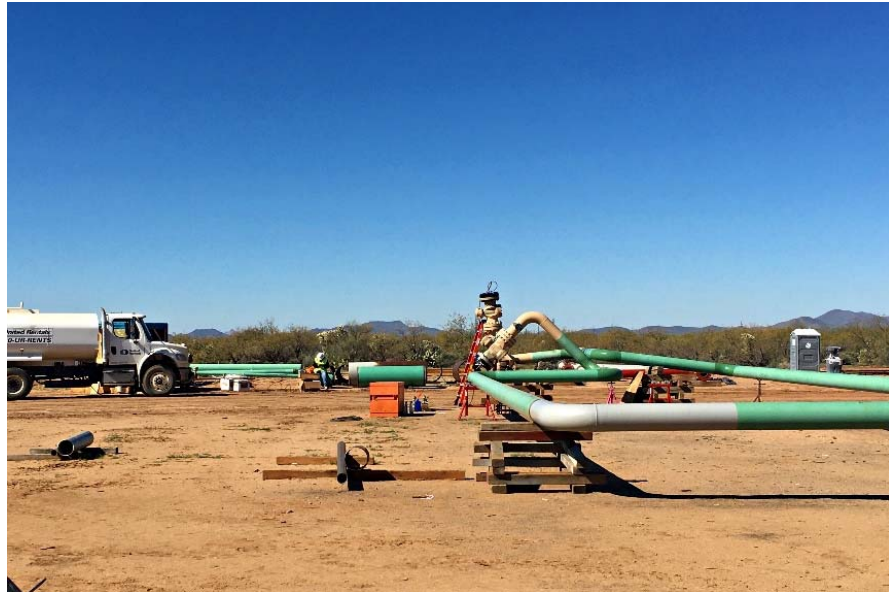
Compressor
Station Site

Hydro testing of
lines.

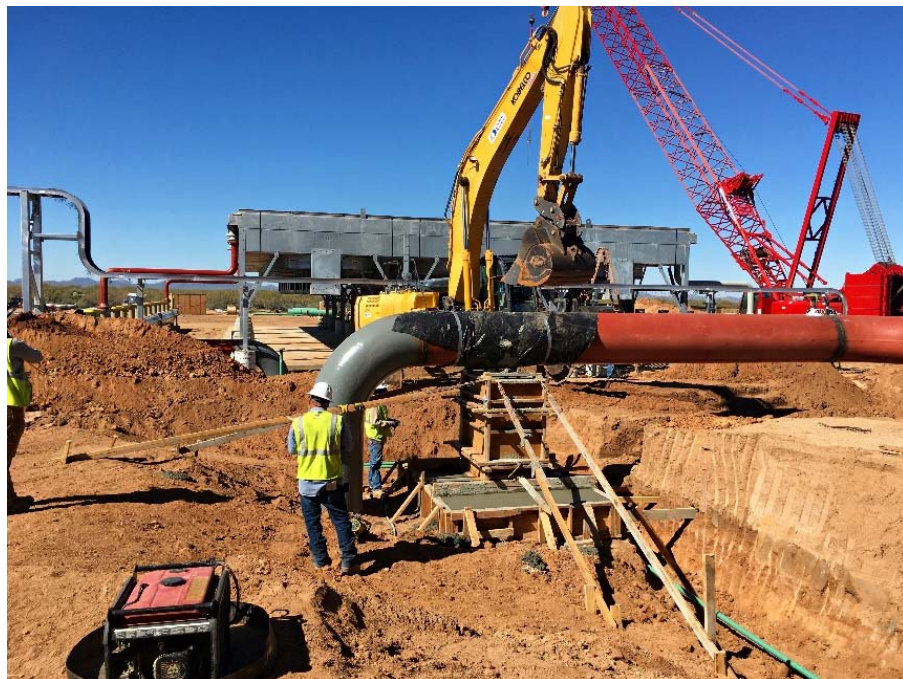
Compressor
Station Site

Concrete
supports forms.

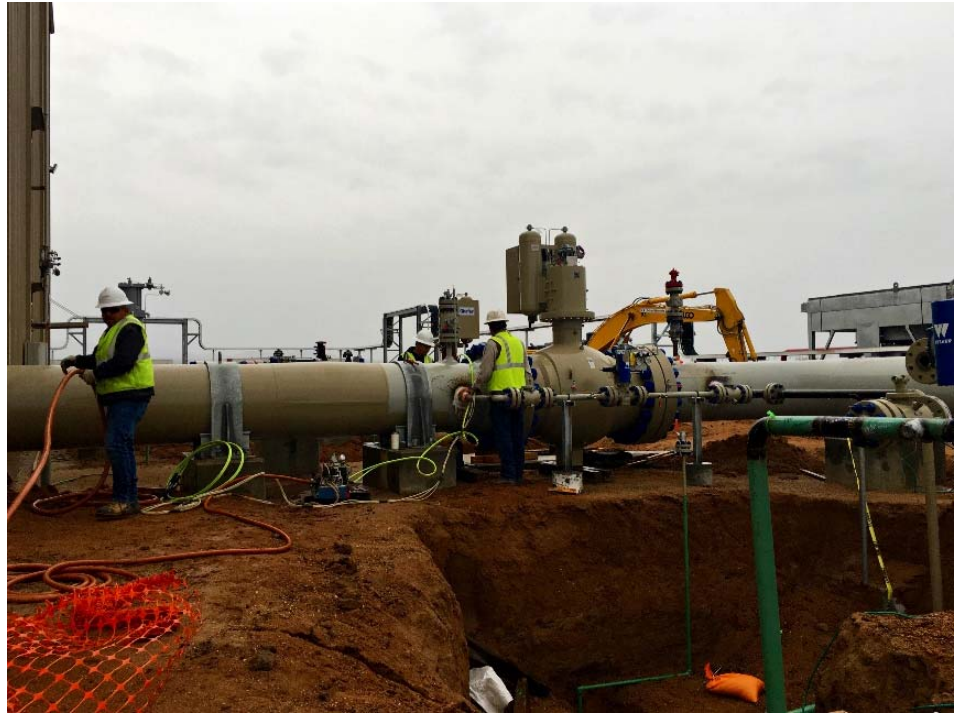
Compressor
Station Site

Description: Pipe
assembly work.

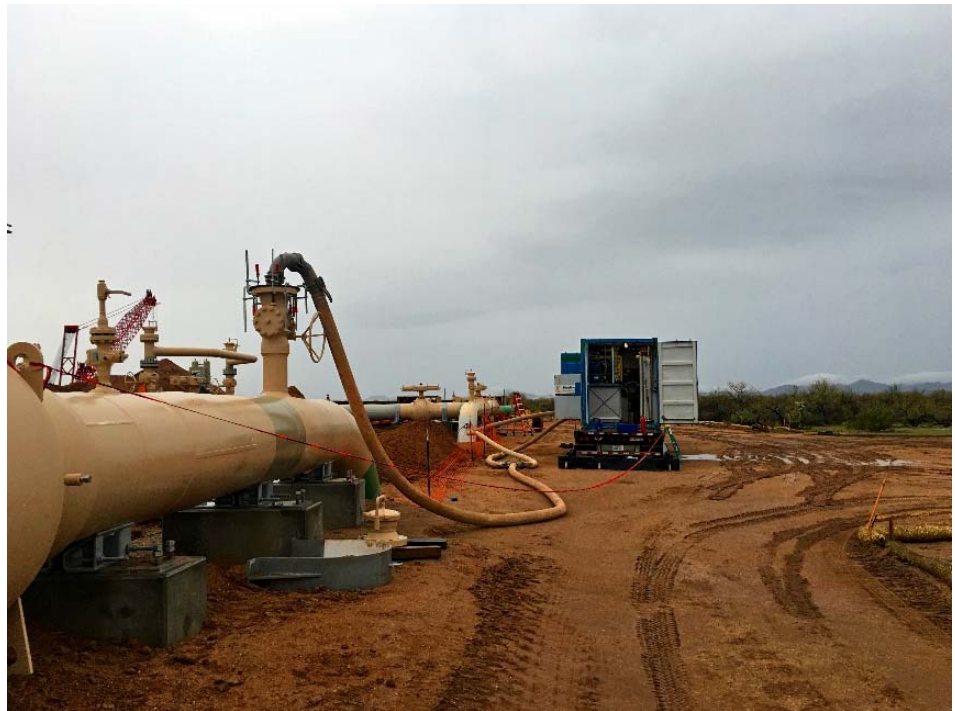
Compressor
Station Site

Description:
Drying pipe after
hydro test.
