Re: Sierrita Gas Pipeline LLC;
Docket No. CP18-37-000;
Sierrita Compressor Expansion Project;
Project Status Report No. 3

Sierrita Expansion Bi-Weekly Environmental Inspector Report No. 3		
Docket No. CP18-37-000		
Project Name:	Sierrita Expansion Project	
County/State:	Pima County, Arizona	Date: 5/23/19
Reporting Period:	May 5, 2019 to May 18, 2019	
Environmental Inspector:	Russell Waldron	
<p>1. Summary of Construction Activity for Inspection Period: During this reporting period, the contractor finished backfilling the ditch. Restoration activities included grading and smoothing the ground surface back to original contours and elevations. The contractor performed cleanup operations. Fence crew mobilized to begin to re-install the chain link security fence. Pole installation was completed.</p> <p>2. Relevant Environmental Activities: During this reporting period, no one received environmental training. A total of twenty-five (25) people have received environmental training on the Sierrita Compressor Expansion Station Project.</p> <p>The contractor has been using water trucks for dust control.</p> <p>3. Environmental Problems/Issues and Corrective Actions Taken: There were no envi

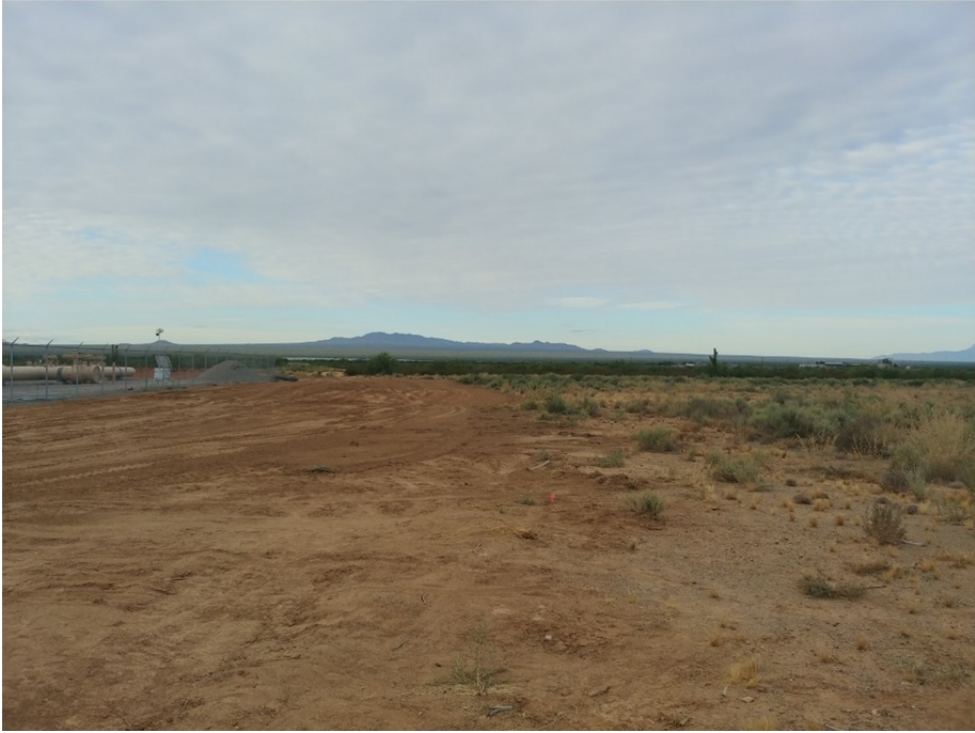
Location: MP 1.2/MLV2
Direction of Photo: South
Description: Looking south from northwest corner of MLV2 workspace on 05-10-19.

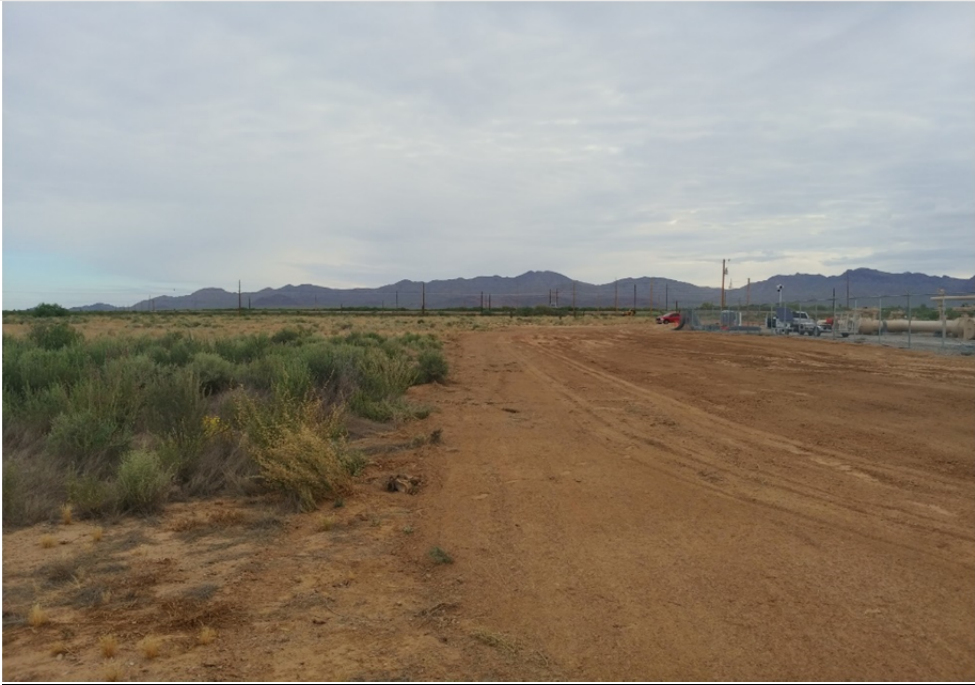
Location: MP 1.2/MLV2
Direction of Photo: North
Description: Looking north along the west boundary of the workspace from southwest corner on 05-10-19.

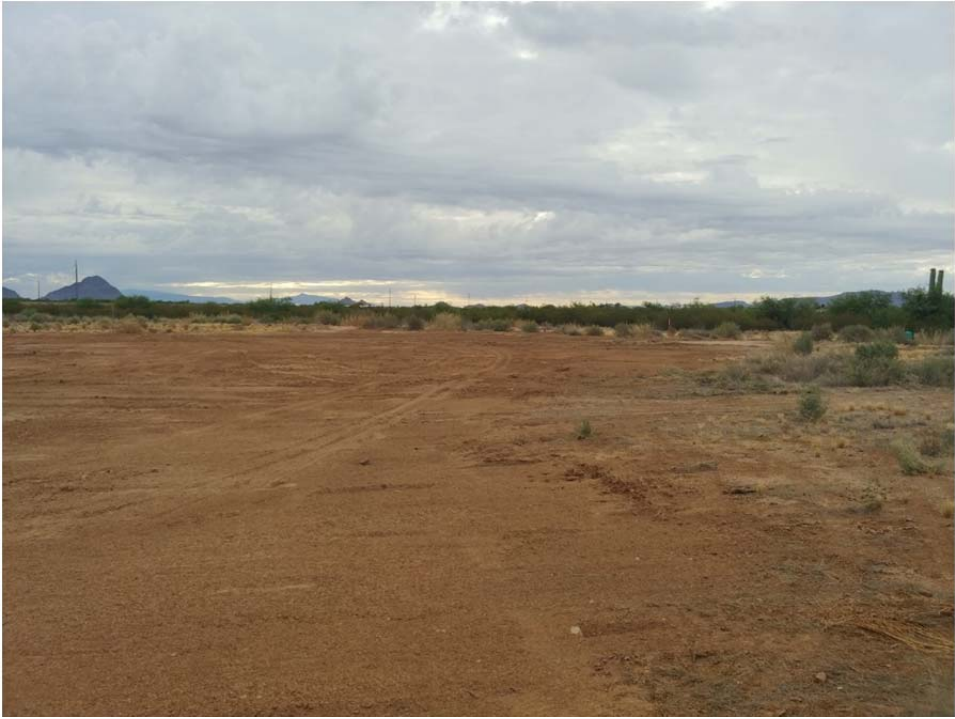
Location: MP 1.2/MLV2
Direction of Photo: Southeast
Description: Looking southeast from southwest corner on 05-10-19.

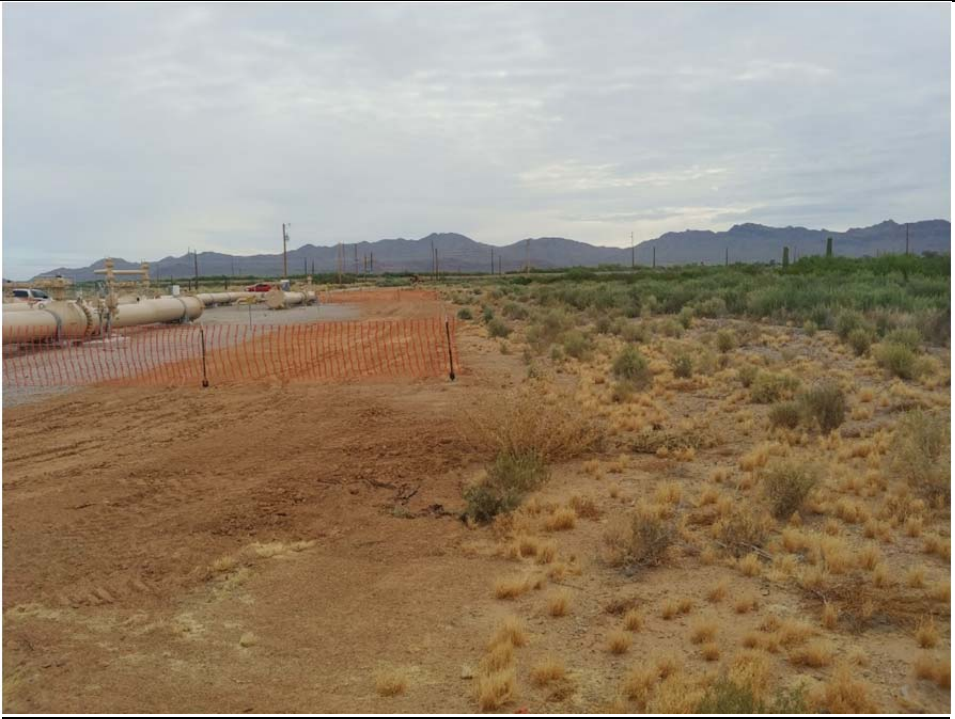
Location: MP 1.2/MLV2
Direction of Photo: North
Description: Looking north along the east workspace boundary on 05-10-19.

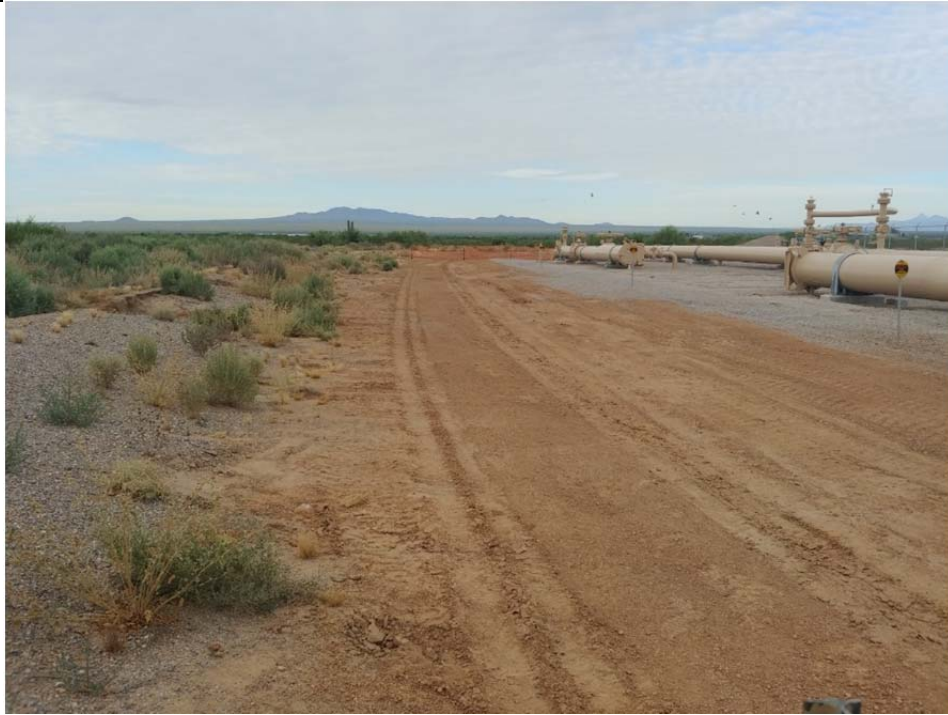
Location: MP
1.2/MLV2
**Direction of
Photo:** South
Description:
Looking south
along the east
workspace
boundary on 05-
10-19.

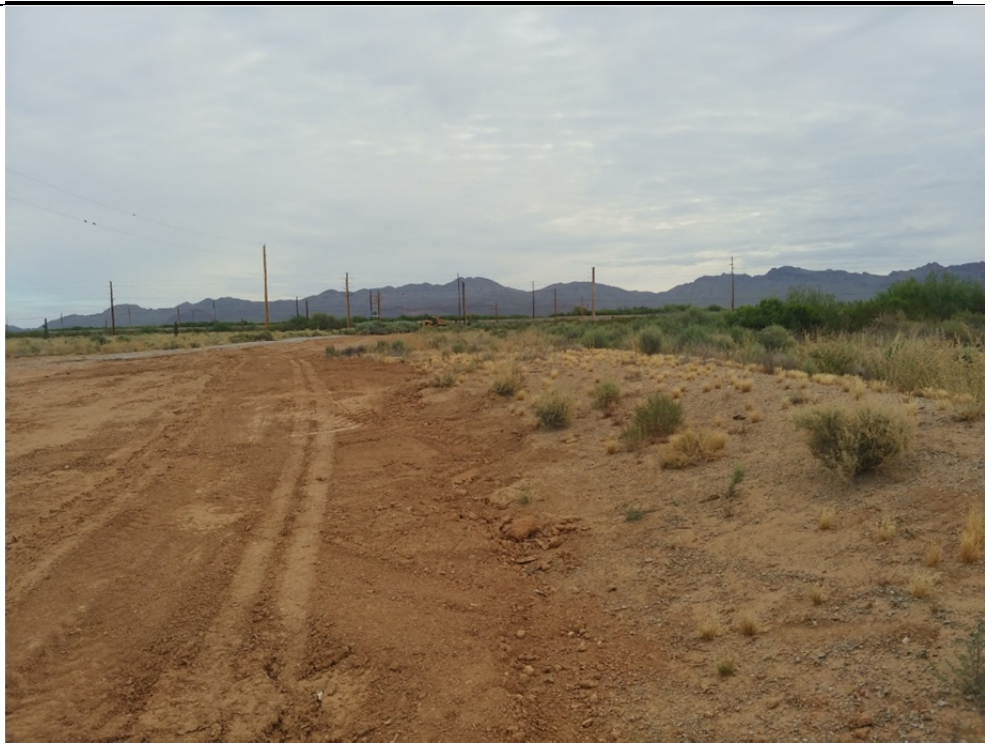
Location: MP
1.2/MLV2
**Direction of
Photo:** North
Description:
Looking north
from north side of
MLV2 facility on
05-10-19.

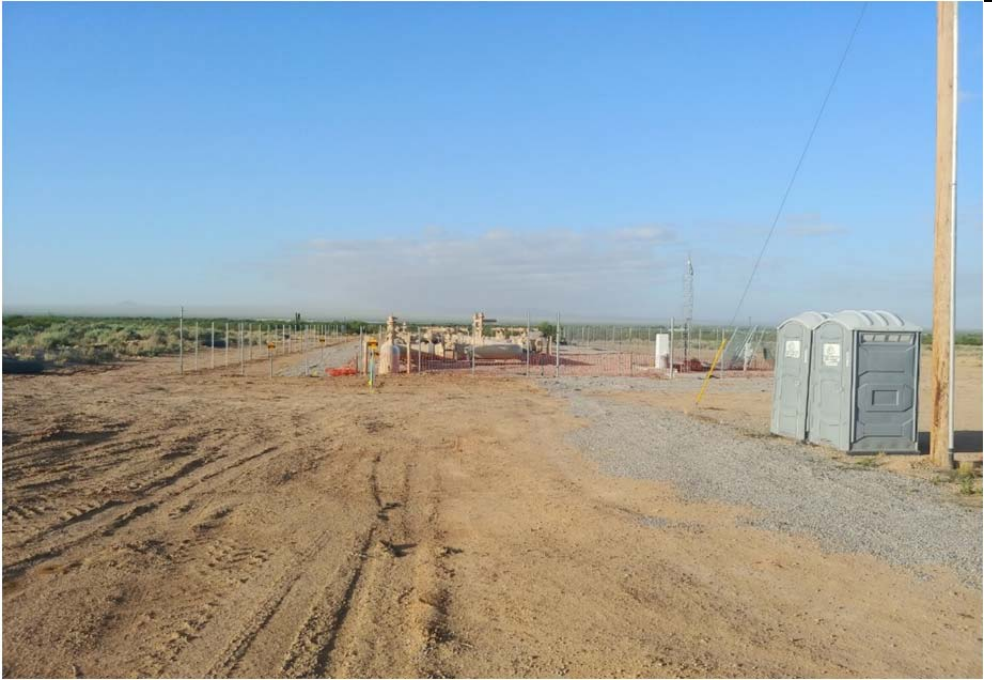
Location: MP 1.2/MLV2
Direction of Photo: South
Description: Looking south from north side of site on 05-17-19. Note chain-link fence poles.

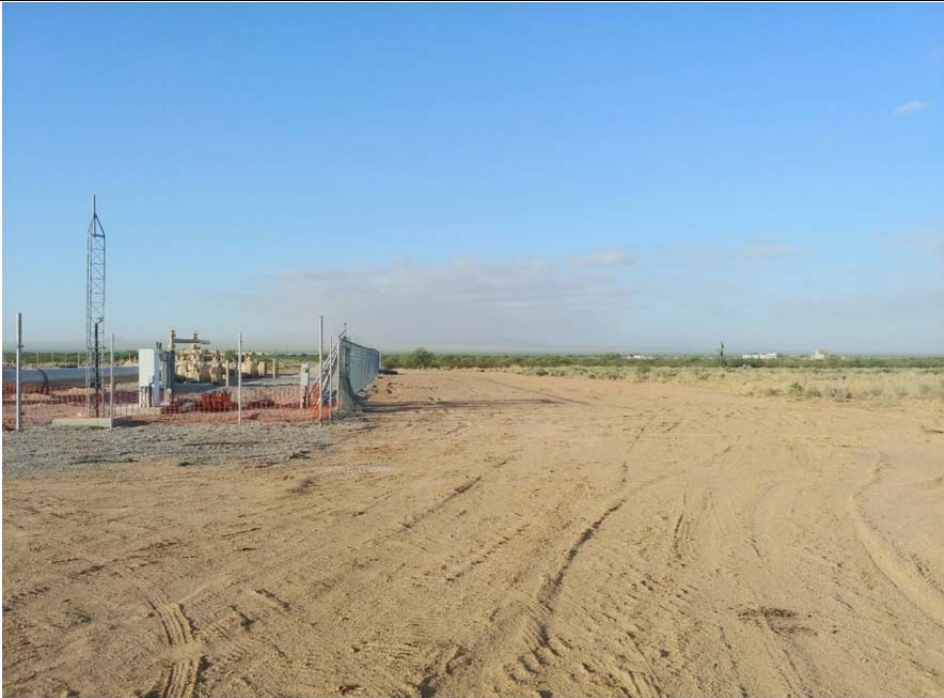
Location: MP 1.2/MLV2
Direction of Photo: South
Description: Looking south along the west side of the workspace 05-17-19.

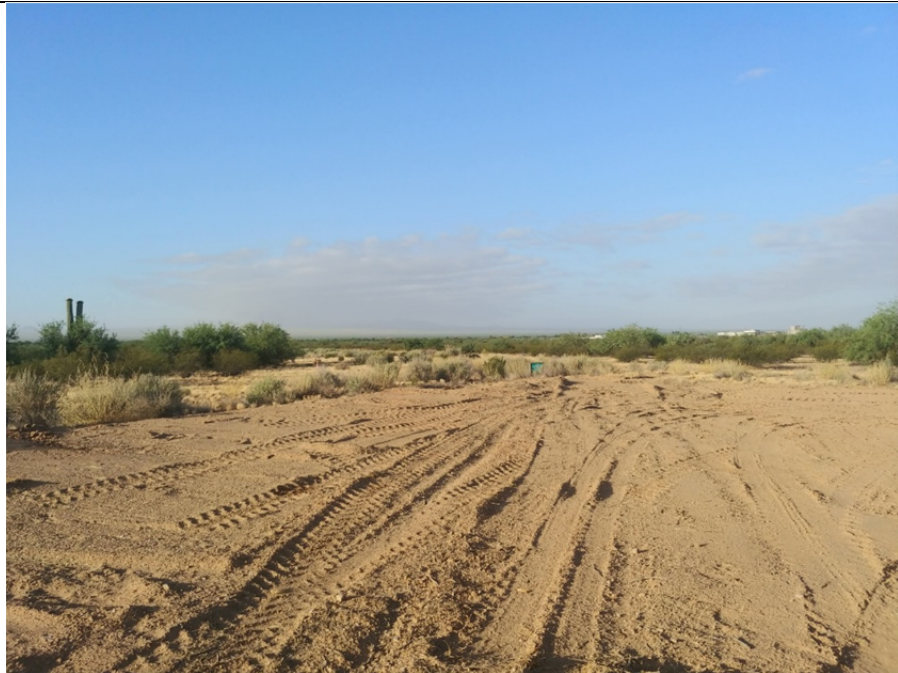
Location: MP
1.2/MLV2
Direction of Photo:
Southeast
Description: Looking southwest from the southeast corner of the workspace 05-17-19.

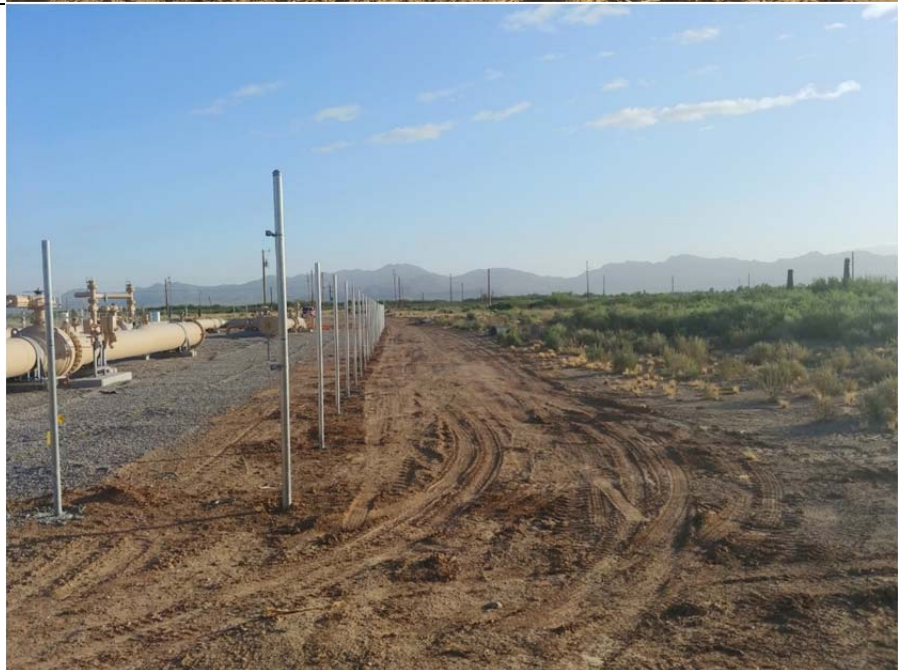
Location: MP
1.2/MLV2
Direction of Photo:
North
Description: Looking north along the east side of the workspace at on 05-17-19.

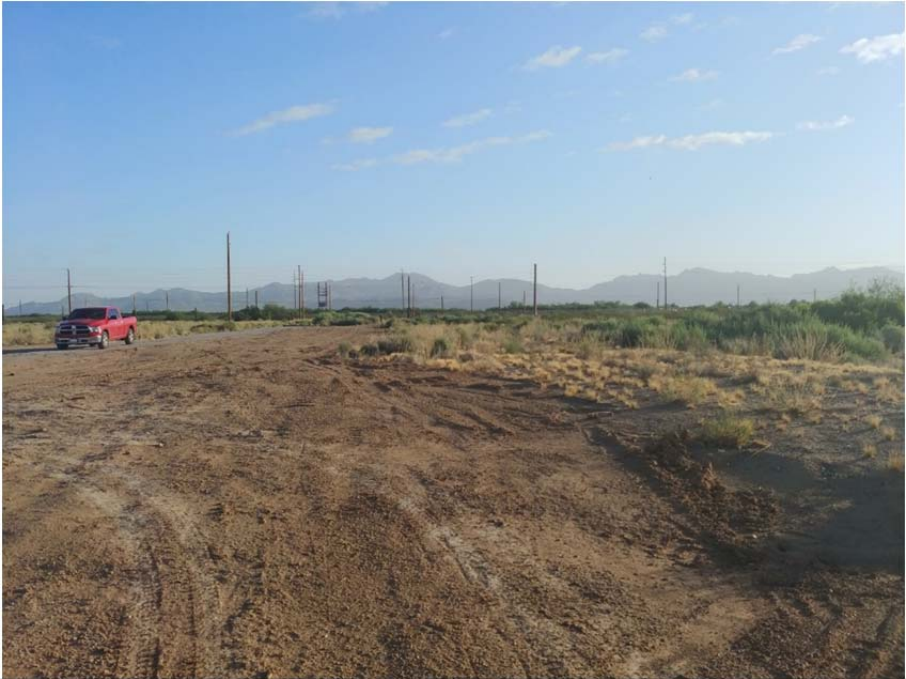
Description: Looking north from northwest corner of workspace along pipeline ROW and MLV2 access road on 05-17-19.
