Re: Sierrita Gas Pipeline LLC;
Docket No. CP18-37-000;
Sierrita Compressor Expansion Project;
Project Status Report No. 4

Sierrita Expansion Bi-Weekly Environmental Inspector Report No. 4		
Docket No. CP18-37-000		
Project Name:	Sierrita Expansion Project	
County/State:	Pima County, Arizona	Date: 6/6/19
Reporting Period:	May 19, 2019 to June 1, 2019	
Environmental Inspector:	Russell Waldron	
<p>1. Summary of Construction Activity for Inspection Period: During this reporting period, the security fence installation was completed on May 22nd. Seeding was completed using broadcast seeding technique.</p> <p>2. Relevant Environmental Activities: During this reporting period, no one received environmental training. A total of twenty-five (25) people have received environmental training on the Sierrita Compressor Expansion Station Project.</p> <p>No relevant environmental issues were noted during this reporting period.</p> <p>3. Environmental Problems/Issues and Corrective Actions Taken: There were no environmental problems or issues identified during this reporting period.</p> <p>4. Environmental Compliance Issues/Resolutions: There were no environmental compliance issues identified duri

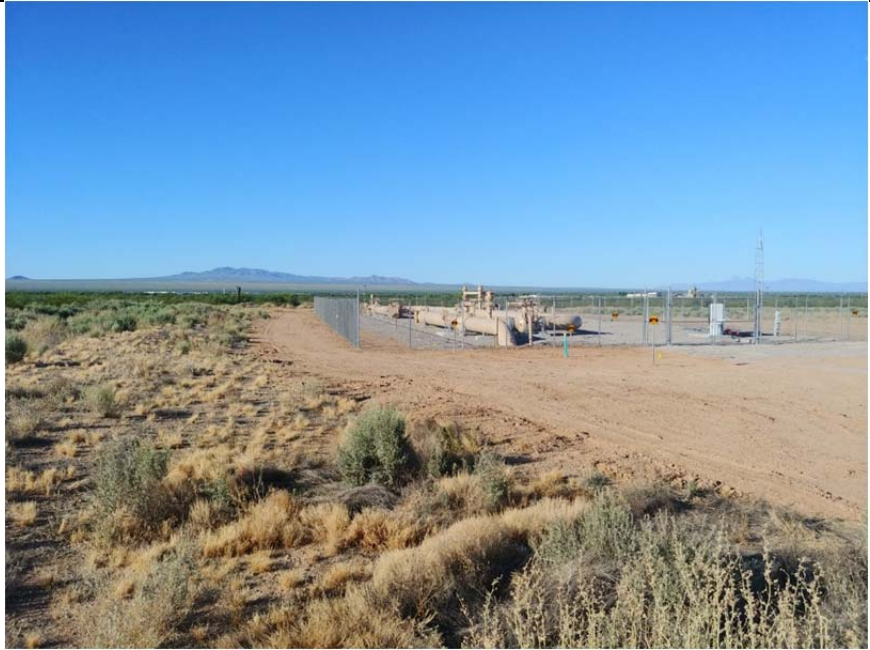
Location: MP 1.2/MLV2
Direction of Photo: South
Description: Looking south from northeast of the site after seeding activities were completed.

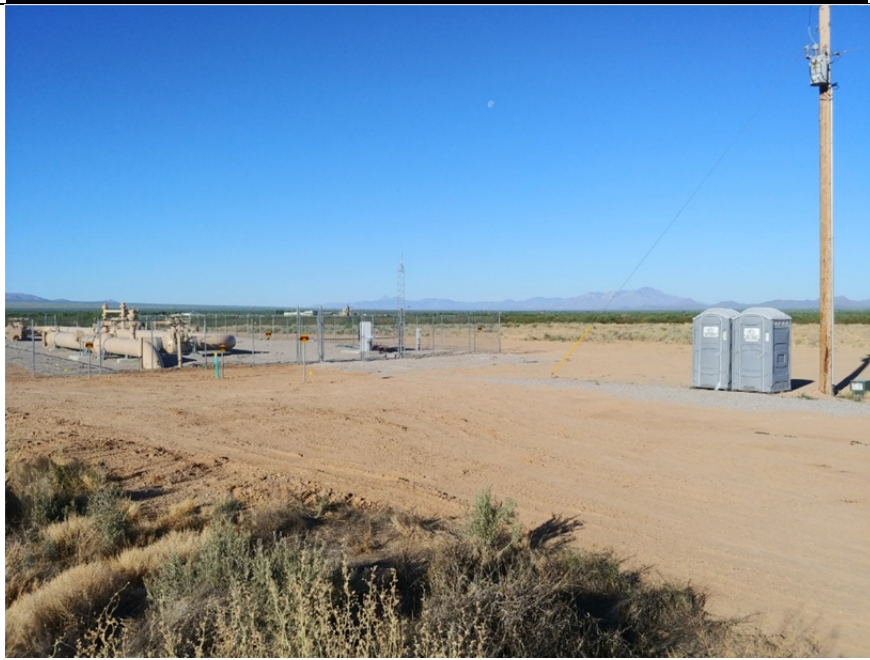
Location: MP 1.2/MLV2
Direction of Photo: Northeast
Description: Looking southwest from the northeast after seeding activities were completed.
