Re: Sierrita Gas Pipeline LLC; Docket No. CP13-73-000; <u>Quarterly Post-Construction Status Report</u>

In accordance with the Project's Upland Erosion Control, Revegetation, and Maintenance Plan reporting requirements, Sierrita is herein filing a quarterly status report describing its post-construction maintenance/reclamation efforts for the period of October 1, 2018 to December 31, 2018.

#### Sierrita Pipeline Project

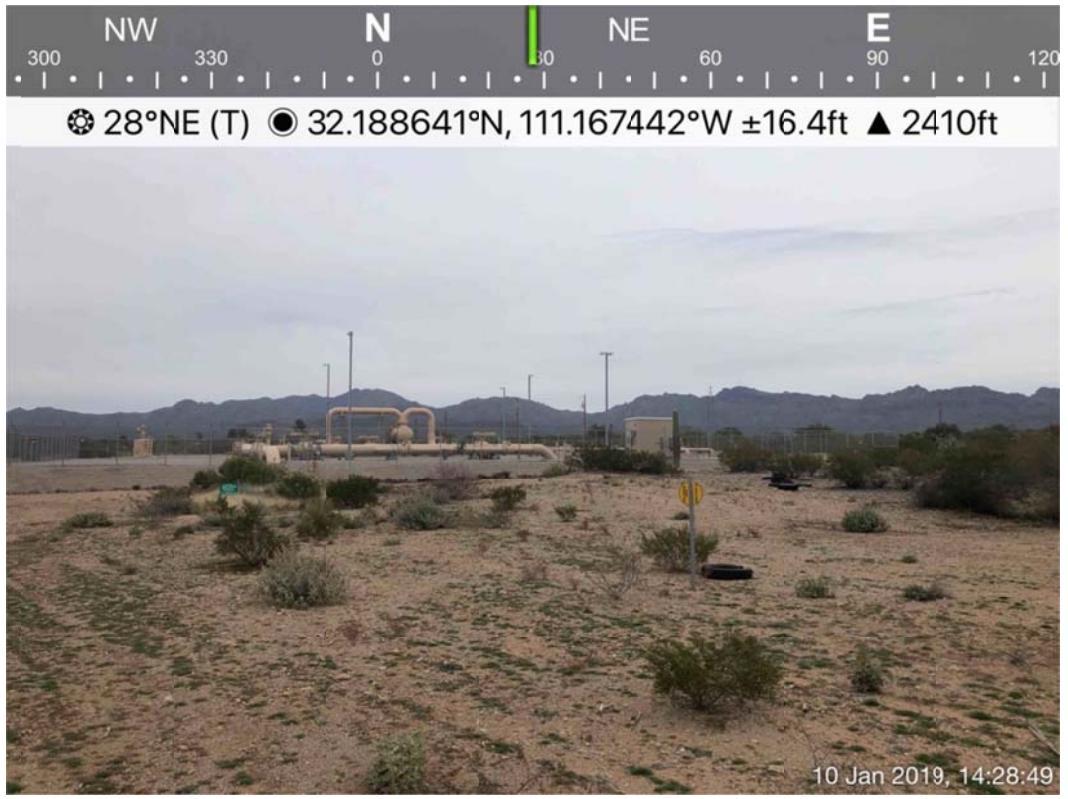
Milepost 0 prior to clean-up activities

During this reporting period, Sierrita completed subsidence repairs at approximately milepost 51.5 and milepost 3 and conducted ROW clean up at approximately milepost 0 all as requested by the FERC inspector during the November 27<sup>th</sup> and 28<sup>th</sup> restoration inspection as noted above.

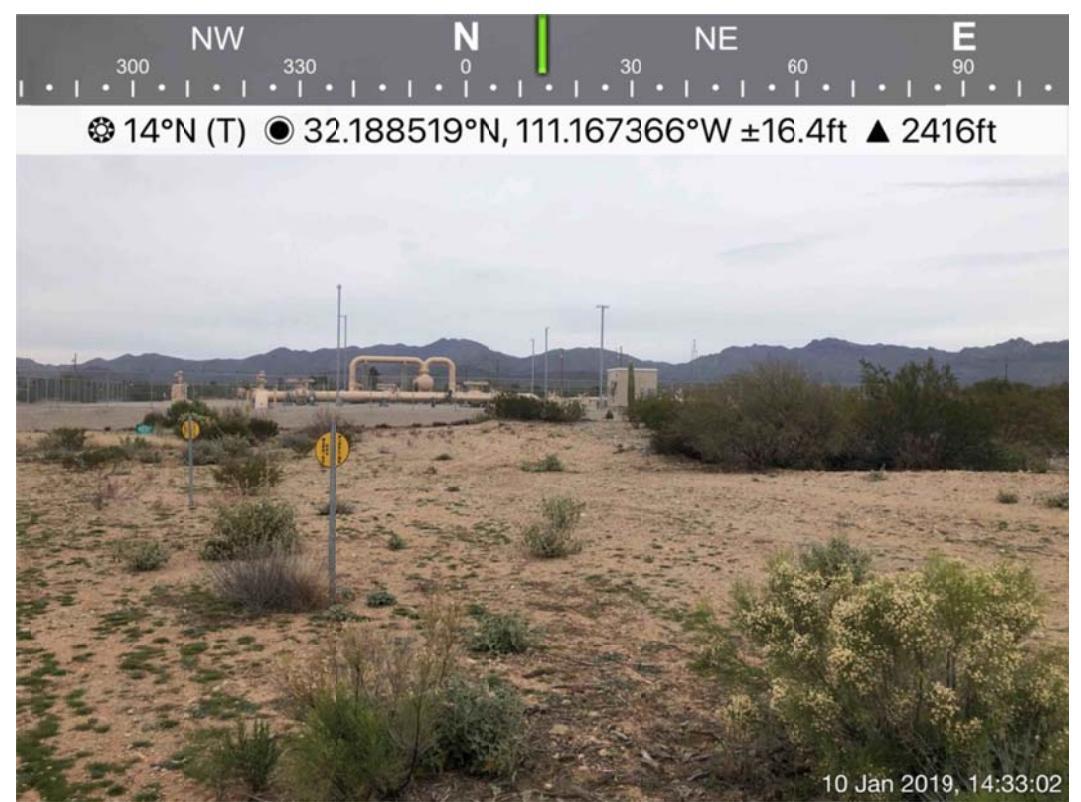
Milepost 0 after clean-up activities

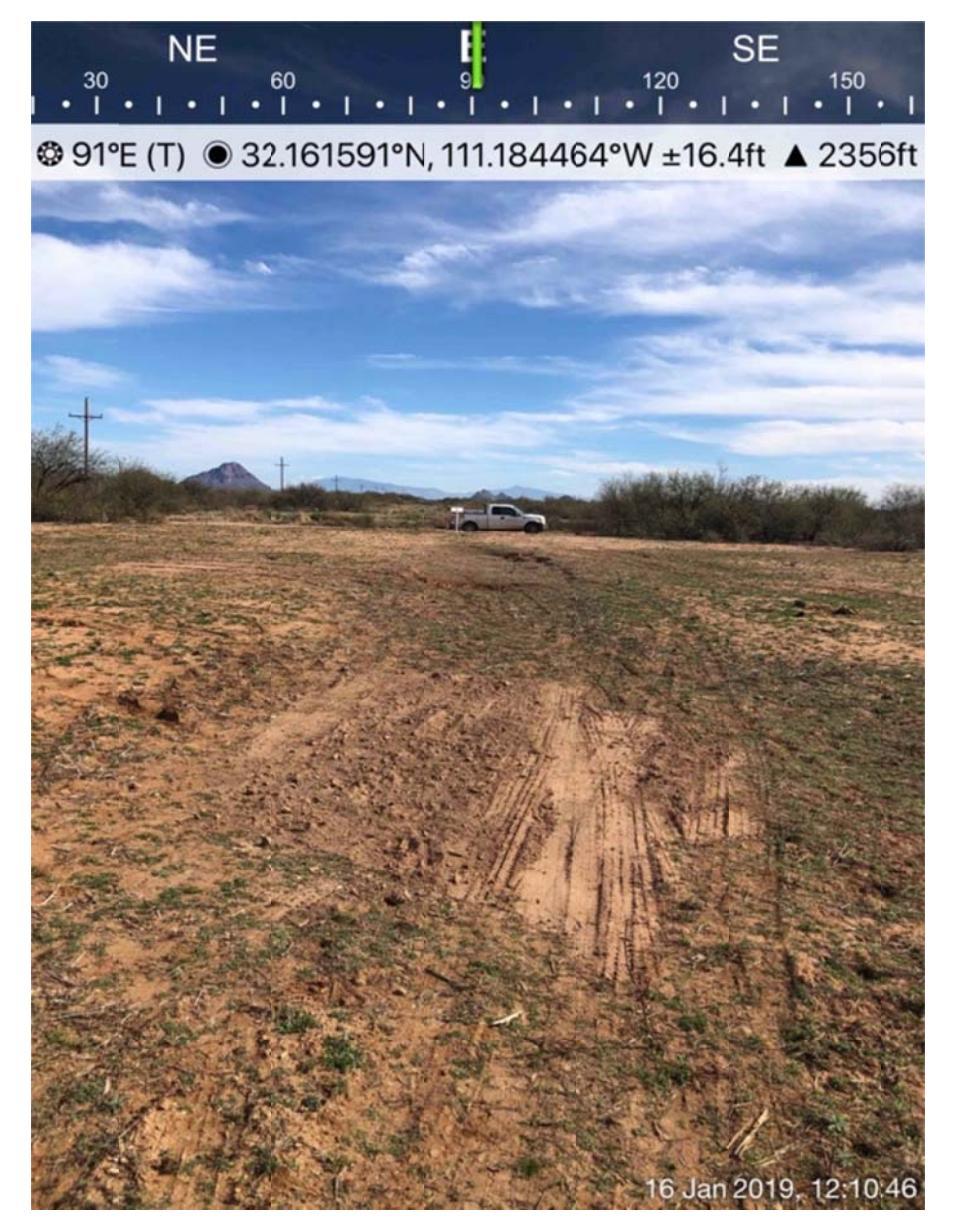
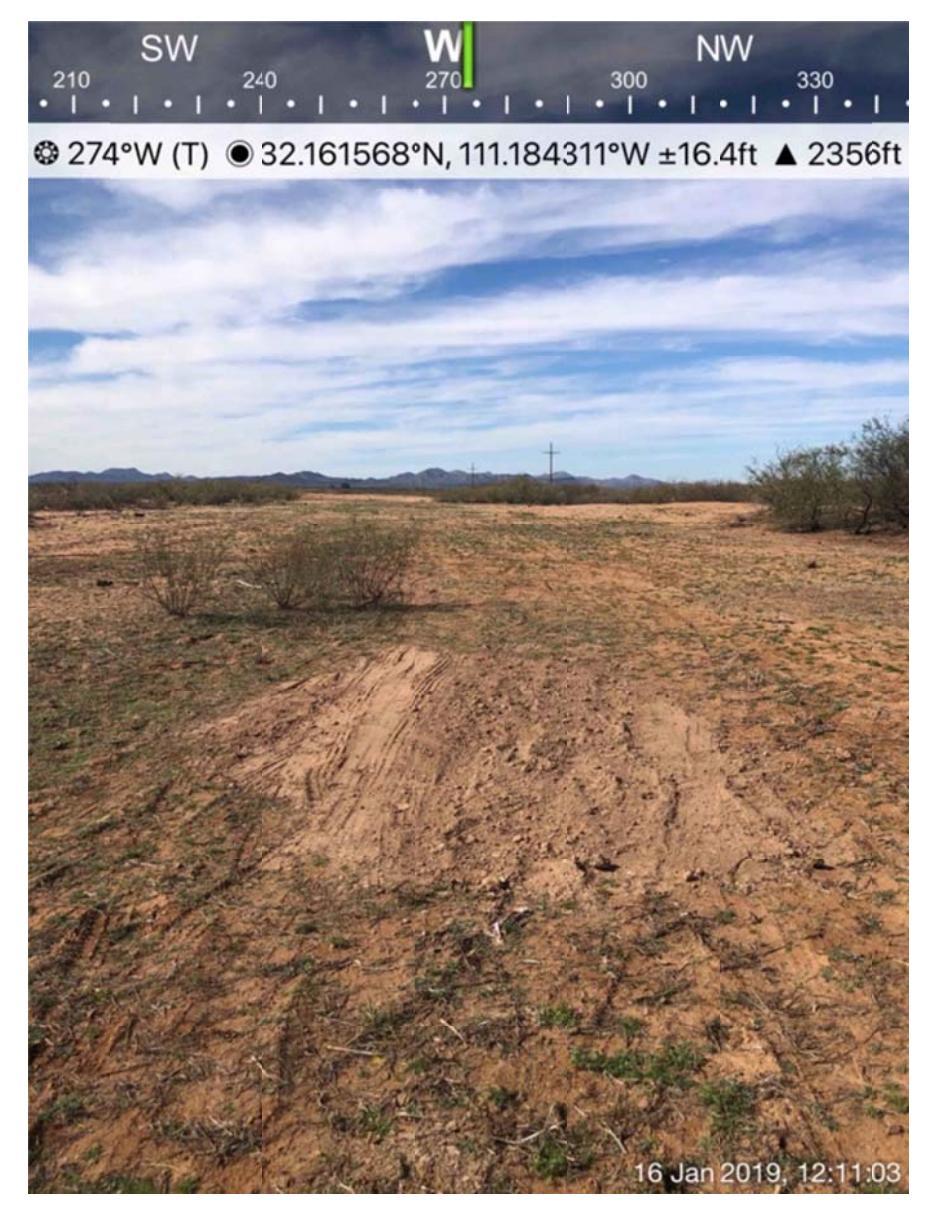
Completed subsidence repairs at milepost 3, view east

Completed subsidence repairs at milepost 3, view west

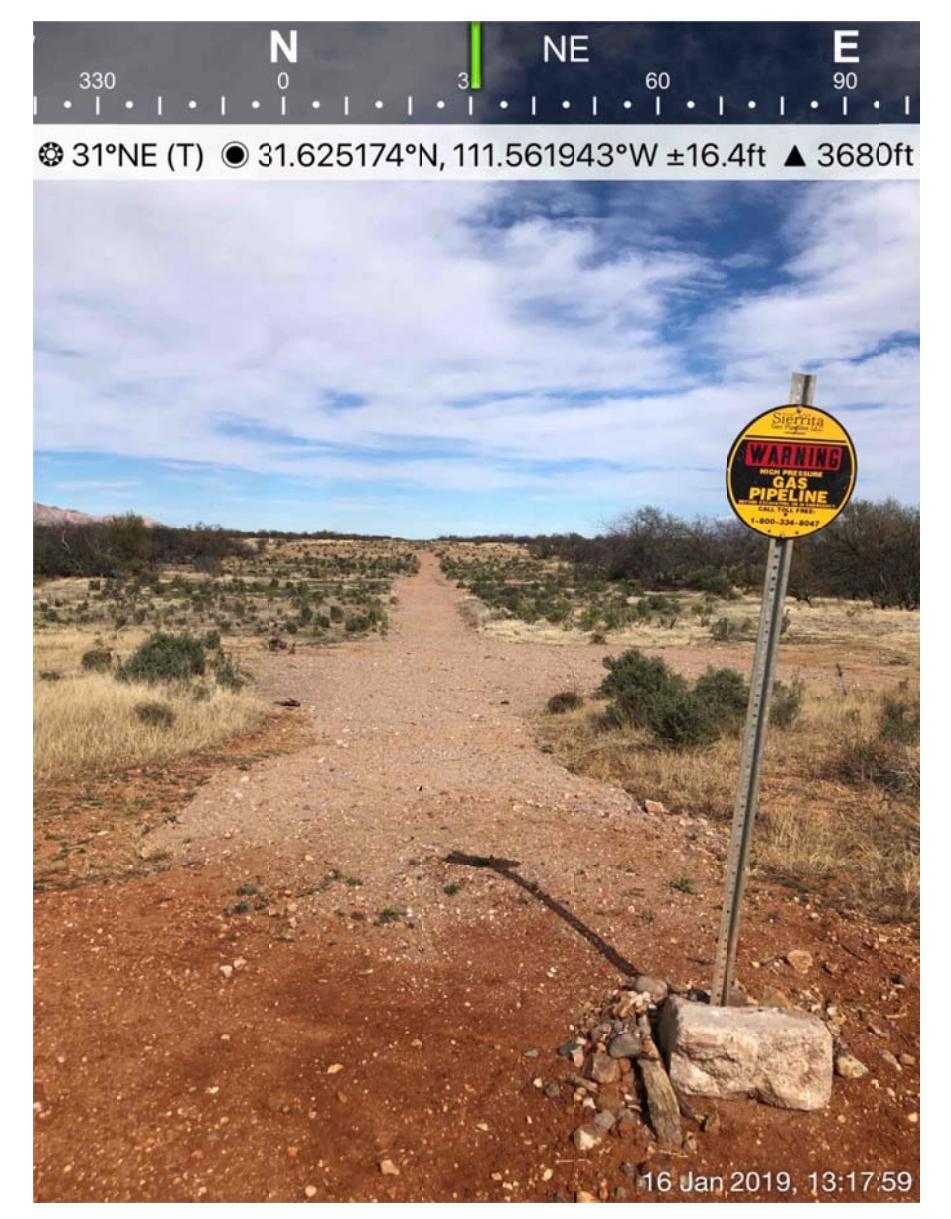
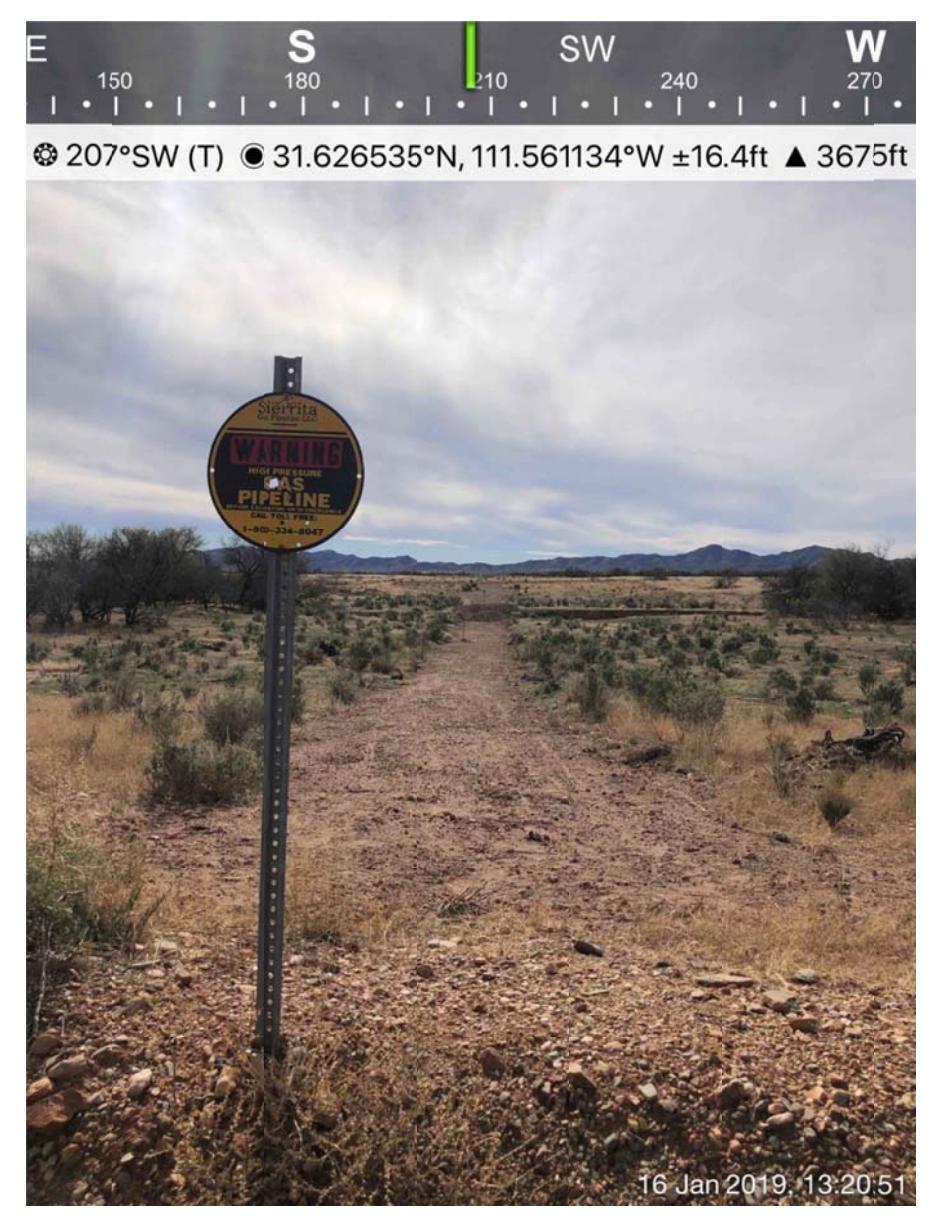
Completed subsidence repairs at milepost 51.5, view south

Completed subsidence repairs at milepost 51.5, view north
