Re: El Paso Natural Gas Company, L.L.C.;
Docket No. CP19-30-000
Kiwani's Delivery Meter Station Project
Weekly Environmental Inspector Report No. 2

EPNG's Weekly Environmental Inspector Report No. 2		
Docket No. CP20-483-000		
Project Name:	Carlsbad South Project	
County/State:	Eddy and Lea Counties, New Mexico	Date: 09/11/2020
Reporting Period:	08/31/2020 – 9/6/2020	
Environmental Inspector:	Raymond Patton	
<p>1. SUMMARY OF CONSTRUCTION ACTIVITY FOR INSPECTION PERIOD:</p> <p><u>Line No. 31113:</u> The contractor continued fencing, grading, grubbing activities. Bell hole excavation started at hot taps. A hammer track hoe is being used to remove rock during excavation.</p> <p><u>Eunice Compressor Station Modifications:</u> No updates during this reporting period.</p> <p><u>Ancillary Facilities:</u> No updates during this reporting period.</p> <p>2. RELEVANT ENVIRONMENTAL ACTIVITIES: During this reporting period, forty-one (41) people received environmental training. A total of one-hundred eighty-two (182) people have received the training on the Carlsbad South Project.</p> <p>Water trucks are operating on Permanent Access Road (PAR) 1 and 3 for dust control. Access road signs were

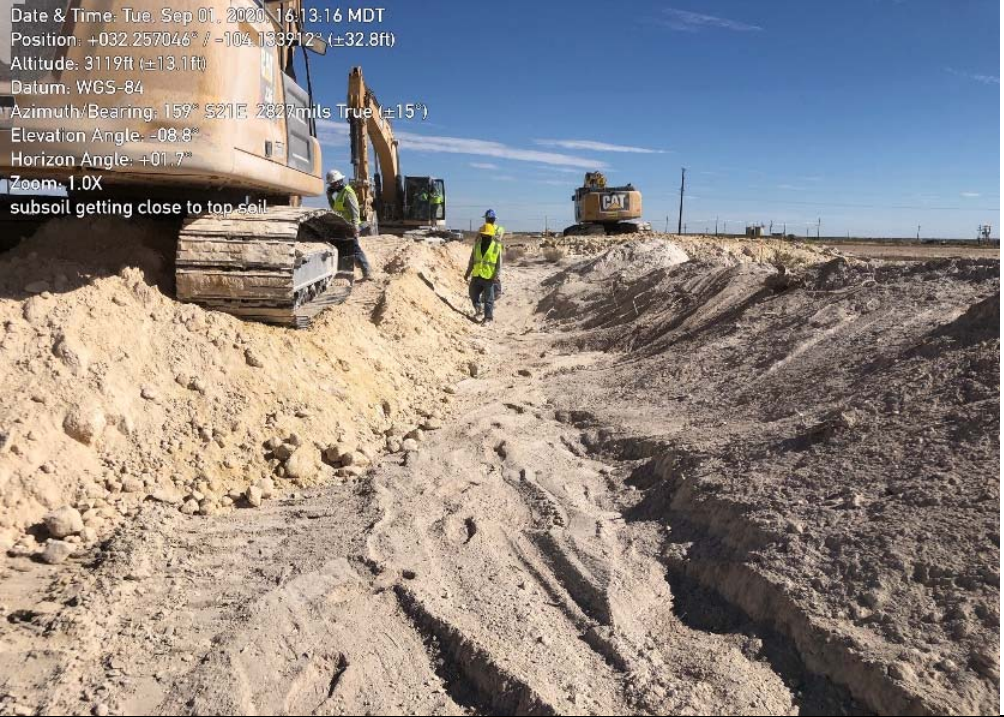
Location: Station Number 7+39

Description: Topsoil and subsoil piles encroaching on each other. Contractor was instructed to maintain separation of the subsoil and topsoil. (See picture dated 9/11/2020 with Geotech fabric between the piles to prevent mixing.)

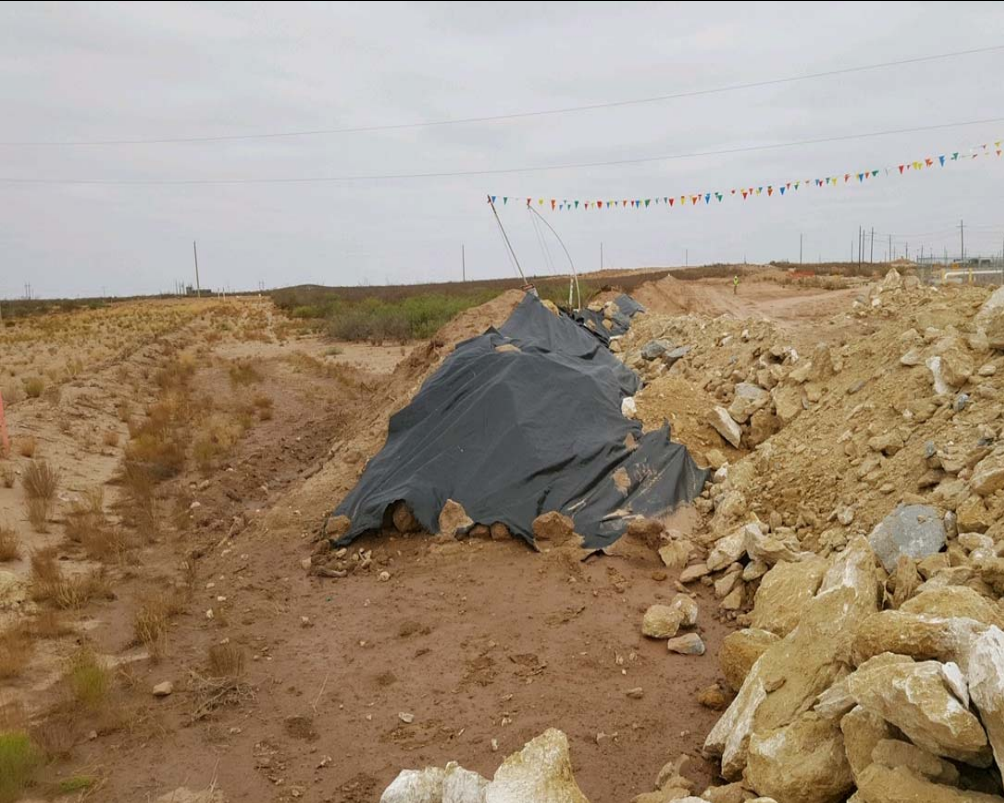
Location: Station Number 7+39

Description: Topsoil and subsoil piles with Geotech fabric between the piles to prevent mixing.

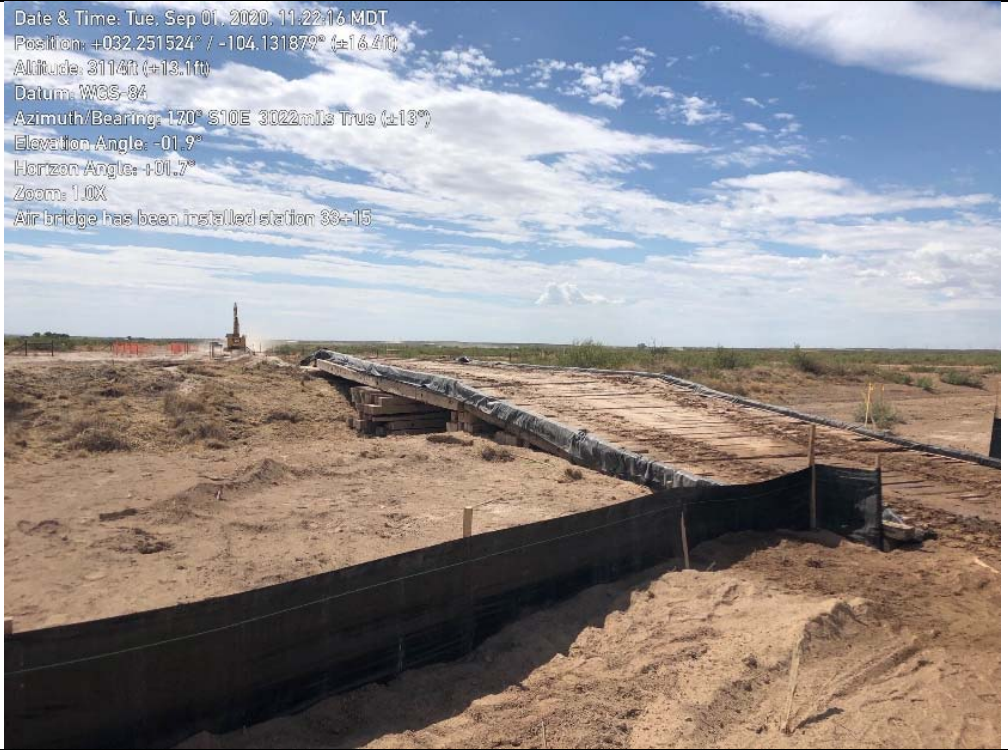
Location: Station Number 28+00
Direction of Photo: East
Description: Air bridge with Geotech and side boards.
Date: 9/1/2020

Date & Time: Tue, Sep 01, 2020, 11:22:16 MDT
Position: +032.251524° / -104.131879° (±16.4ft)
Altitude: 3114ft (±13.1ft)
Datum: WGS-84
Azimuth/Bearing: 170° S10E 3022mils True (±13°)
Elevation Angle: -01.9°
Horizon Angle: +01.7°
Zoom: 1.0X
Air bridge has been installed station 33+15

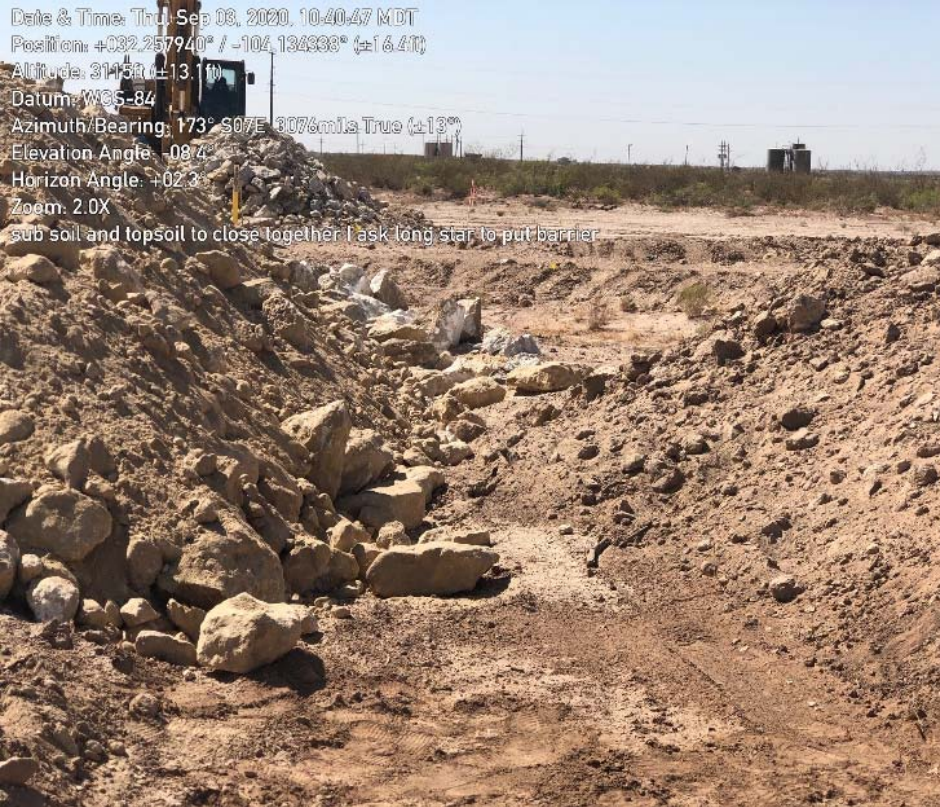
Location: Station Number 7+30
Direction of Photo: North
Description: Subsoil encroaching on topsoil. Contractor was instructed to install Geotech fabric to separate the piles.
Date: 9/3/2020

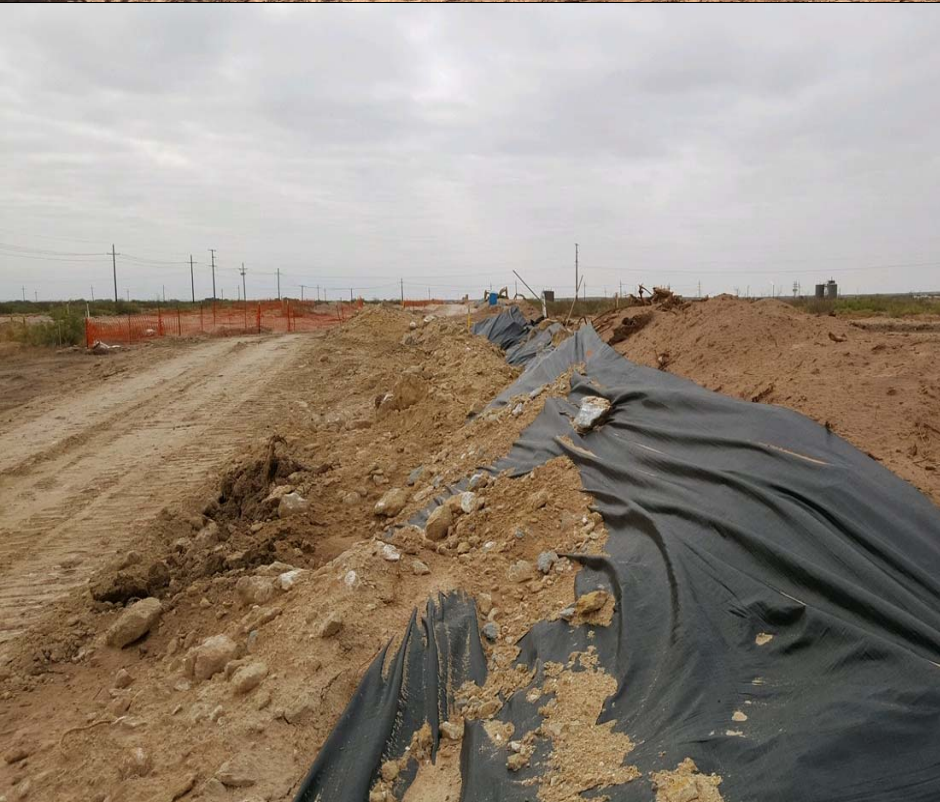
Location: Station Number 7+30
Direction of Photo: South
Description: Topsoil and subsoil piles with Geotech fabric between the piles to prevent mixing.
Date: 9/11/2020
